**Customer: PRINCETON PLASMA PHYSICS LAB**

Contact: Mike Viola  
E-Mail: [mviola@pppl.gov](mailto:mviola@pppl.gov)

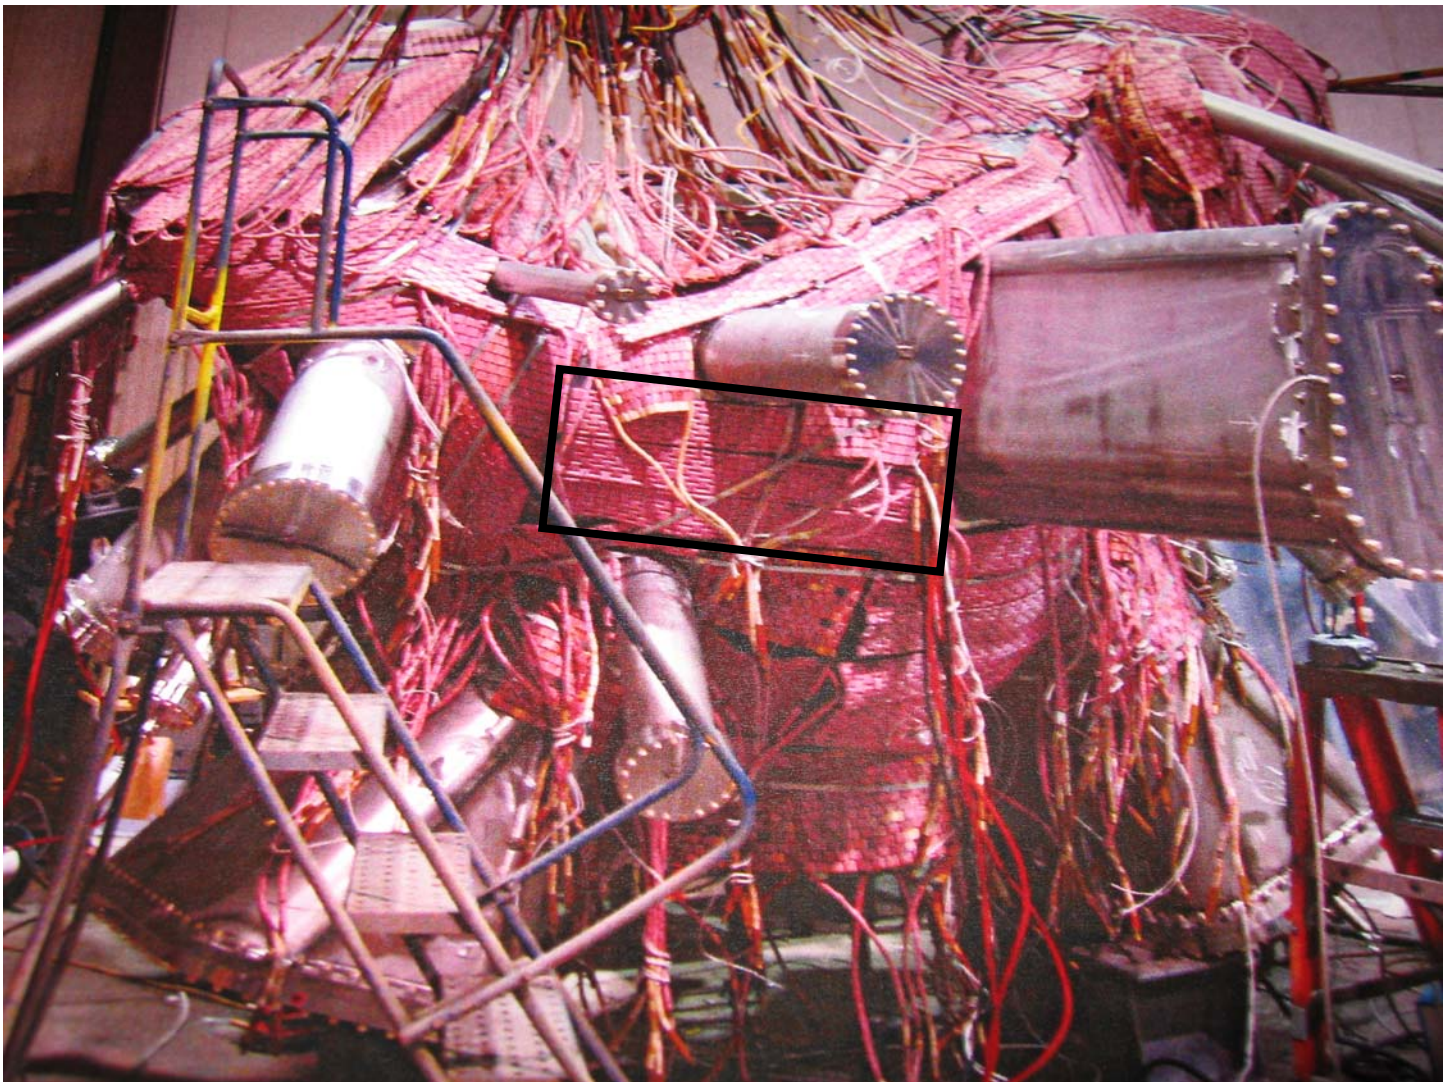
**Project Disposition:**
