Customer: PRINCETON PLASMA PHYSICS LAB

Contact: LARRY SUTTON
E-Mail: S-04286-F

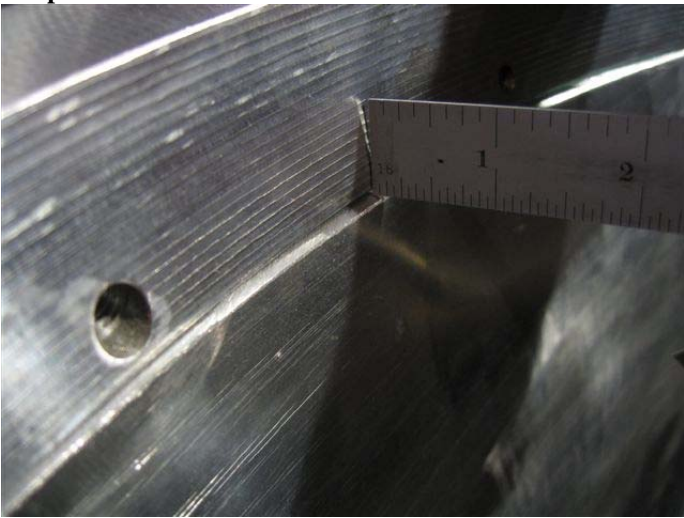
8 O'clock Inside of Flange B

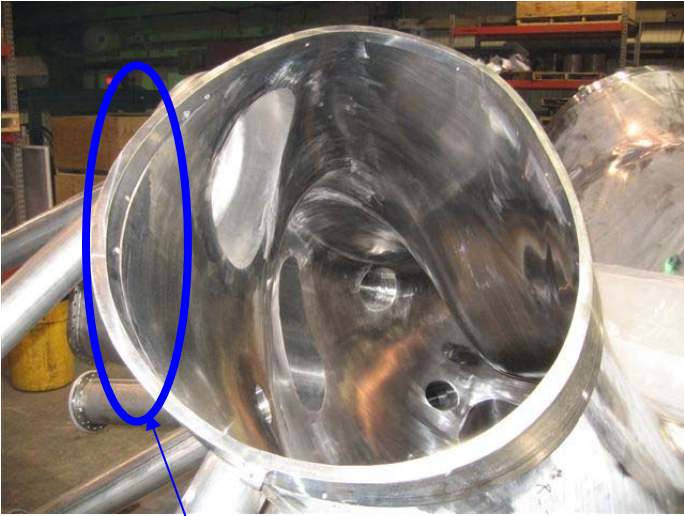
Will probably loose fiducial holes and clamp holes to “buttering” weld. These welds would have to be made without heavy cover plate welded on to heat sink & hold flange. Consider doing “buttering” as part of field weld process

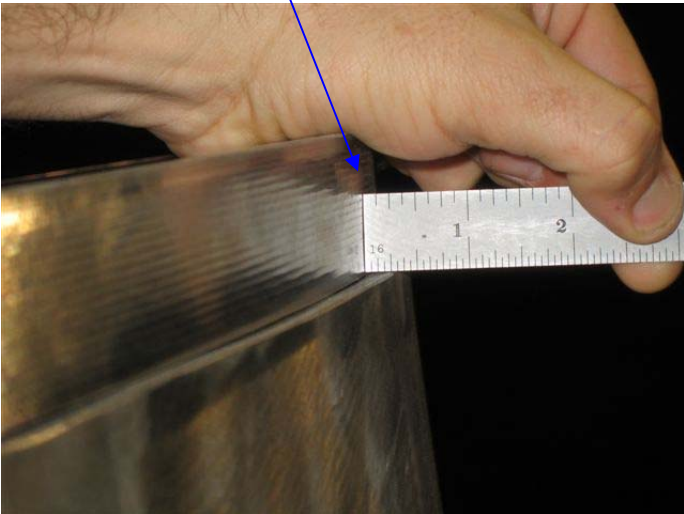
If the vessel max. outwards tolerance coincided with the flange maximum inwards tolerance, this would be the condition

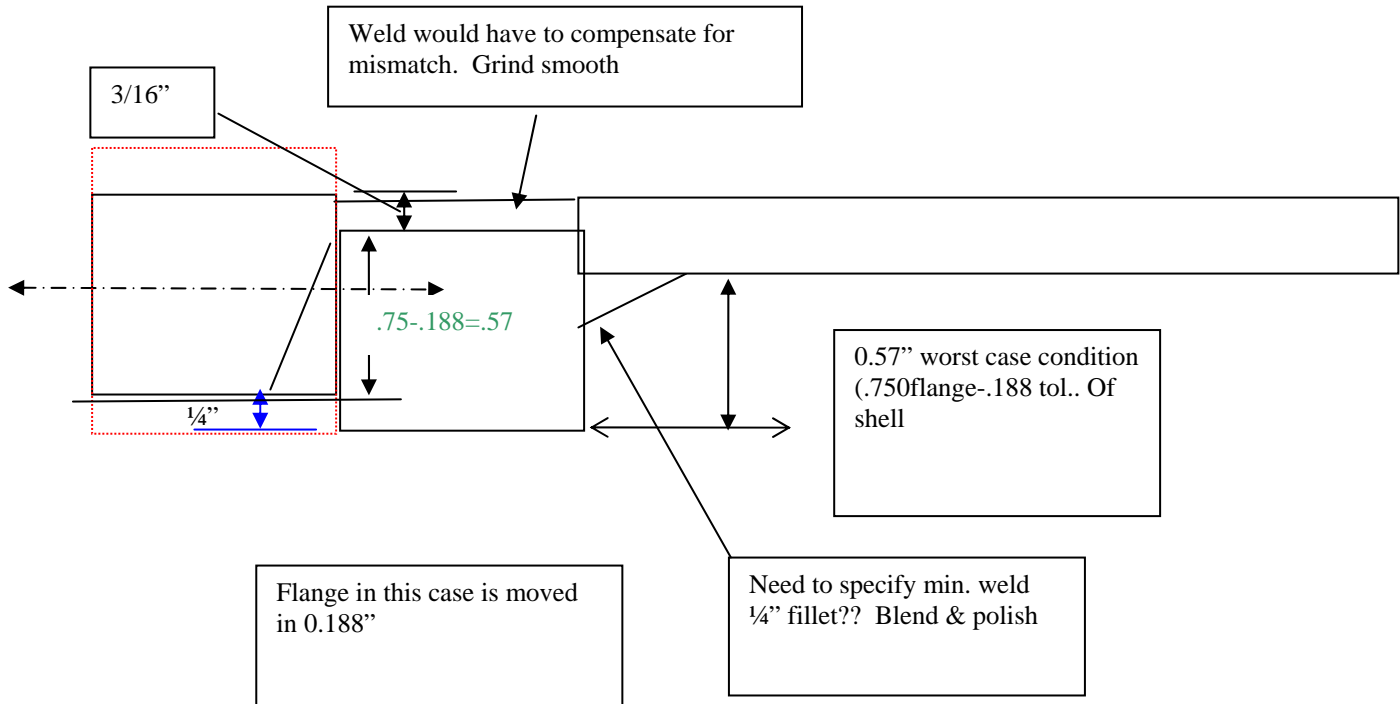
For VVSA2, end A, this maximum encroachment was evaluated by Art and is acceptable in the pre-welded condition.
