Major Tool & Machine, Inc.
1458 East 19th Street
Indianapolis, IN 46218-4289

MTM N/C: 17746

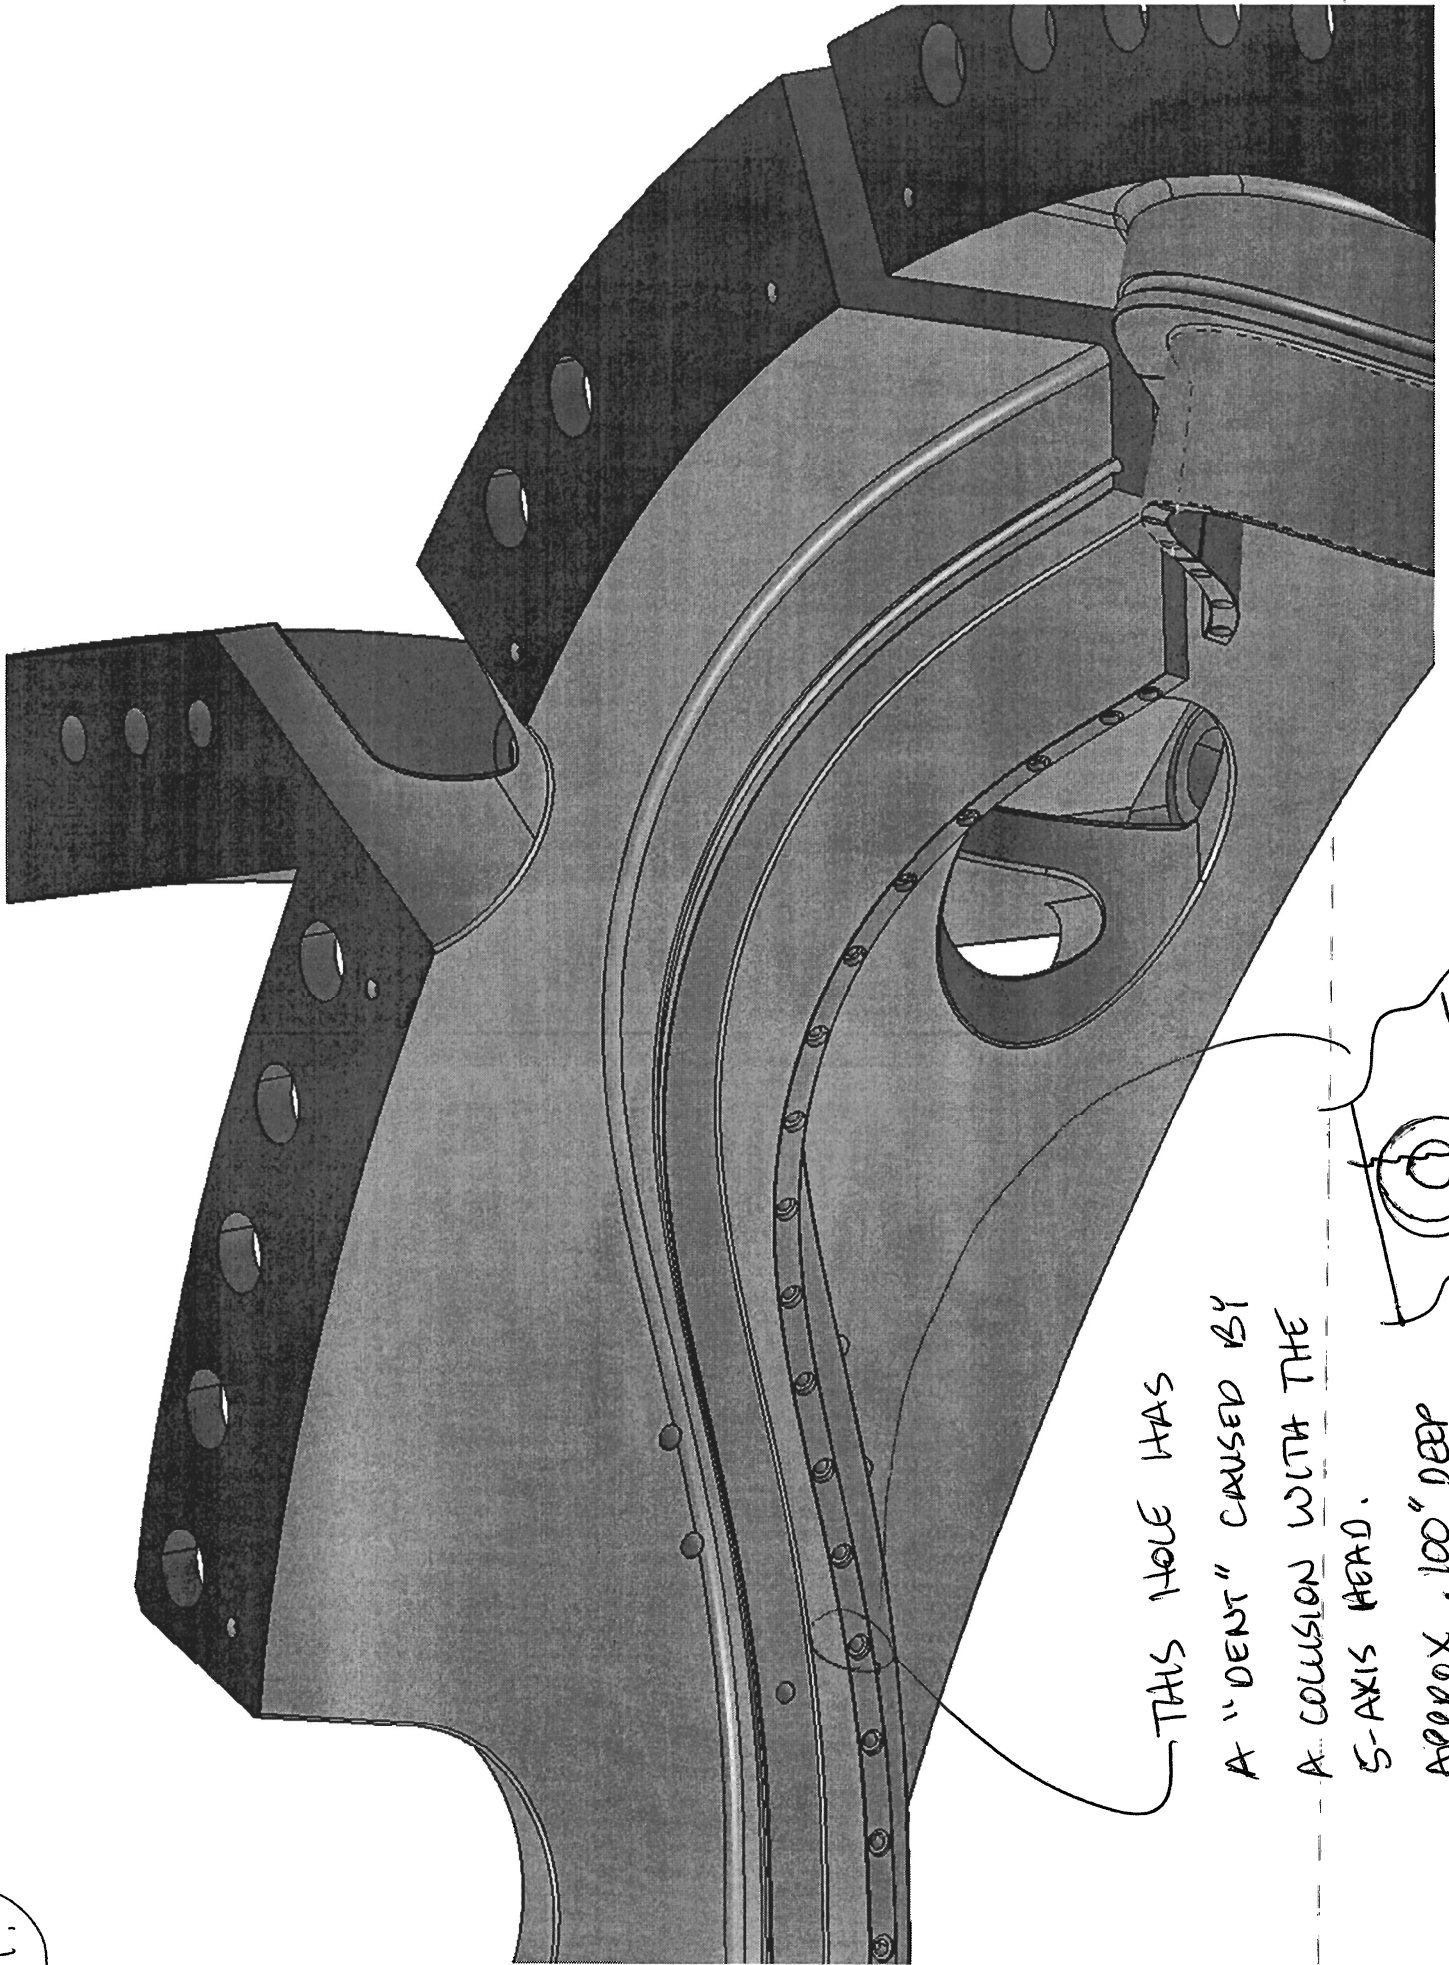
THIS HOLE HAS
A "DENT" CAUSED BY
A COLLISION WITH THE
5-AXIS HEAD.
APPROX. 100" DEEP
