MTM N/C: 21265

Customer:	ENERGY INDUSTRIES OF	FOHIO	
Contact:	NANCY HORTON		Telephone: 216-496-2314
E-Mail:	NKHFlowen@aol.com		Fax: 216-328-2001
Part:	SE141-114 / MODULAR CO	DIL WINDING FORM TYPE	Customer P.O.: S005242-F/Ln:5
W/O Links:	1-Type:W: 65709/5.0 Sub: 0	Revision: 5	Senai No./Qty: AS
Reported By:	MIKE GRIFFITH		Telephone: 317-636-6433
E-Mail:	il: mGriffith@MajorTool.com		Fax: 317-634-9420
Problem:	Visual review of A5 identified several tool marks on T section and other miscellaneous items. See attachment for details.		
Proposed Dispo	sition:		
	MTM Proposes to accept devi	ations as-is.	
Number of additional pages: 9 page attachment

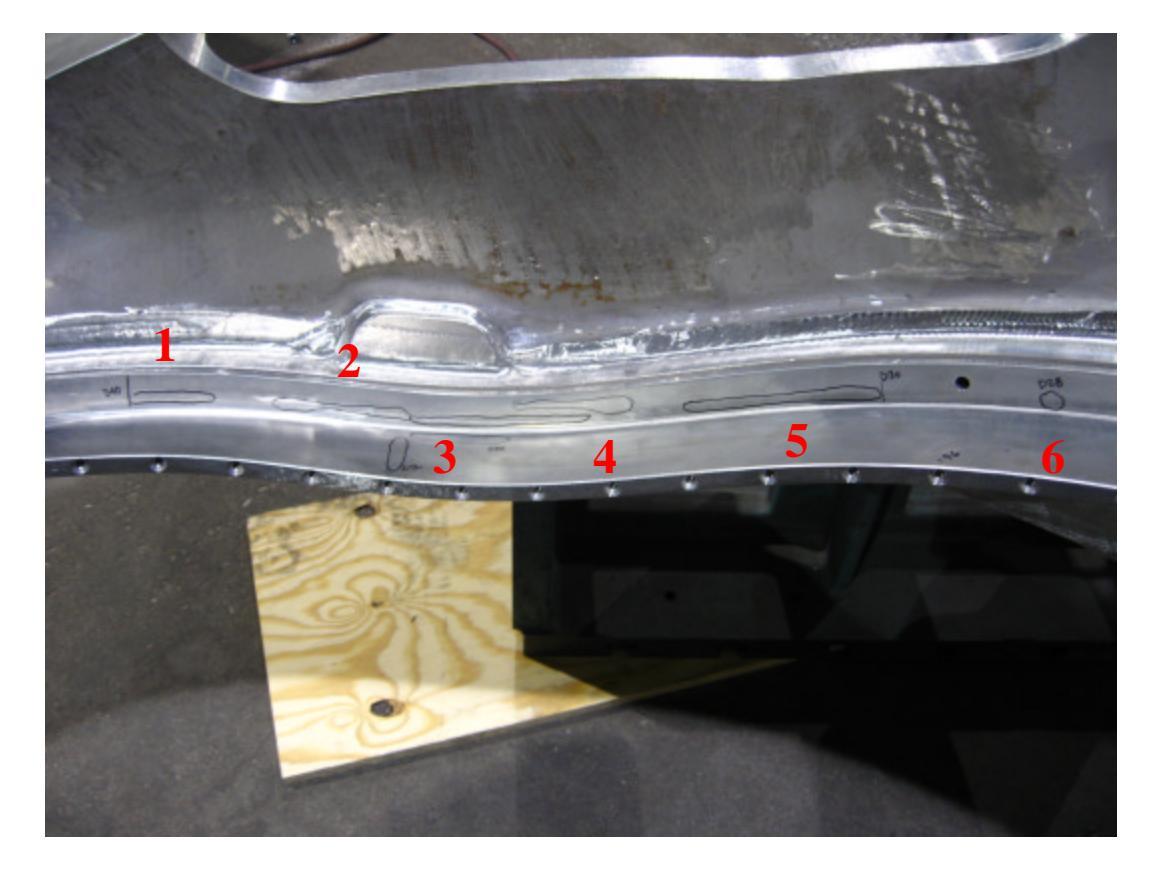
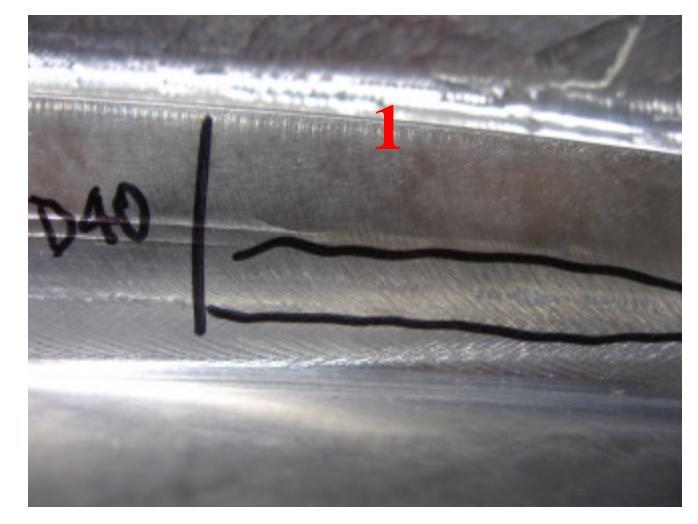
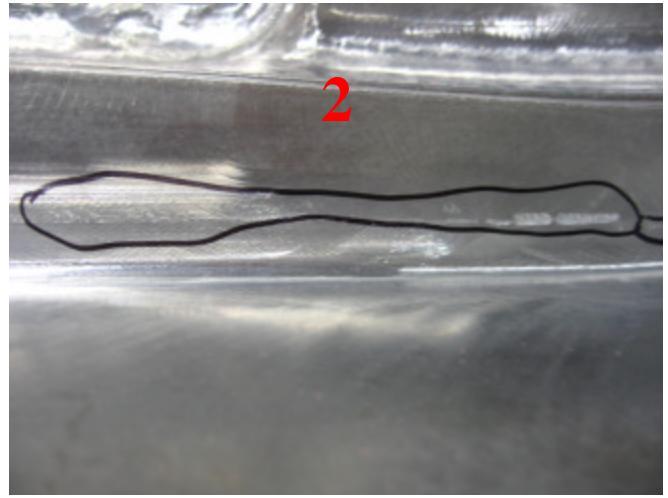
There are several shallow tool marks (<.010") on the datum D side between T holes 28 and 40. These are shown on slides 1 and 2.

The attached list was reviewed during a conference call attended by J. Chrzanowski, L. Sutton, F. Malinowski, L. Dudek, D. Williamson, T. Brown, and P. Heitzenroeder on 2/28/07. The surface defects are shallow (<0.010") and therefore are not an issue. During the call it was noted that the lead pad offset caused by a less than optimal choice of initial casting best fit location brought the pad uncomfortably close to the lead slots; MTM resolved this by grinding a 0.5" chamfer immediately (see attachment). The break-out of some of the bolt threads were also discussed, but there is adequate thread engagement beyond this so it is accepted as is.

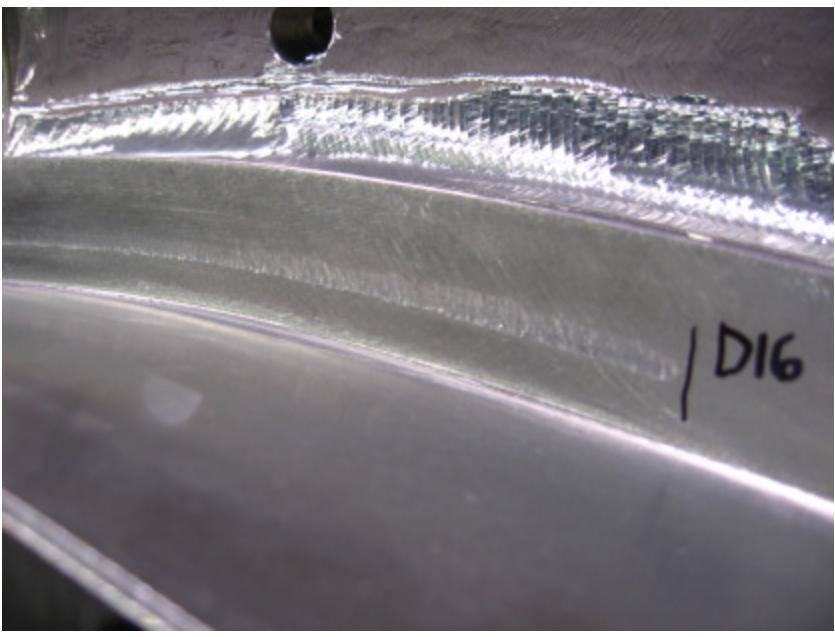
Shallow tool mark on D side short leg, between T holes D16 and D19. Tool mark is <.005" deep.

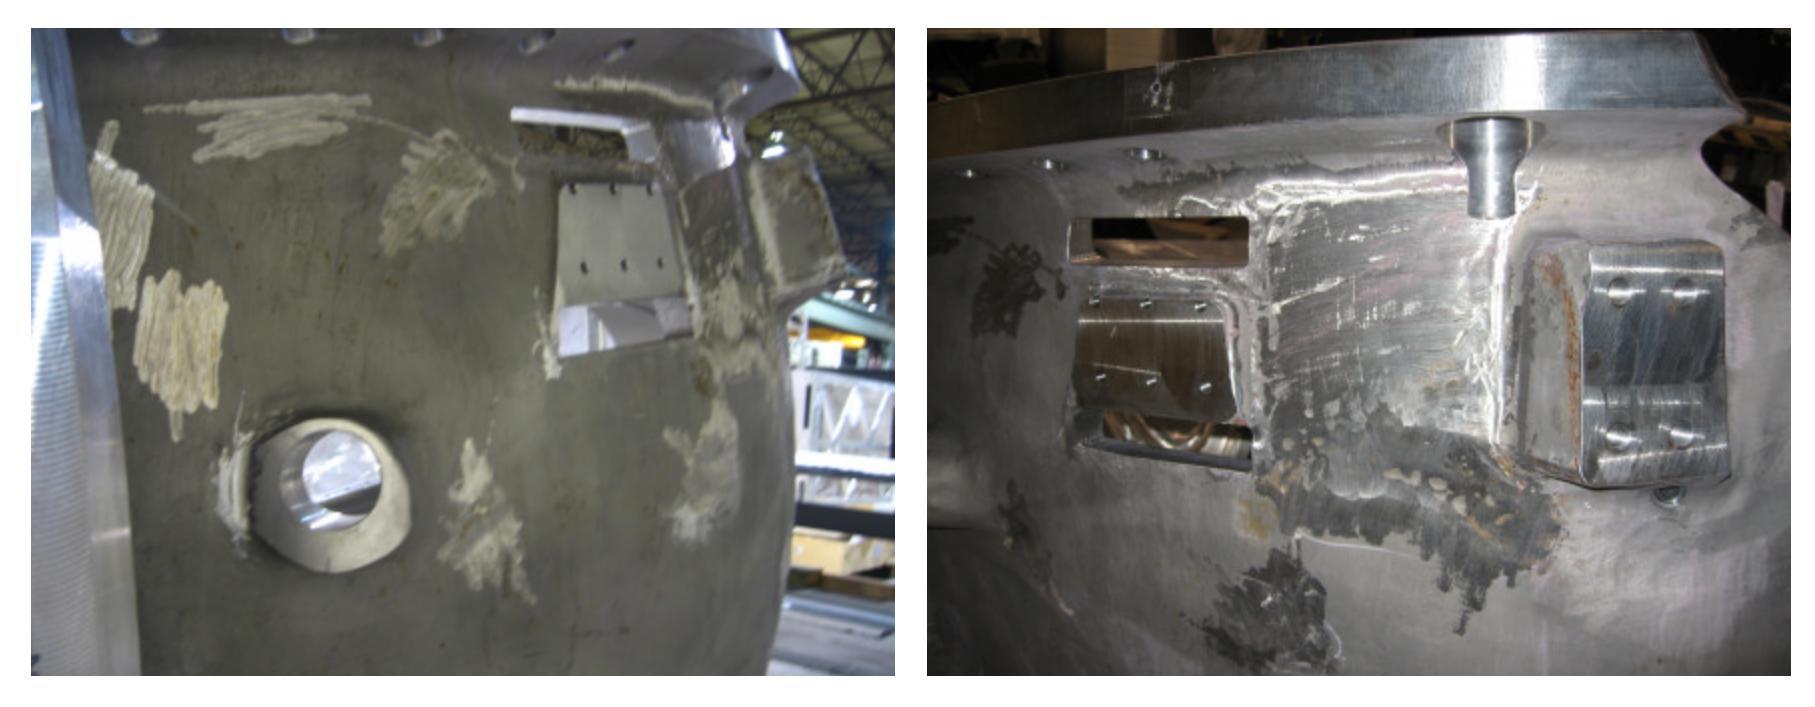
It appears that the casting stock was not balanced as well as it could have been when the casting was qualified on the 1st roughing operation at MTM. A rotation of approximately .400" near the lead block area would have improved this condition. This resulted in a thicker flange on datum D and a thinner condition on datum E (as reported in previous slide). This also affected the lead pad and the cast stock around the 2.5" holes (see next slide).

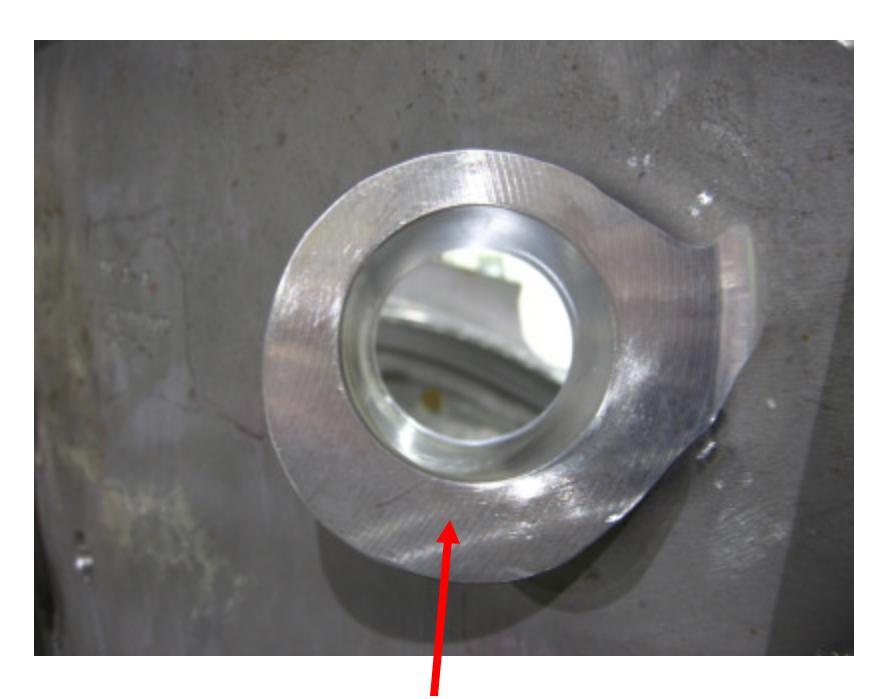
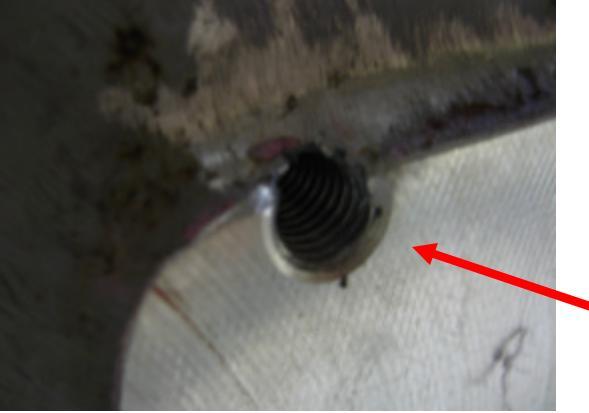
The picture above and the one in the previous slide show how the hole is shifted relative to the cast stock.

The 1st 2 ¹/₂ threads break out the edge of the hole. This hole (and the other five) checks good with a thread gage.

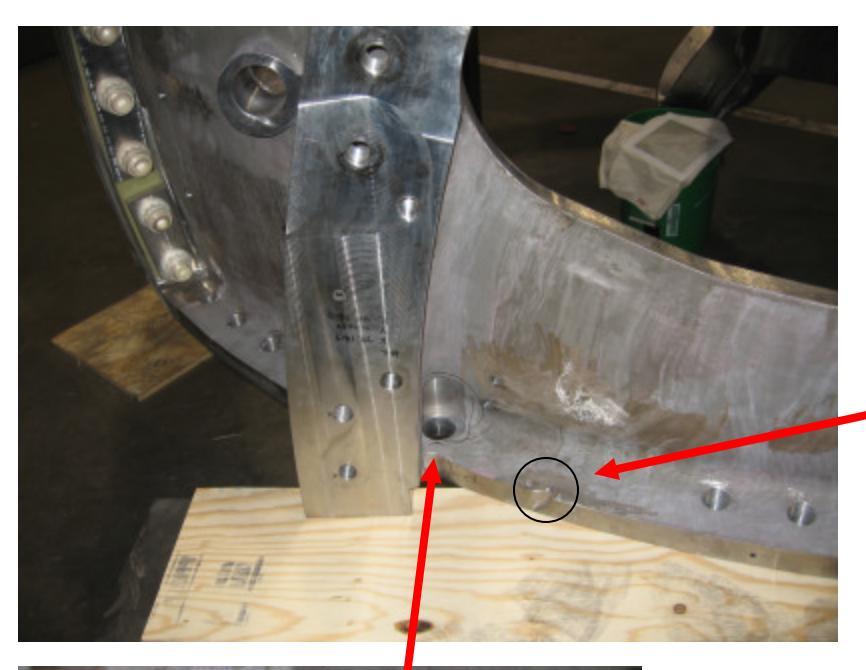
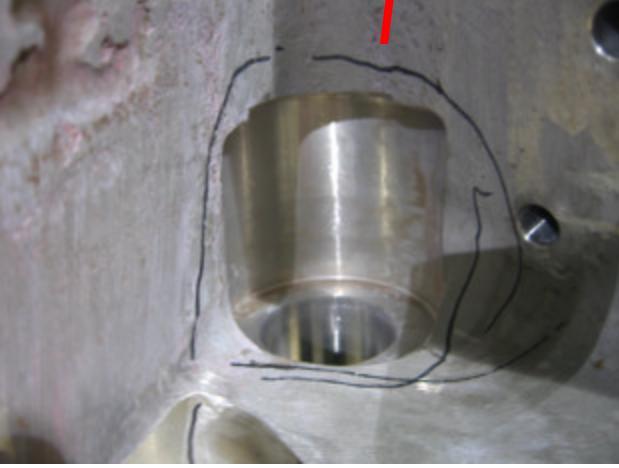
Picture to the left is of the 3" counterbore in the datum E flange as reported on NC21252 step 810. Area shows heavy stock around hole (too much to grind).

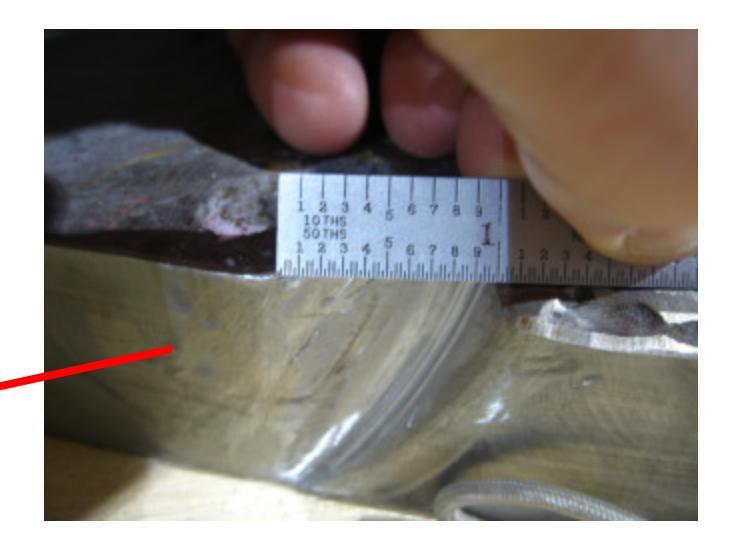
Tool Gouge on perimeter of Datum E flange, approximately 1" wide by .50" deep.

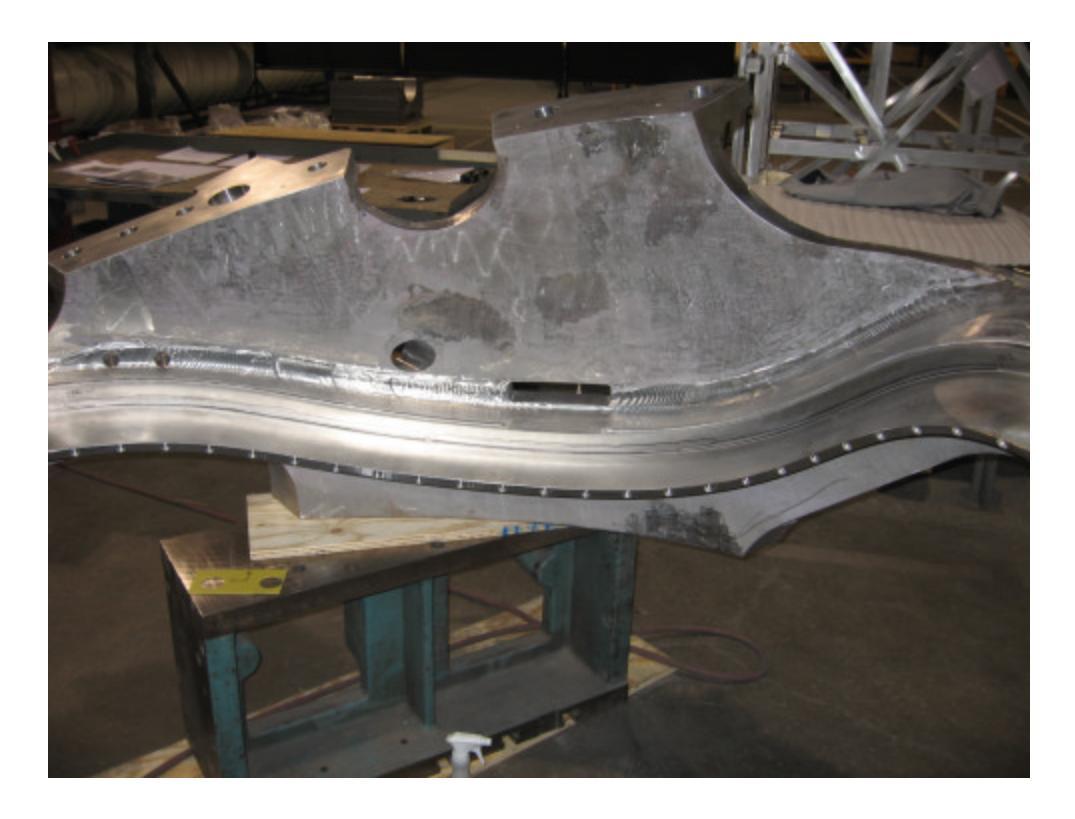
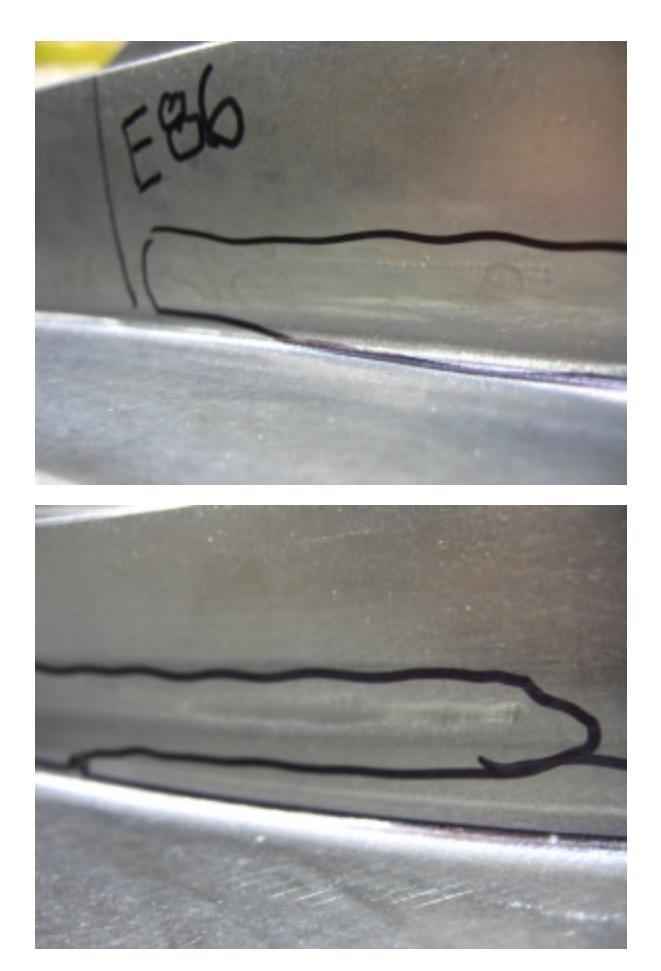
Shallow tool marks on short leg of E side from T hole E86 to E1 thru E12. Marks are less than .005" but in too big of an area to try to blend out. Pictures to the right are close-up of the tool marks but even in the picture they are hard to see

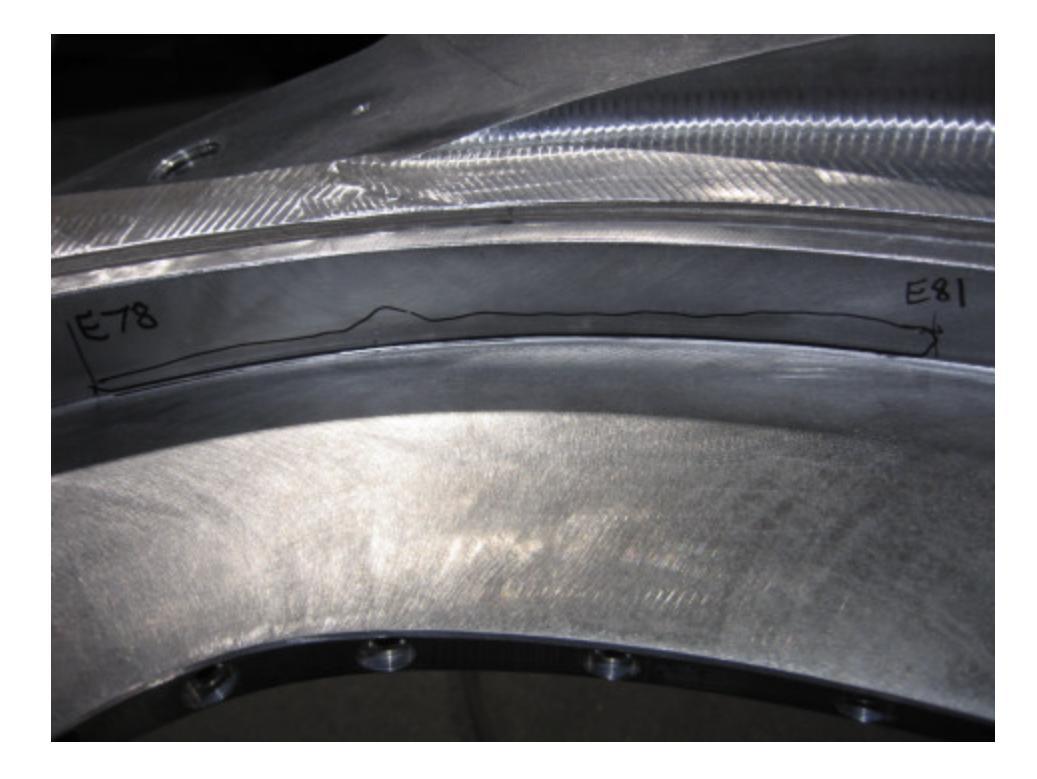
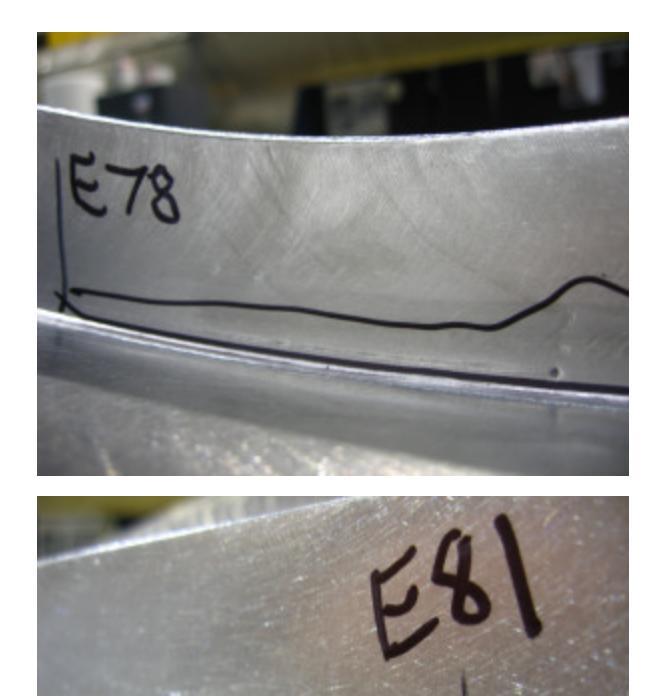
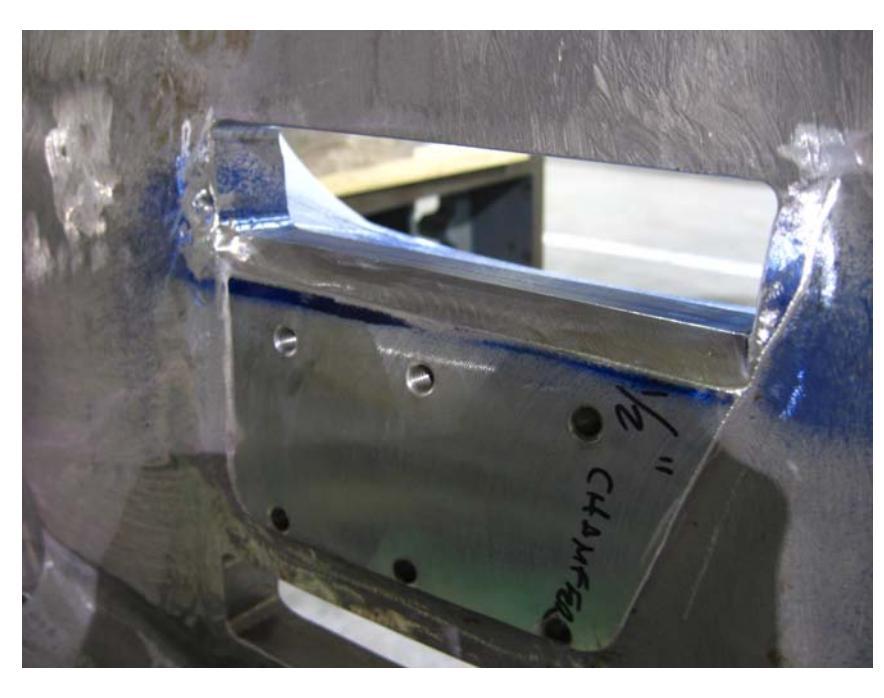
Another area of tool marks between holes 78 and 81 on the E side short leg. Again, very shallow (<.005").

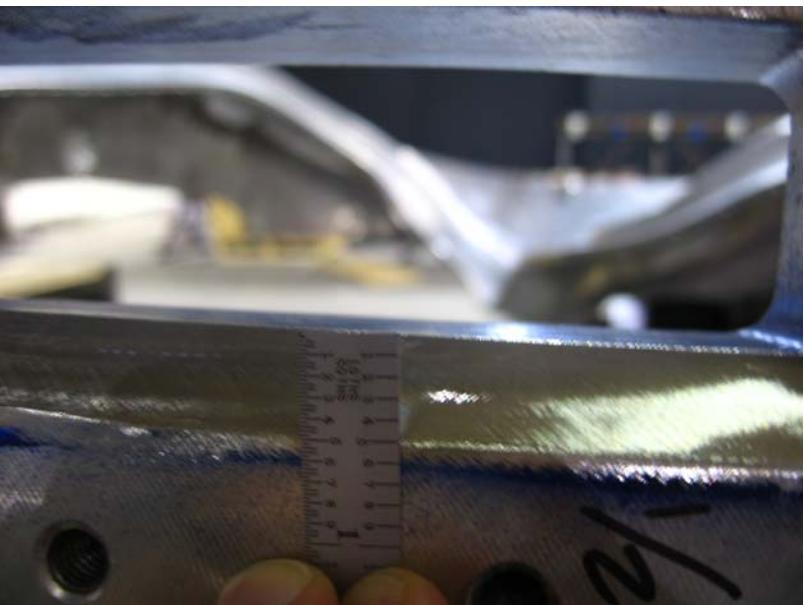
Photos showing chamfers added to lead pad
