Customer: ENERGY INDUSTRIES OF OHIO

Contact: NANCY HORTON
E-Mail: NKHFlowen@aol.com

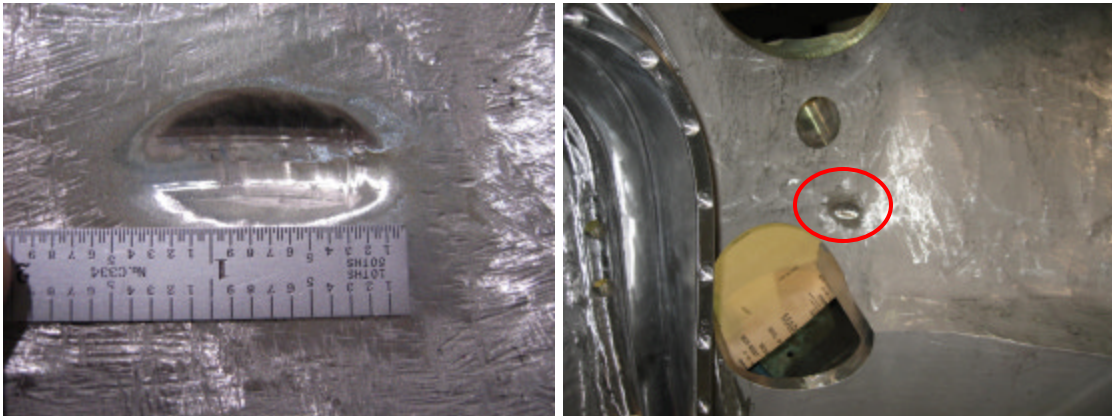
7. The scribe marks do not match the drawing requirements as described on sheet 7, zone E6. The scribing was performed prior to notification of the revision 9 changes. The scribing is to be aligned with sections U2 and U3 of the drawing (perpendicular and parallel to the base of the T). The scale in the below pictures show what would be the correct orientation (This conditions exists on both the D and E sides).

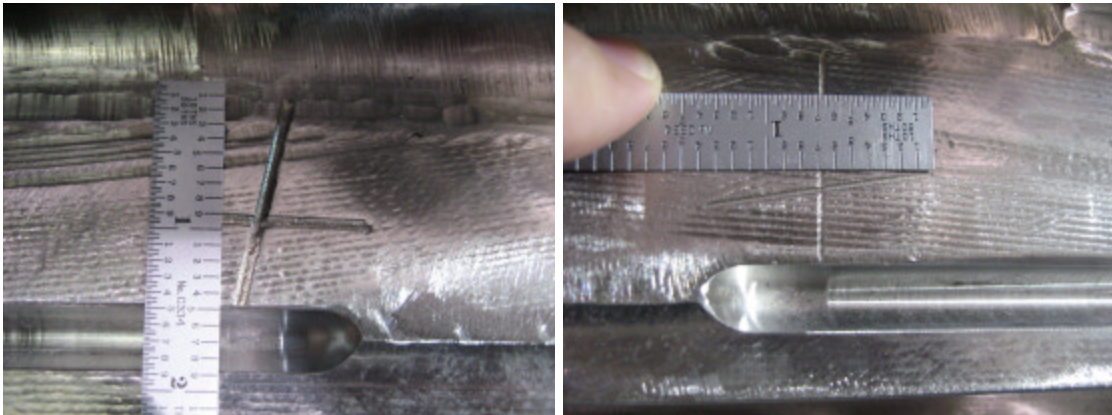
SE141-115 B1
NC20519 attachment
