NCSX

Modular Coil Shim Testing

NCSX-CALC-14-003-00

25 Feb 2008

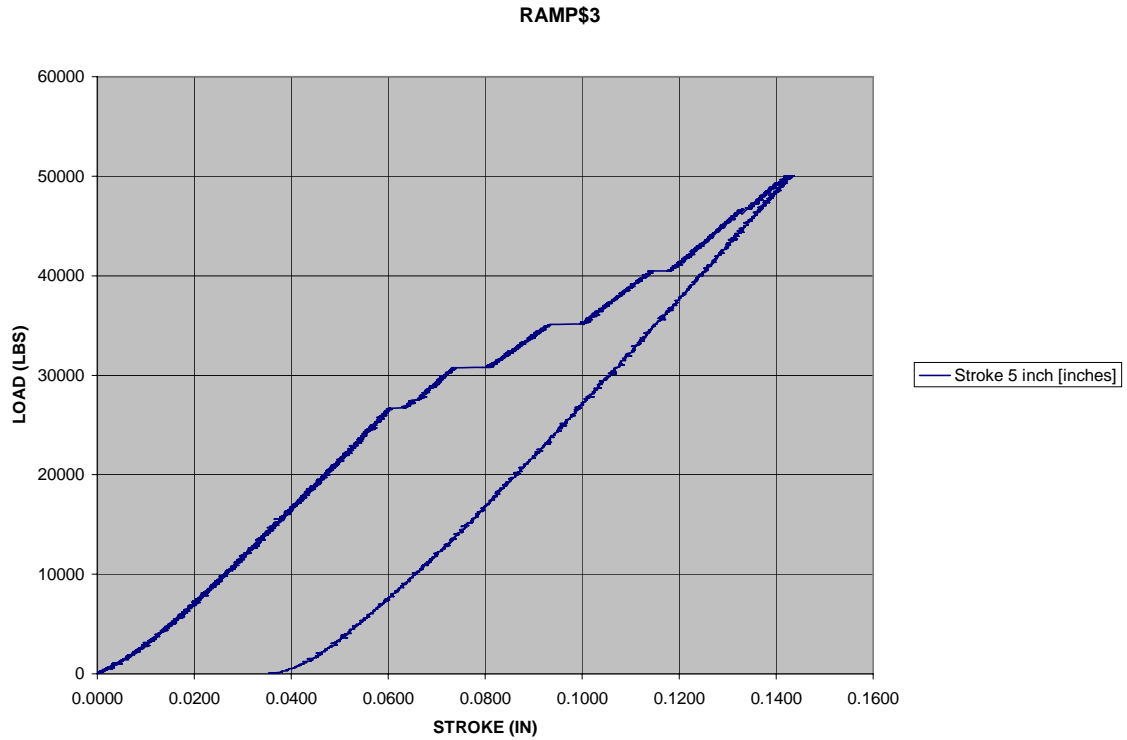
The joint showed a sudden slippage at 26,700 lbs and continued to load to 50,000 lbs with four more slippage events. The first event correlates to a coefficient of friction of 0.59 with an uncertainty of $\sim\pm 0.9$. It was not possible to determine if one side broke free before the other or if subsequent events were the same side or the opposite side of the joint releasing, nevertheless, the results do give a minimum value for the joint friction and it is in close agreement with other testing at PPPL.¹ **Figures 8 and 9** show the load curves for the test. Note the close agreement of the LVDT readout with the load train readout at the slip point. The LVDT readouts show a non-linearity at ~ 21000 lbs but there

Figure 8. Load train readout showing slippage during the loading.

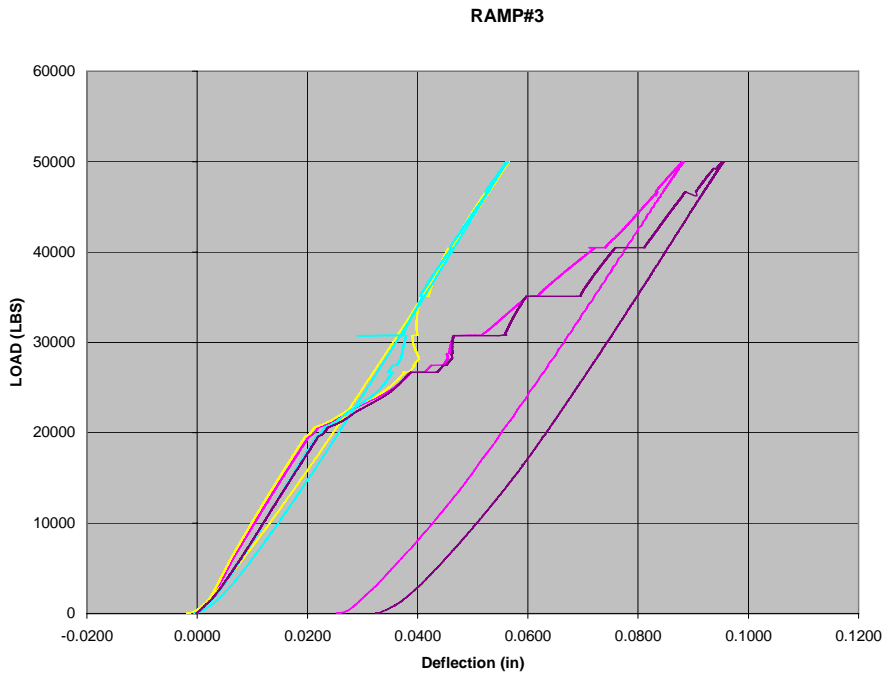
is no relative motion, therefore, no slippage has occurred between the halves of the assembly. The perturbation is probably a thermal effect due to a change in gas flow.

Figure 9. LVDT readout showing slippage during the loading.

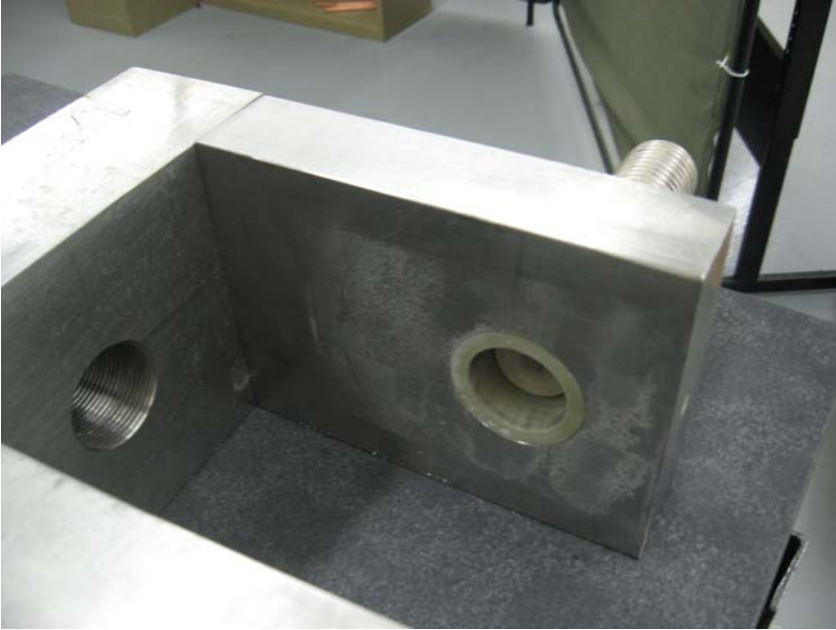
surface. Fine white alumina powder was evident on the matching stainless surfaces. See the photographs in the appendix. The as-coated surface was not perfectly smooth to begin with and showed a rather dimpled or “orange peel” appearance under magnification.

Outer trunnion showing powder after completion of testing.

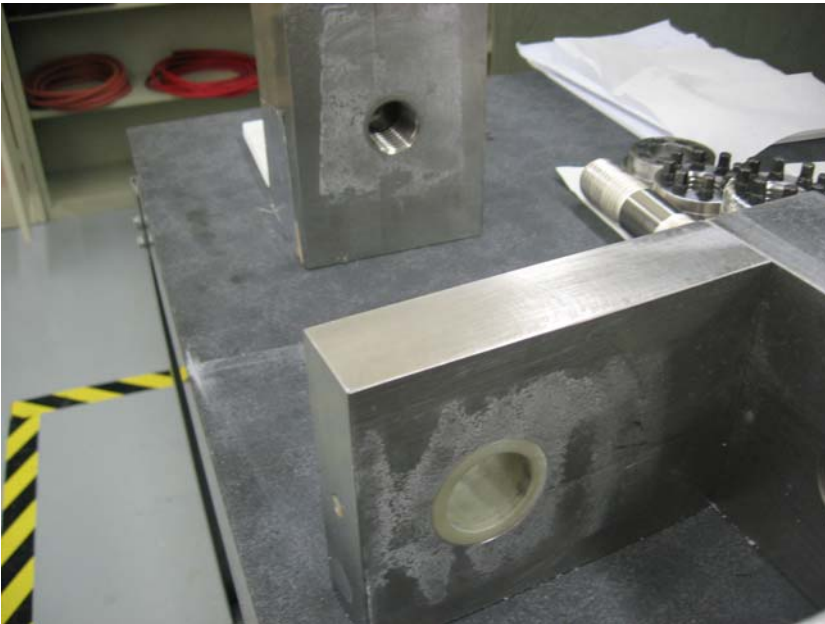
Other half of trunnion.

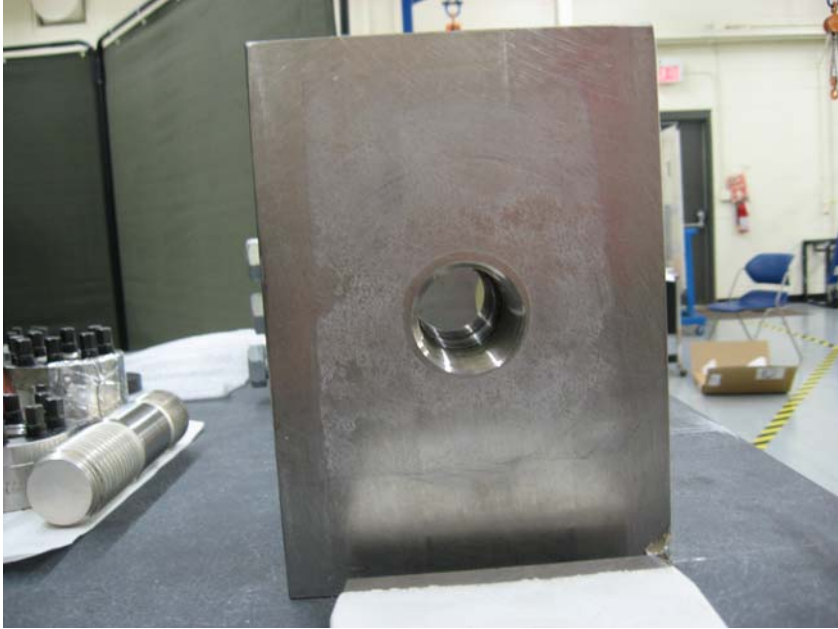
Center trunnion showing powder after completion of testing.

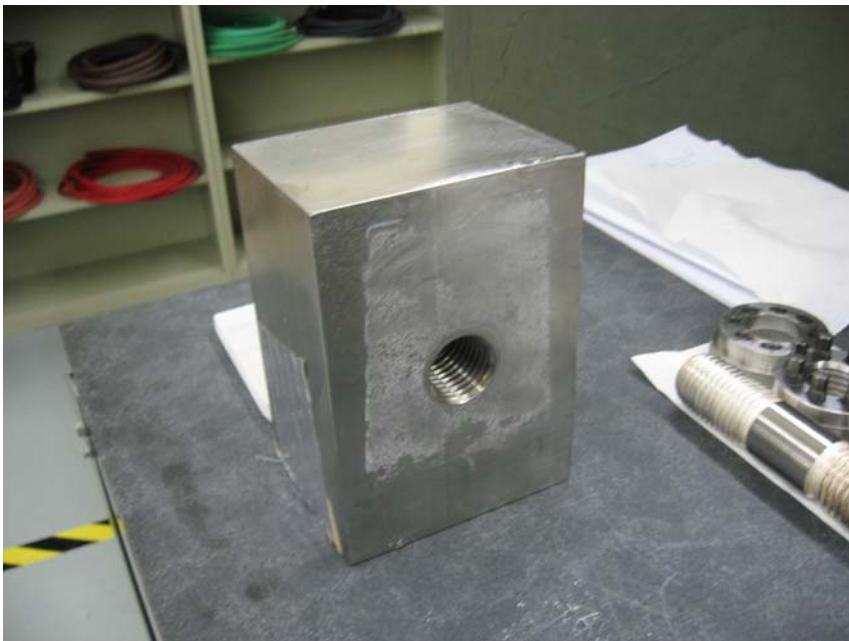
Other side of trunnion.

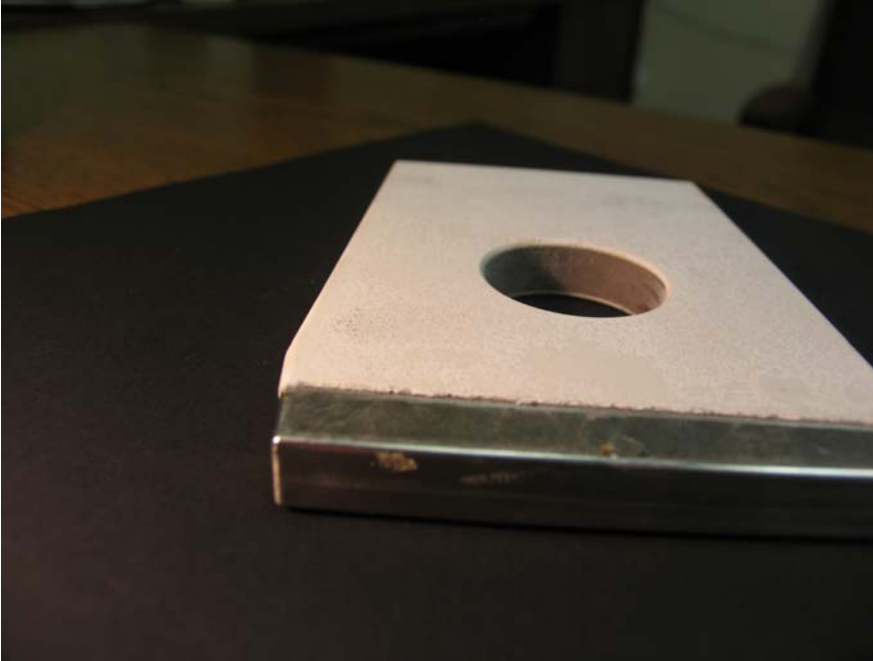
The shims were undamaged but did indicate some wear, with a somewhat frosted appearance in a ‘quilted’ pattern that was not there initially. Under 10 power magnification this pattern seemed to be concentrated on the high points on the alumina

- The slight loss off the alumina surface is probably due to a combination of the stress concentration on the high points of the surfaces and the differential movement during cooling and heating, not slippage during testing, as the data indicated no such events. The alumina may benefit from a smoother (ground) surface to reduce the local stressing of the coating. This would probably change the friction coefficient, however.

Shim after cycling test, showing “quilted” pattern on alumina.

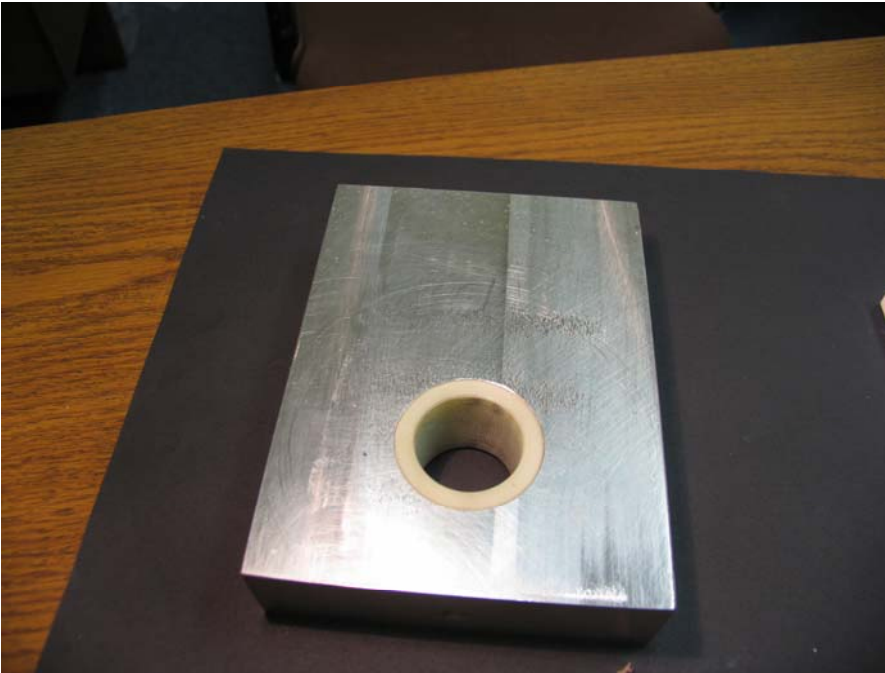
After completion of testing the unit was disassembled and the shims inspected for damage. The only change from the inspection after cycle testing was the presence of stainless steel transferred onto the alumina. The slippage appeared to have sheared off material from the stainless surfaces, leaving a visible pattern of pits and scratches in distinct horizontal stripes (at least 4) on the stainless. A matching pattern was evident on the mating shim surface and the pattern was approximately the same on both sides of the assembly, indicating both shims had slipped during loading.

Outer trunnion showing scratch pattern after testing was completed.

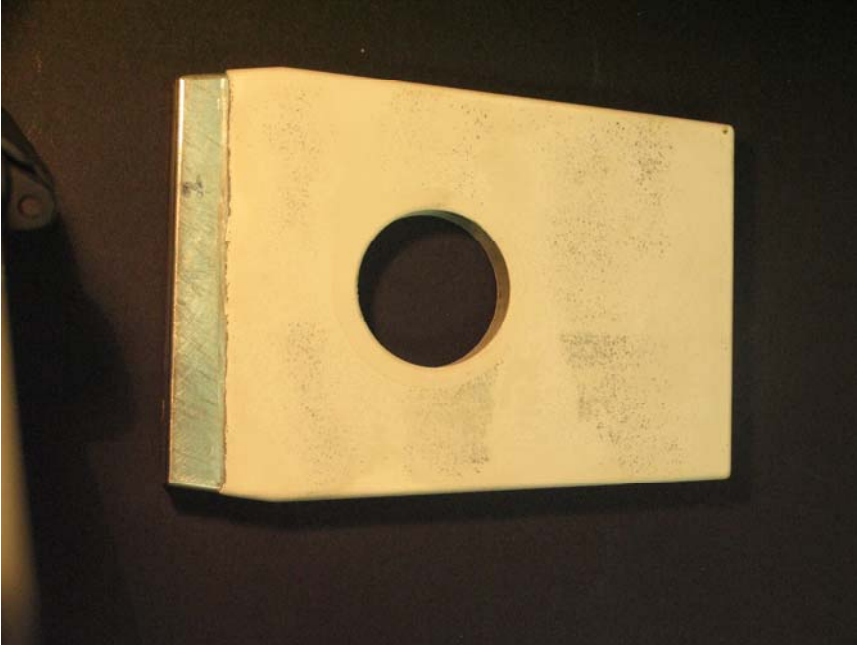
Stainless material on shim after testing was completed.
