# NCSX

## Modular Coil Shim Testing

NCSX-CALC-14-004-00

25 Feb 2008

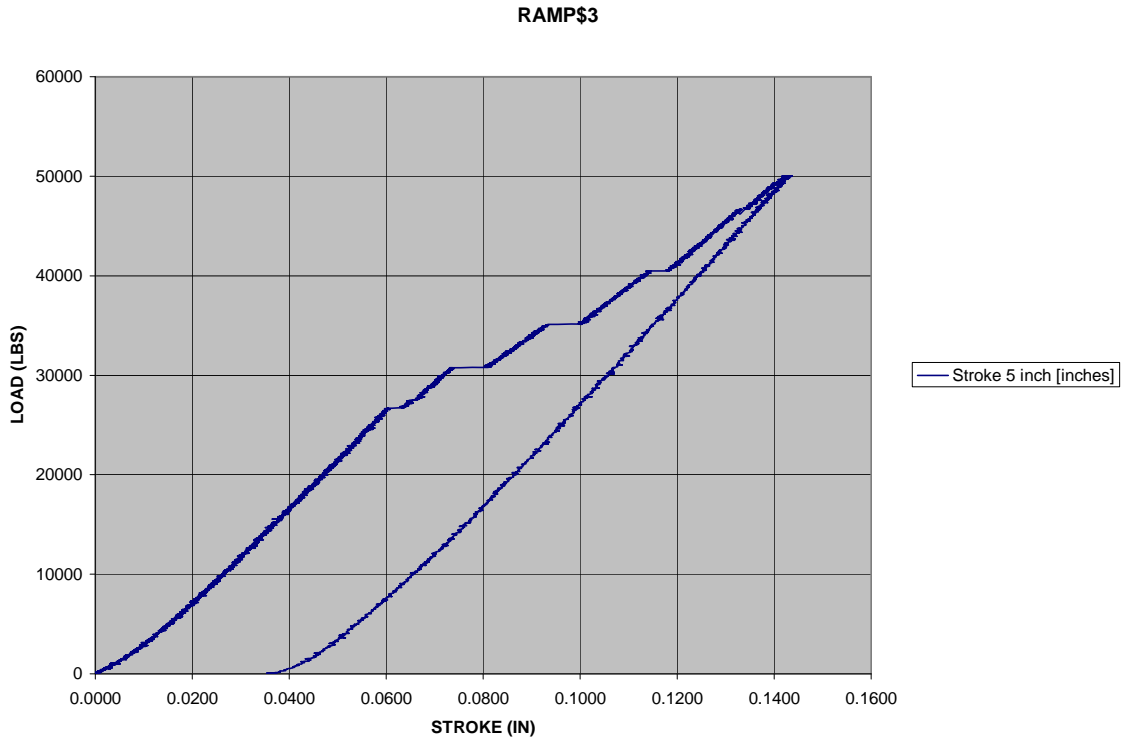
The joint showed a sudden slippage at 26,700 lbs and continued to load to 50,000 lbs with four more slippage events. The first event correlates to a coefficient of friction of 0.59 with an uncertainty of  $\sim\pm 0.9$ . It was not possible to determine if one side broke free before the other or if subsequent events were the same side or the opposite side of the joint releasing, nevertheless, the results do give a minimum value for the joint friction and it is in close agreement with other testing at PPPL.<sup>1</sup> **Figures 8 and 9** show the load curves for the test. Note the close agreement of the LVDT readout with the load train readout at the slip point. The LVDT readouts show a non-linearity at  $\sim 21000$  lbs but there

**Figure 8.** Load train readout showing slippage during the loading.

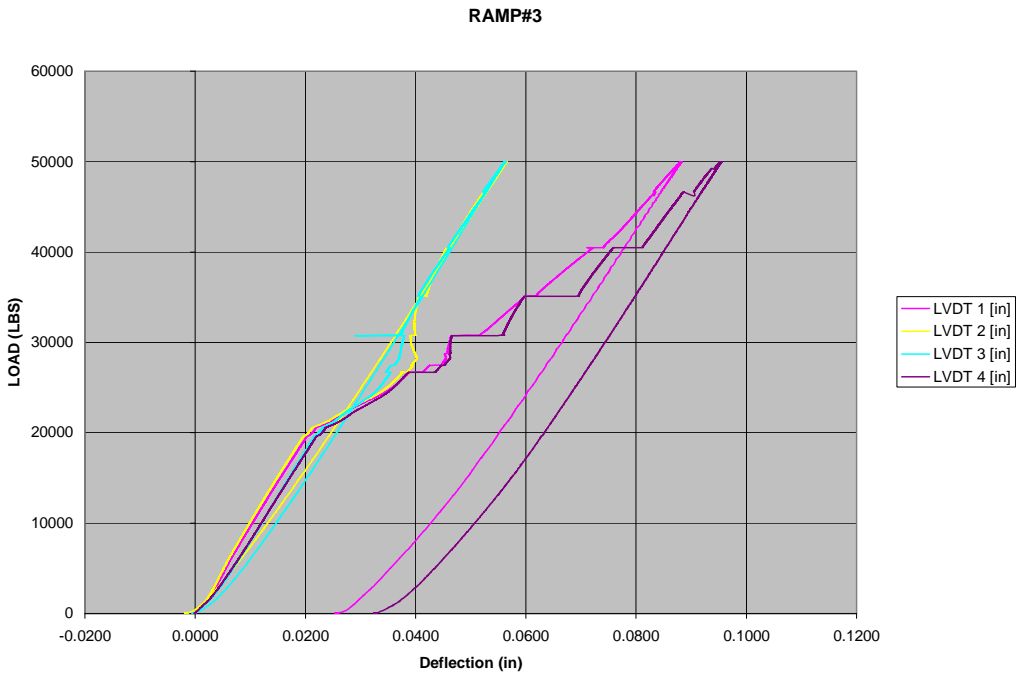
is no relative motion, therefore, no slippage has occurred between the halves of the assembly. The perturbation is probably a thermal effect due to a change in gas flow.

**Figure 9.** LVDT readout showing slippage during the loading.

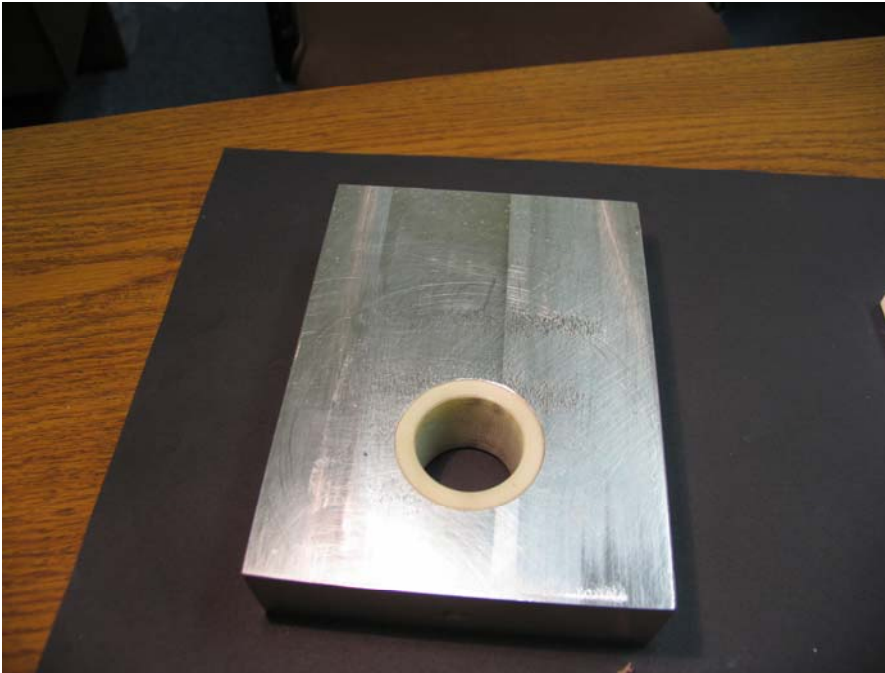
After completion of testing the unit was disassembled and the shims inspected for damage. The only change from the inspection after cycle testing was the presence of stainless steel transferred onto the alumina. The slippage appeared to have sheared off material from the stainless surfaces, leaving a visible pattern of pits and scratches in distinct horizontal stripes (at least 4) on the stainless. A matching pattern was evident on the mating shim surface and the pattern was approximately the same on both sides of the assembly, indicating both shims had slipped during loading.

Outer trunnion showing scratch pattern after testing was completed.

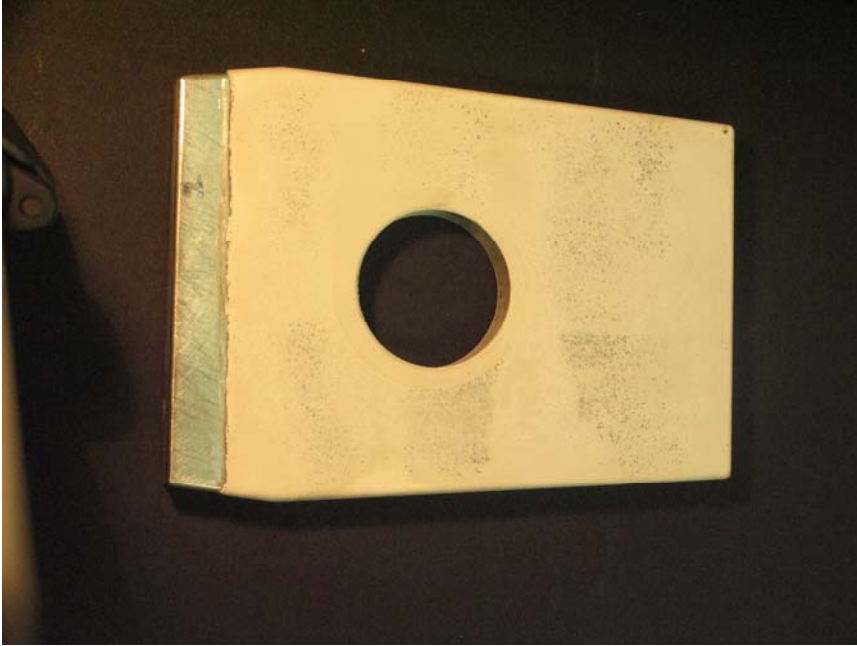
Stainless material on shim after testing was completed.
