# NCSX

## Modular Coil Shim Testing

NCSX-CALC-14-004-00

25 Feb 2008

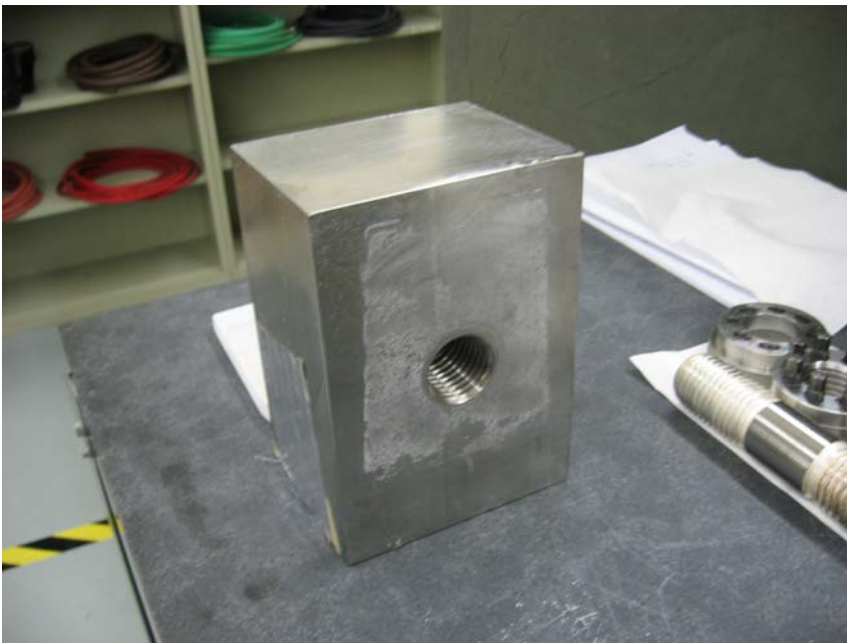
Other side of trunion.
