Recommended Remedy

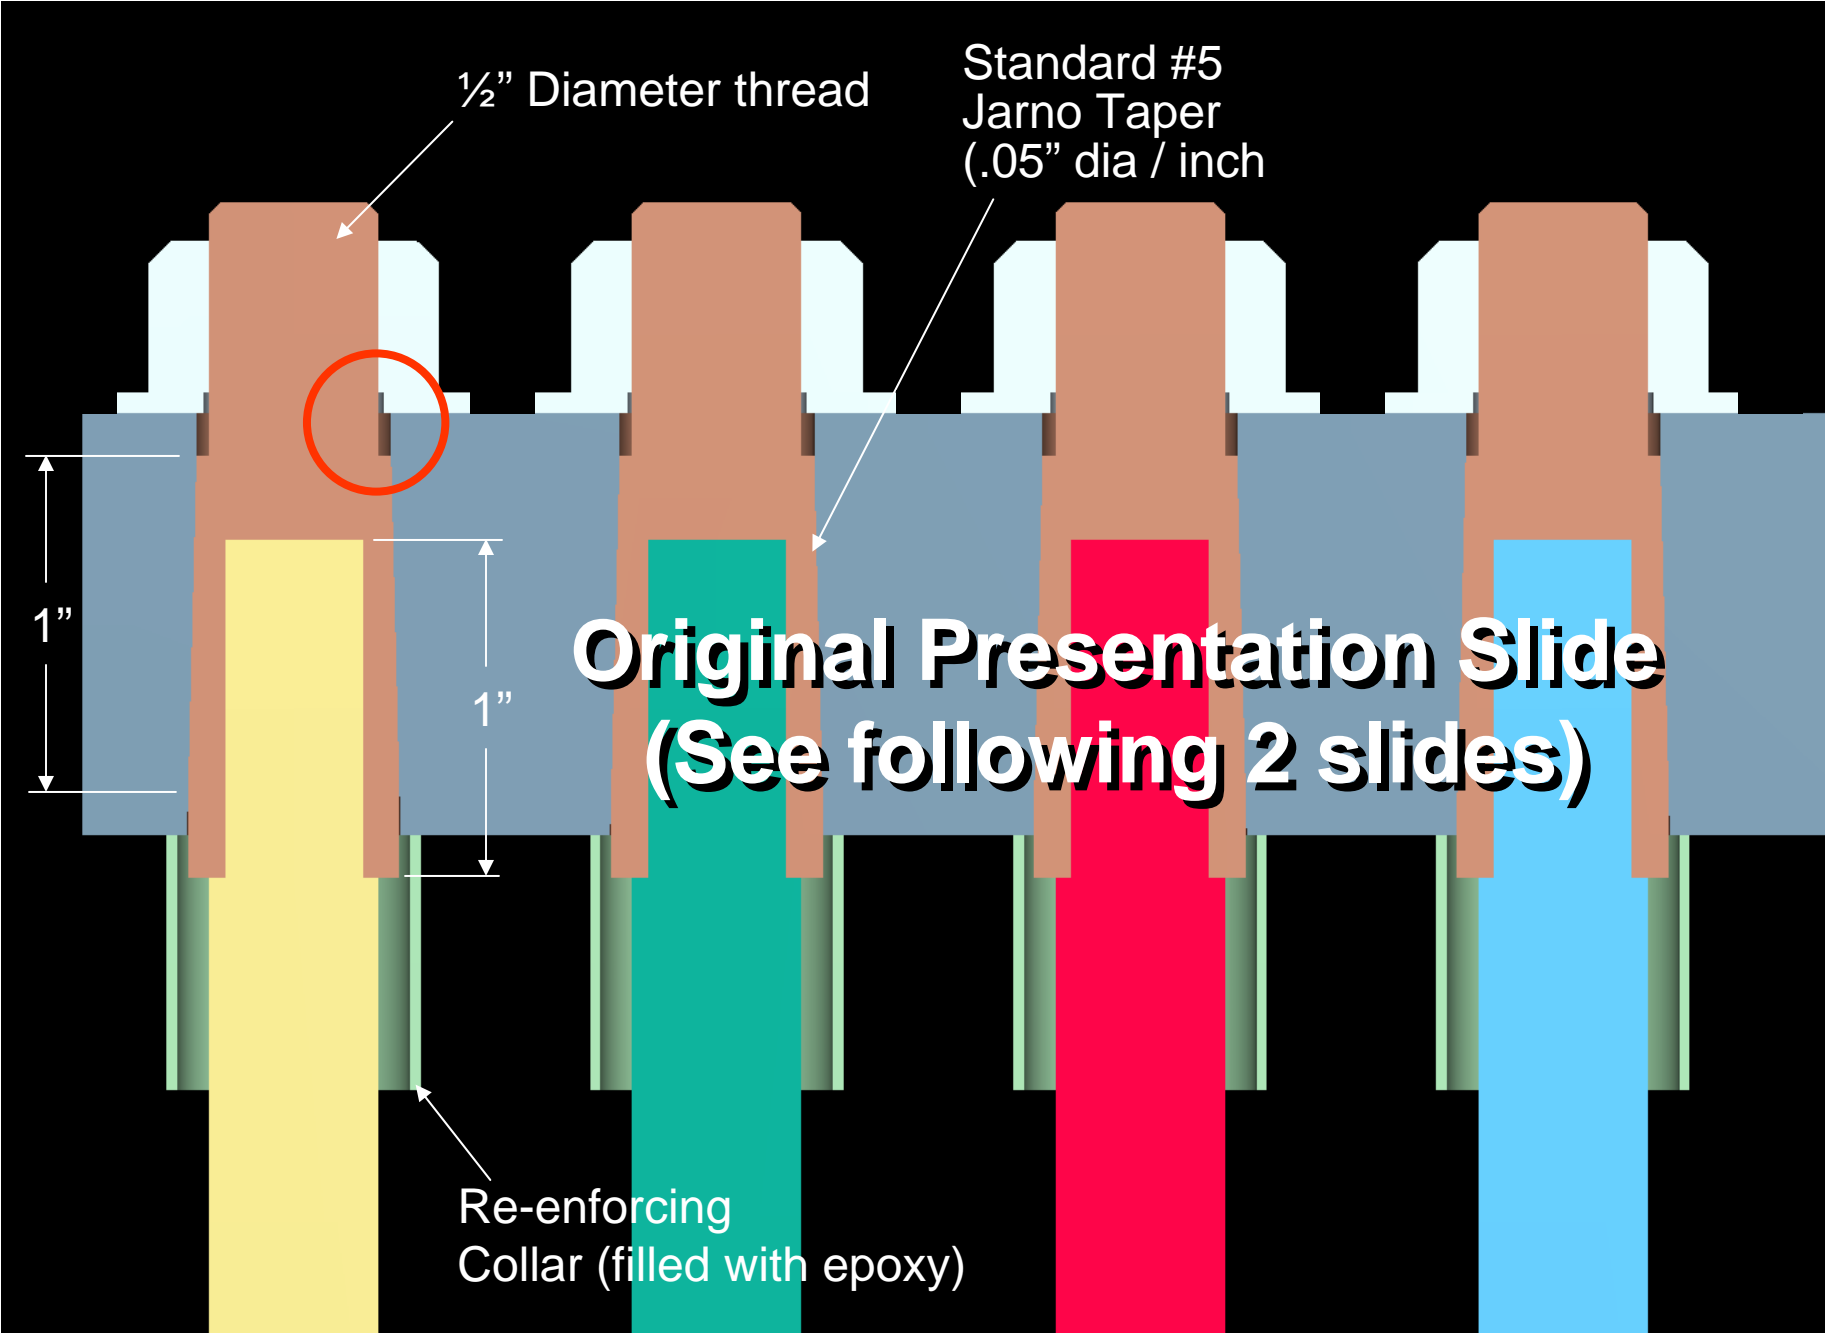
Early cartoon done in July of '04 showing a longer shoulder that would not interfere with the washer(s) (simple schematic)

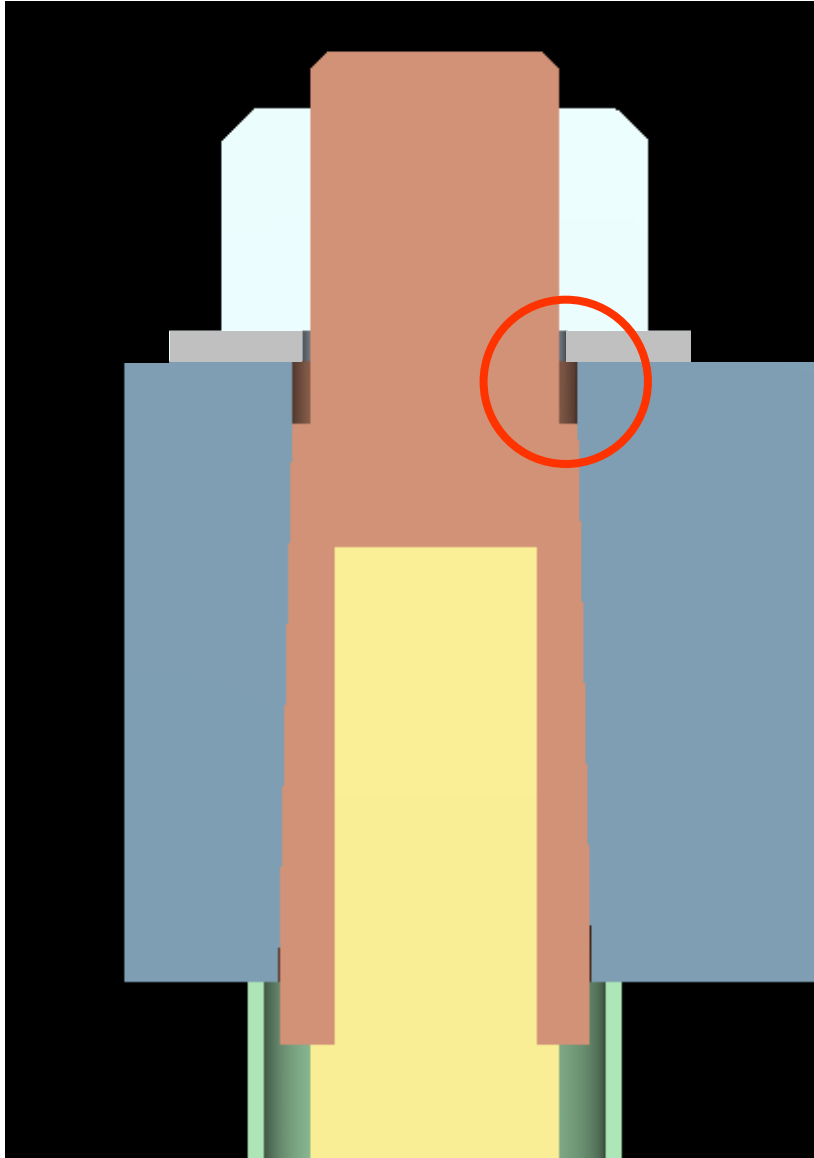
It's no mystery as to why the connector may not get fully seated in the jumper or lug sockets. The nut tightens the bellville washers against the connector shoulder, but not necessarily the socket, giving a false sense of "tightening".
