**Part: SE141-103-1 / MOD COIL WINDING FORM ASSEMBLY**

Drawing ID: MCWF TYPE-C XRAY MA Revision:

Problem: The radiographic inspection performed on the "T" Section revealed eight (8) entrapped, gas-type discontinuities in film location 0-1.

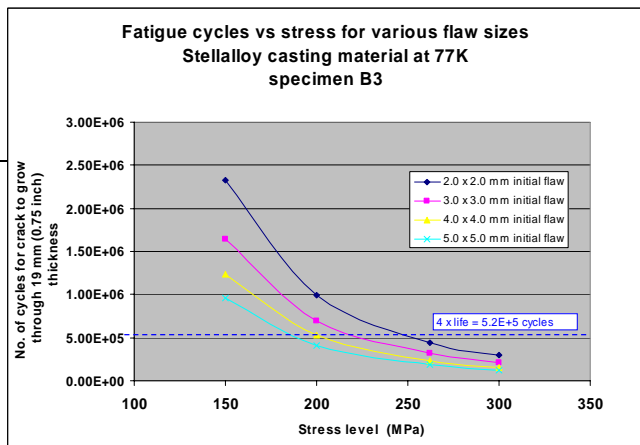
The attached Reader Sheet indicates that the (8) rejectable discontinuities are 0.090-0.110" (2.25-2.75 mm) in diameter. They are located roughly between holes 45 and 50. Since the stress in this region is <100 MPa, the discontinuities can be accepted "as is".

Propose to Use As Is.
