## NC20741 Attachment – A4 RT Failures

The picture to the left is of an overlay that shows the three .25" long rejections between holes 43 and 44.

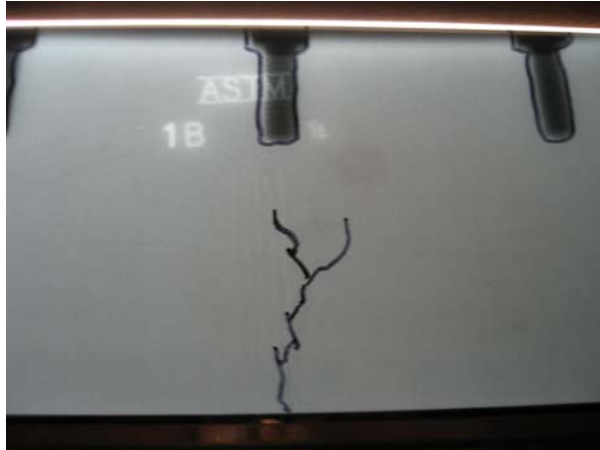
The picture to the left is of an overlay that shows the reject directly below hole 28. This indication did show up during the PT inspection on the D side of the T but it has a “Y” shape to it that we did not see during PT.
