5/23/2007

Mike Griffith

NC21871 – B6 Visual Review

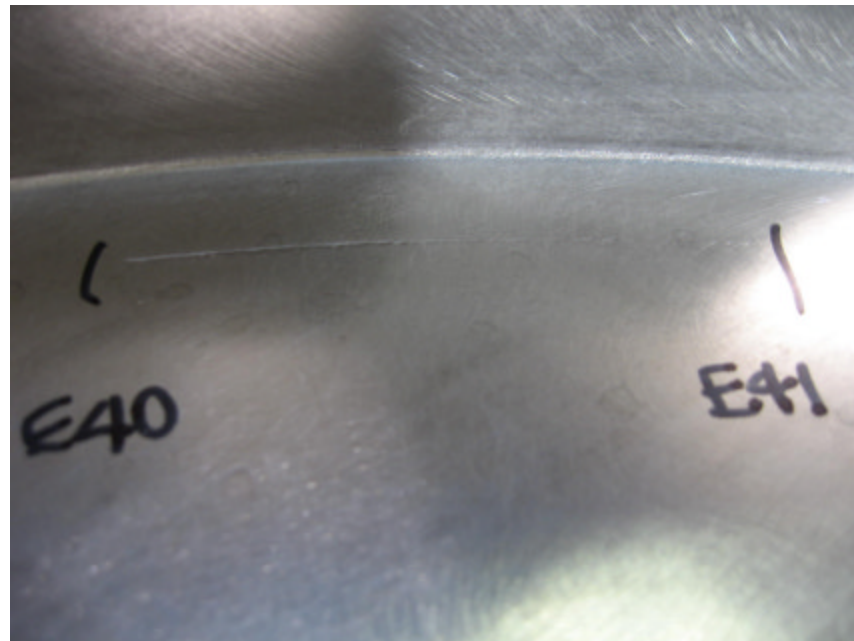
Tool gouge on E side long leg
between T holes 40 and 41. This
tool gouge is less than .005" deep.

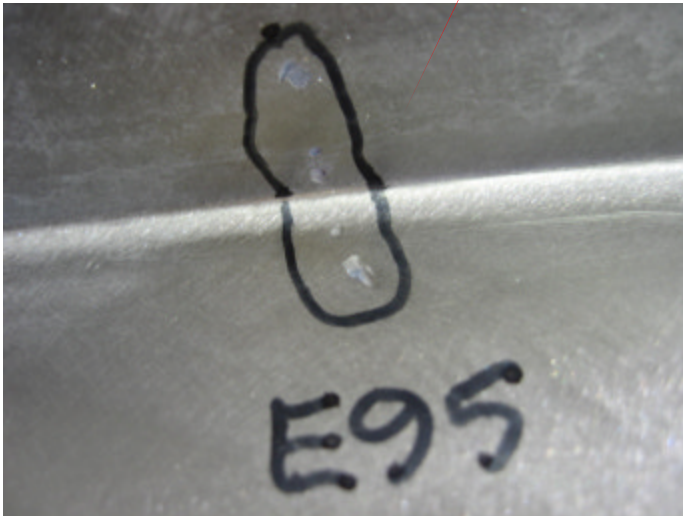
Tool gouge between holes 87 and 92 along long leg of datum E side. Depth of gouge is between .005” and .008”.

Tool marks near hole 95 are less than .005” in depth.

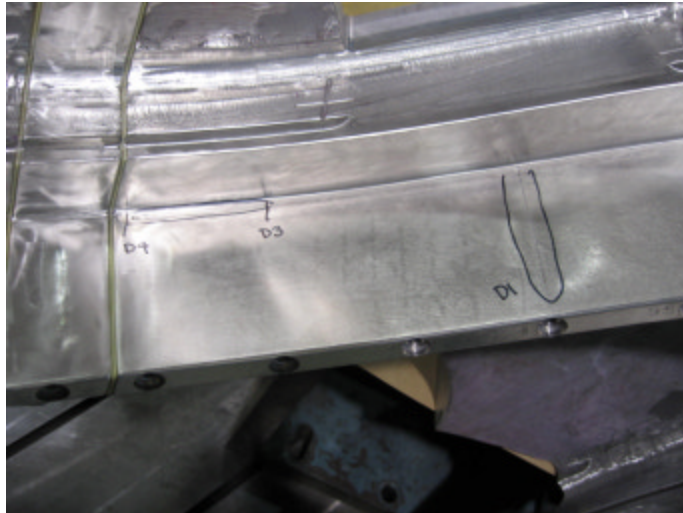
These pictures show tooling gouges on the long leg of the T on the datum D side near hole 1 and between holes 3 and 4. Gouge at D1 is $<.005$ " in depth and between D3 and D4 are $<.010$ " in depth.

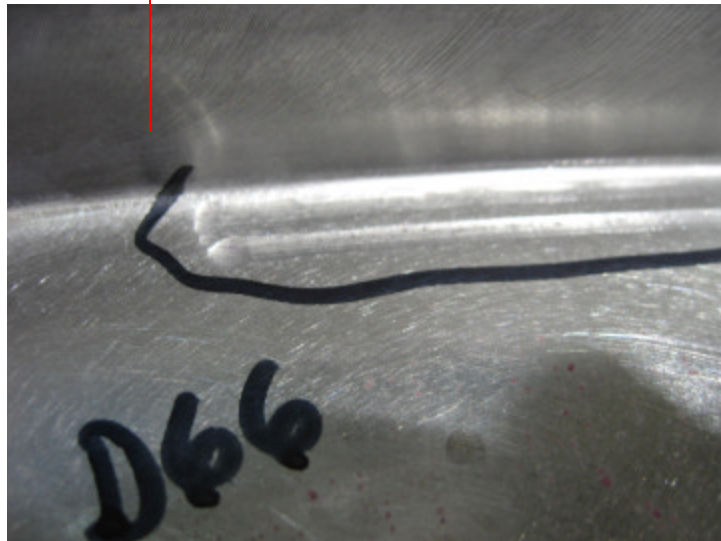
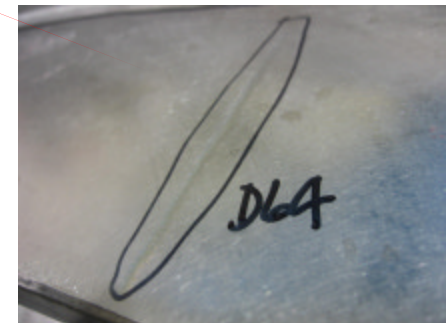
Tool gouges on D side long leg between T holes 59 and 66. Gouge near radius between D59 and D66 is $<.010''$ in depth. Gouge at D64 is $<.005''$ in depth.

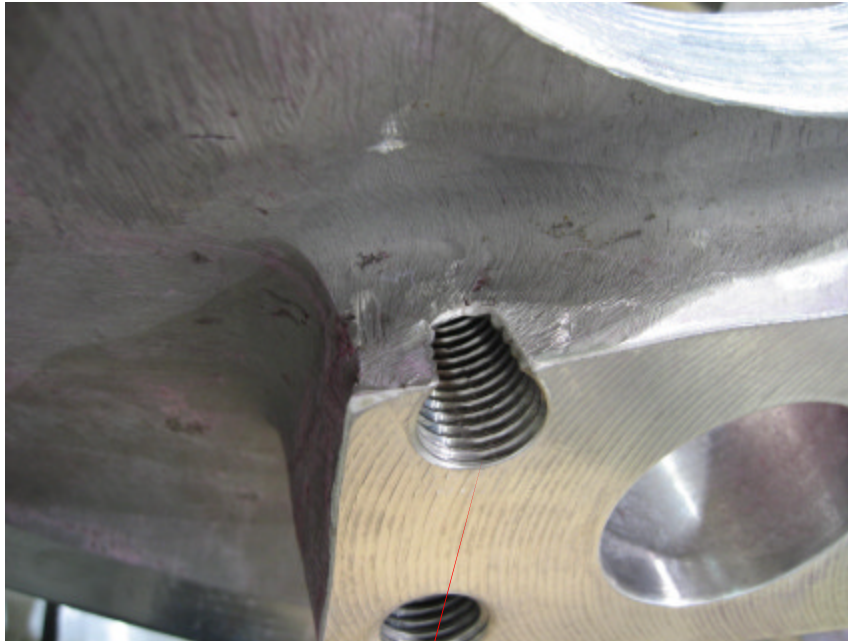
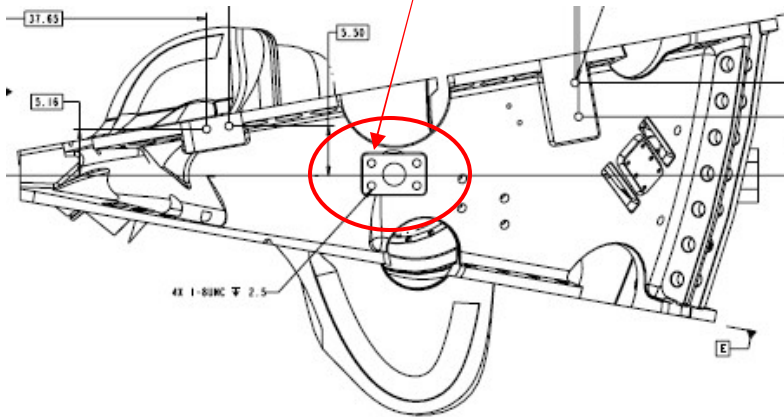
Vacuum support pad located on drawing sheet 3 zone C6 has one of the 1-8” tapped holes breaking out the side of the pad. There are approximately 5 threads breaking out the side which leaves 15 functional threads remaining.
