Subject: Summary of NCSX
VV Field Weld Joint Tests

The tests identified an acceptable joint configuration (sample 7) that when welded from one side displayed complete fusion on the backside, $1/16$ " shrinkage across the joint and acceptable fatigue life. The tests were conducted using samples cut from Inconel 625 plate, which were shaped to approximate the NCSX VV field weld joint. The initial weld cross section exhibited problems with incomplete fusion on the backside of the weld. Revision of the weld preparation resulted in an acceptable joint design.

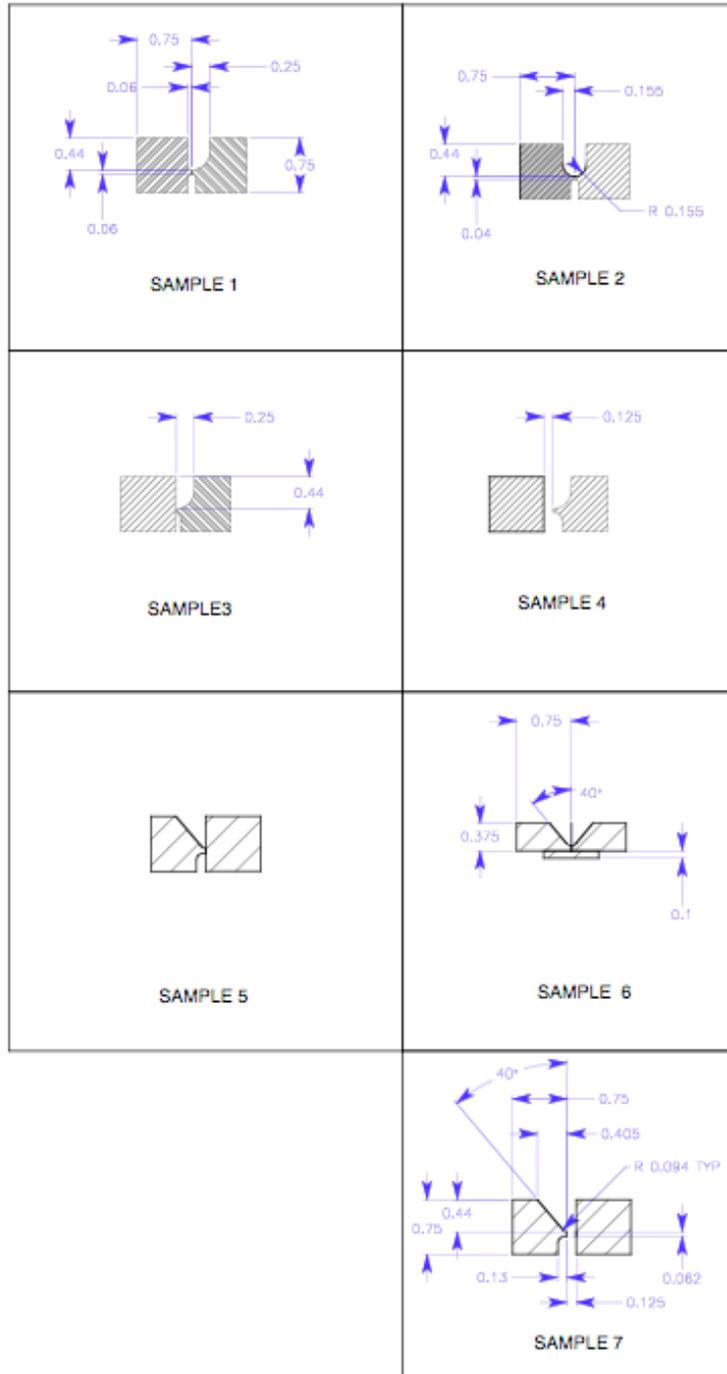
Figure 1: Dimensioned cross sections of Weld Samples

The samples were aligned to the cross sections shown in Figure 1 and tack welded into place. Measurements of the axial shrinkage were made during the welds.

Sample ID	Description (See Figure 1)	Purpose of Test	Result
1	Unequal U Groove 0.00" Root	Test sealing of fiberglas rope for shield gas on backside, test microtherm for damage from heat of weld	Rope seal worked, microtherm discolored but was unharmed, unable to get complete fusion of root on backside
2	U Groove	Reduced root to 0.040" to improve fusion, test use of Graphite packing material	Incomplete fusion on backside, Graphite packing was unacceptable due to excessive smoking during welding
3	J Groove	Test of planned (flat) spool flange shape	Incomplete fusion on backside
4	J Groove 1/8" root	1/8" root ORNL Recommendation	Incomplete fusion on backside
5	Single Bevel, 0" root	ORNL Recommended configuration	Tungsten access was much better than the previous welds due to the wider access. Incomplete fusion on backside, fatigue tested 1,000,760 cycles
6	Double Bevel with backing ring	To determine if backing ring weld could be done	Easy to weld, fused into backing ring

7	Single Bevel with 1/8" root	Used ORNL standard weld cross section	Root of backside improved., modest shrinkage on order of 1/16"

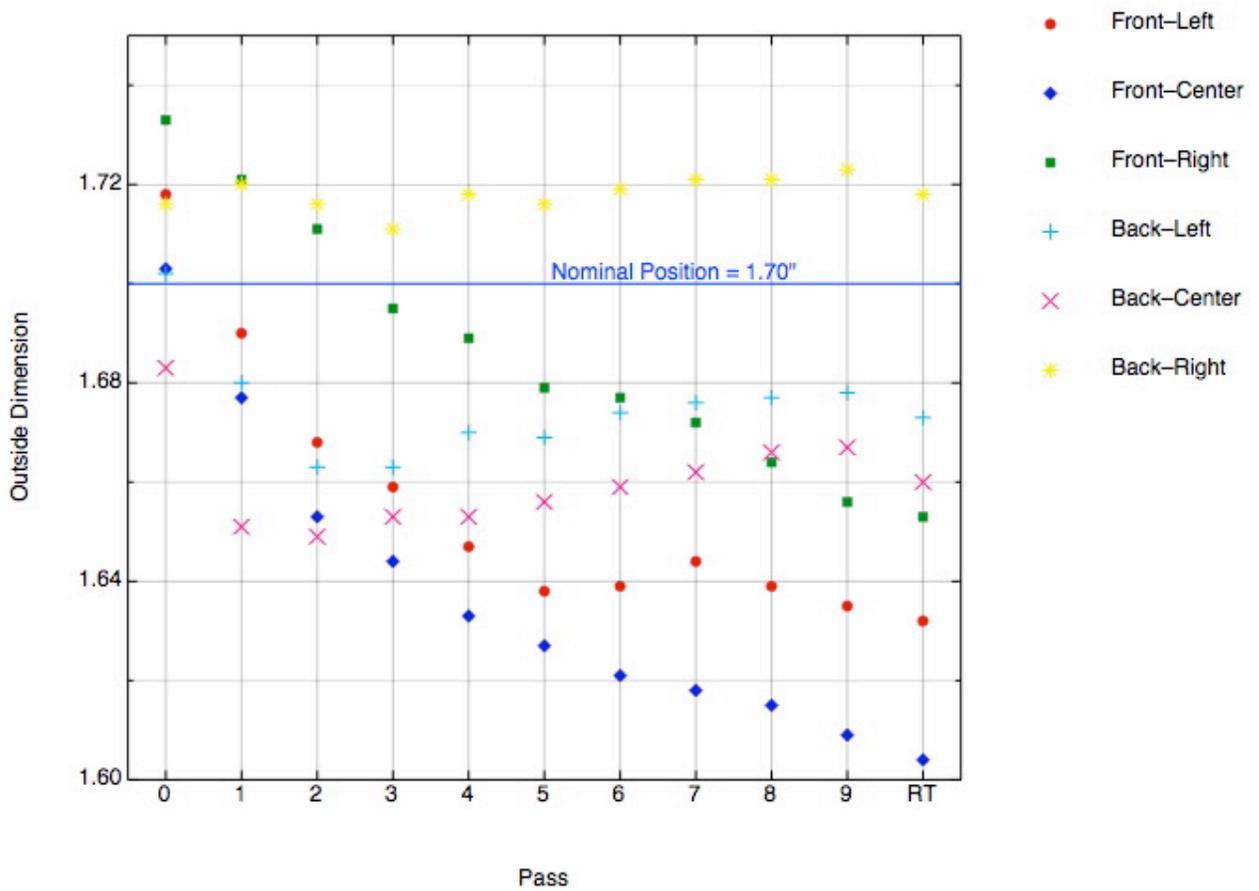
Figure 2: Measurement of Weld Distortion

Weld distortion was measured across the weld joint at three places along the weld test sample and at the front (welded) and back (unwelded) side. The direction of the weld was from Right to Left. The measurements were taken as the piece was setup in the fixture before welding (pass 0), after each pass (pass 1-9) and once more after the piece cooled back to room temperature (RT). The average contraction of the parts due to welding was approximately $1/16$ ".

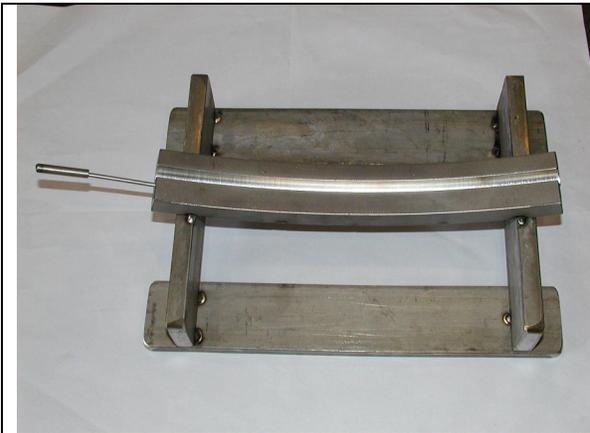
Photo 1: Weld Sample with purge in support cradle

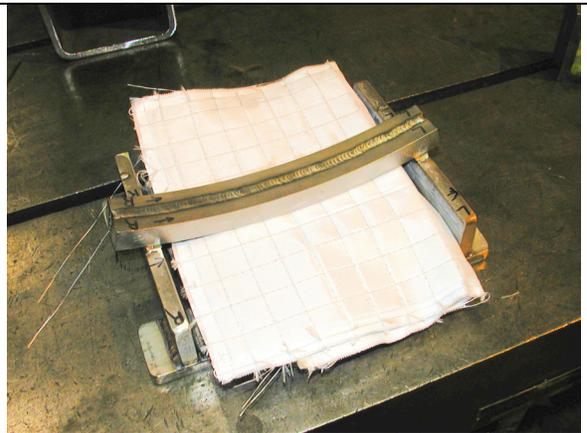
Photo 2: Weld sample with microtherm test setup

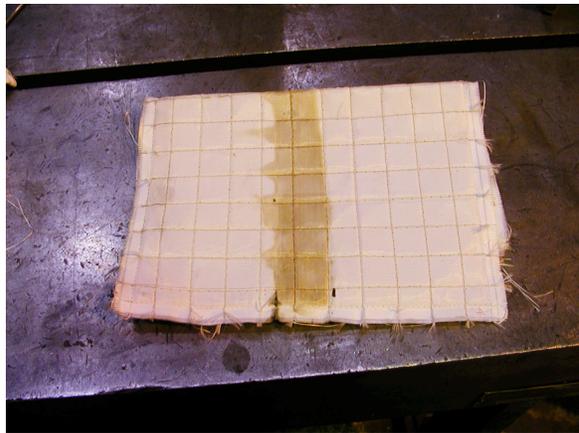
Photo 3: Microtherm insulation after the weld discolored but unharmed

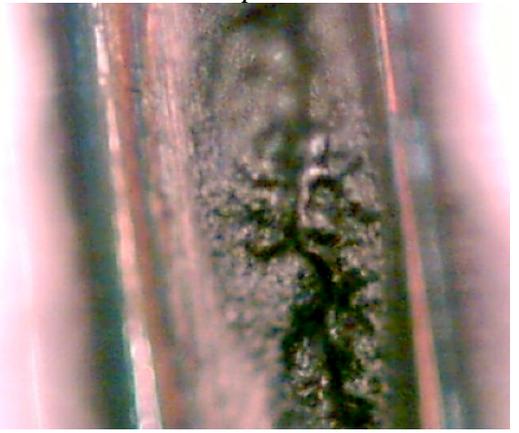
Photo 4: Weld Sample 1- Incomplete fusion on the backside

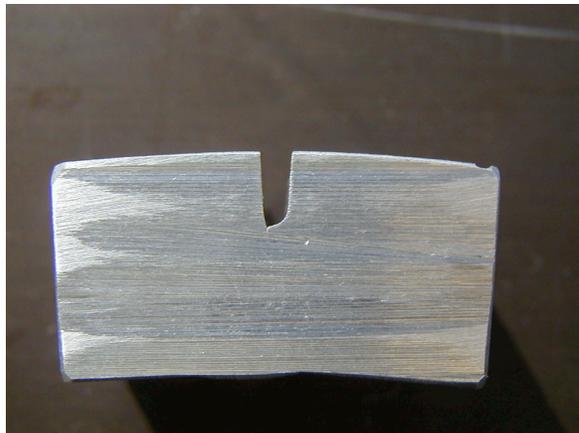
Photo 5: Weld Sample 1- Cross Sectioned

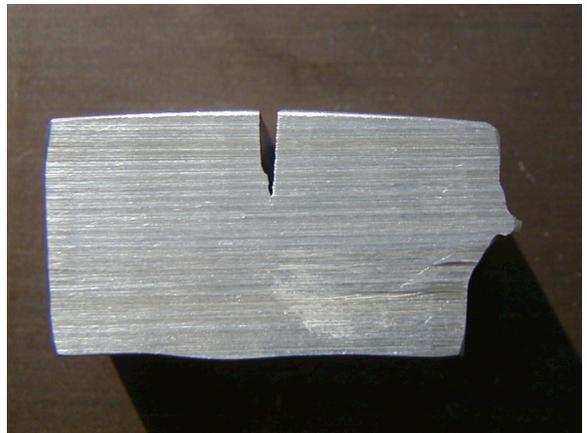
Photo 6: Weld Sample 3 - Sharp notch on backside

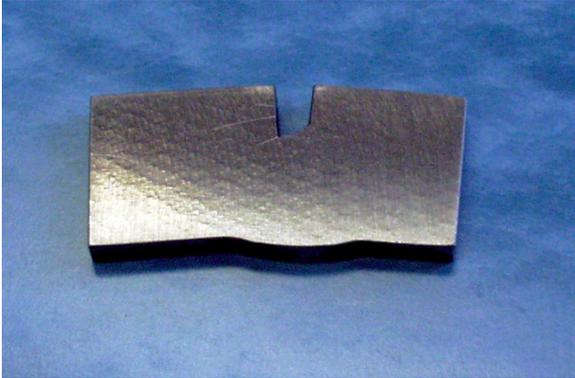
Photo 7: Sample 5- Single bevel

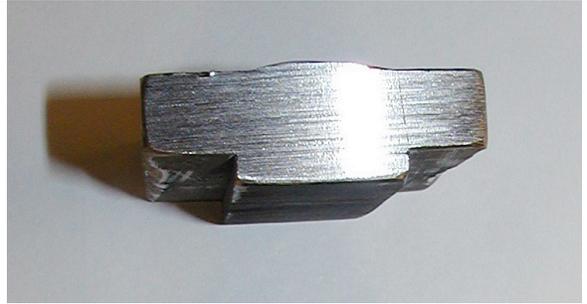
Photo 8: Sample 6- Double Bevel with backing ring

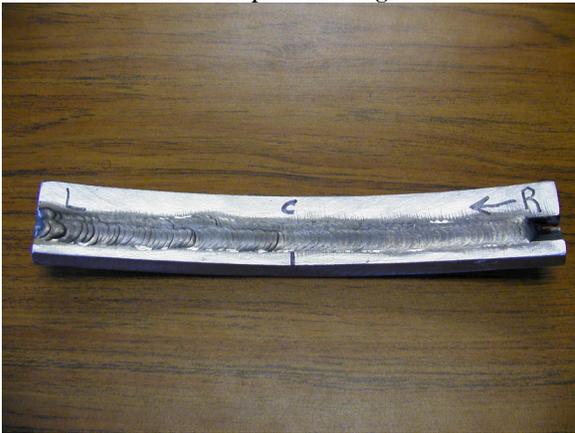
Photo 9: Weld Sample 7 - Frontside

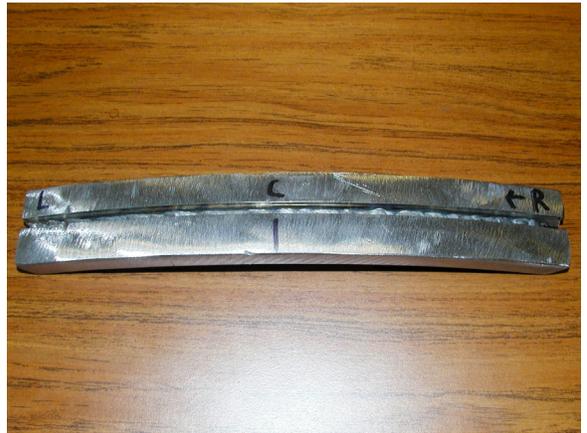
Photo 10: Weld Sample 7- Backside complete fusion

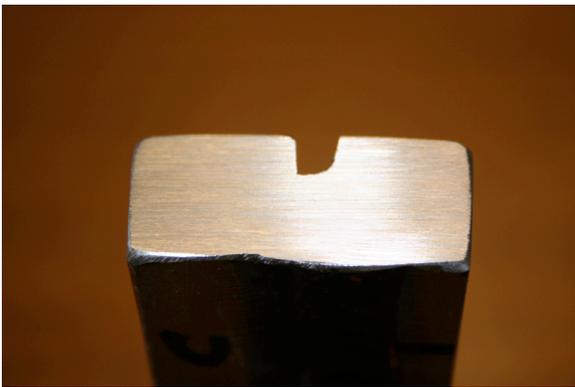
Photo 11: Sample 7- Cross sectioned
