NCSX Field Period Assembly

August 15, 2007

Mike Viola
Field Period Assembly Manager

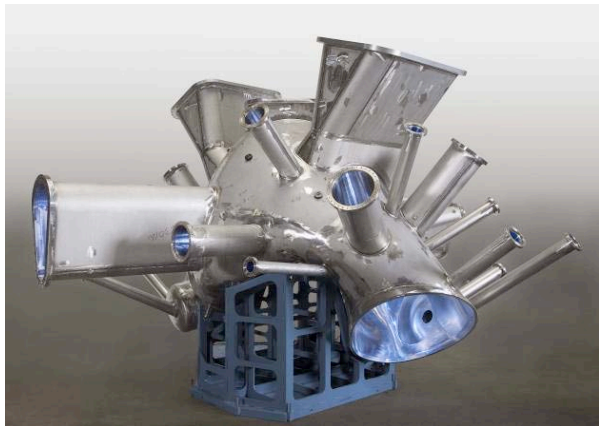
VVSA with ports welded

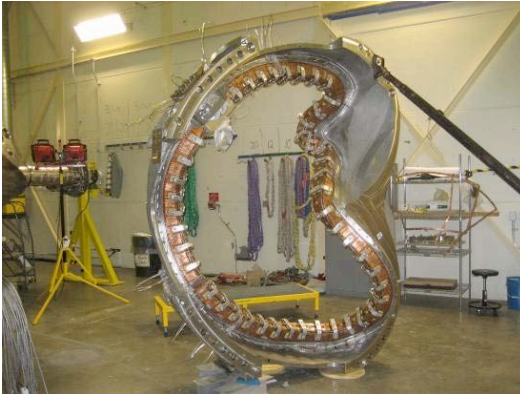
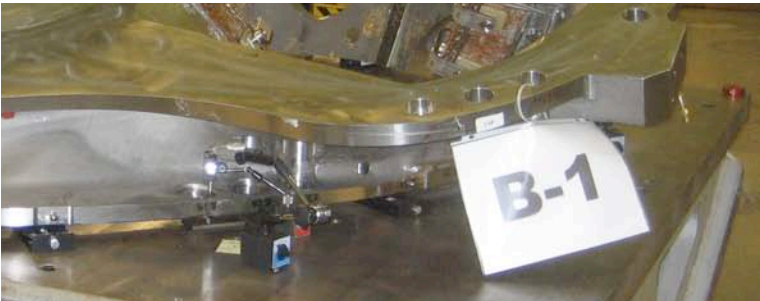
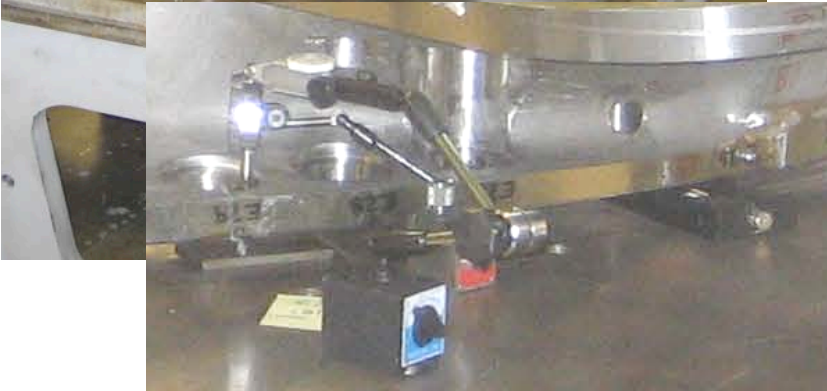
FPA Station 2 Activity

- Station 2 (3 coil preassembly – scan, align, shim, **weld**, and assembly using laser tracker)
- Activity has begun:
 - A1, B1, and C1 have all been gross fit to each other

- found minor interferences that are all understood and straightforwardly resolved in a few days.
 - Measurements started – new technique for reproducing original scans shows great promise.

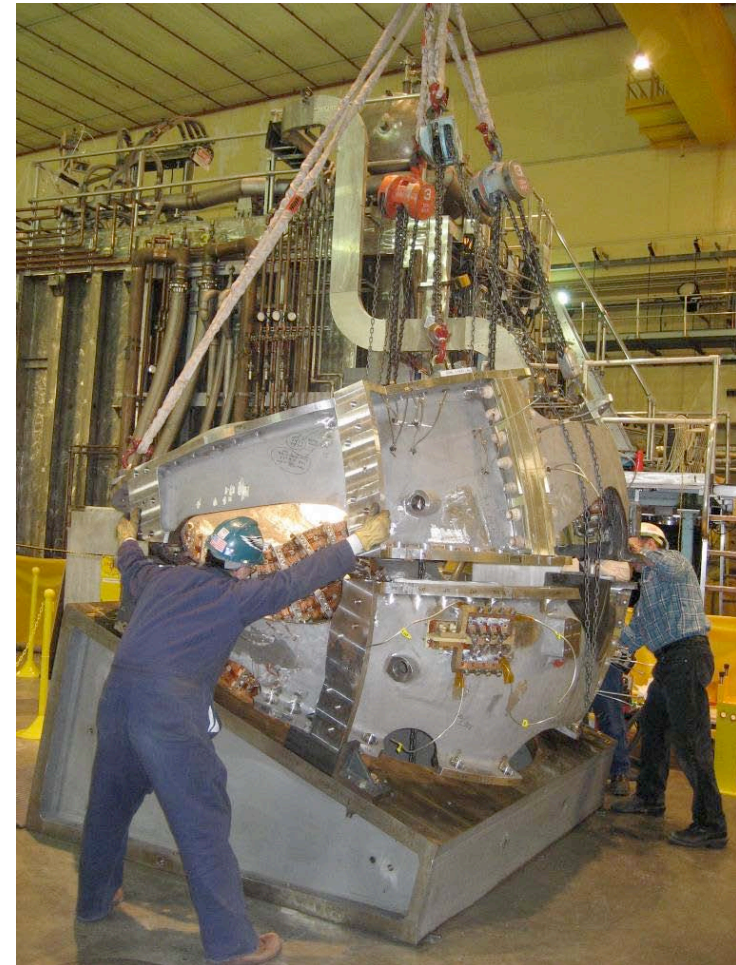
- Learned that positioning and leveling is simpler than expected
 - Simple corner plates with dial indicators
- Achieved
 - X-Y +/-0.002”
 - Z +/- 0.001”

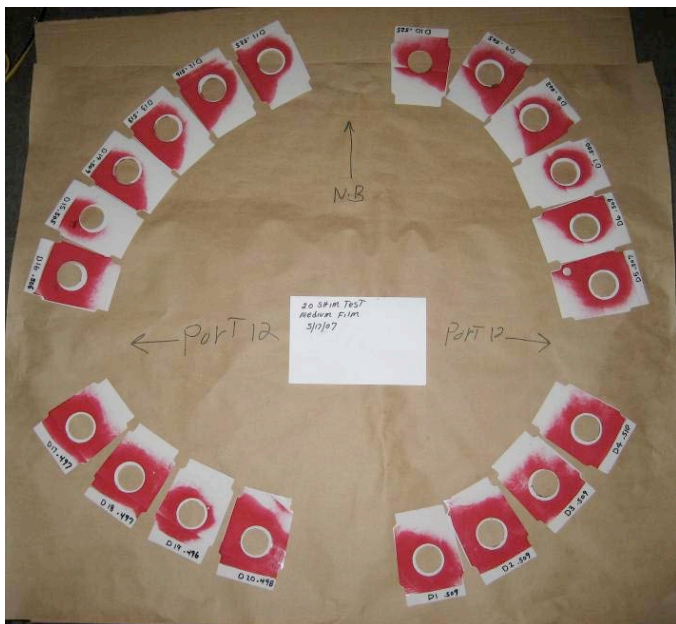
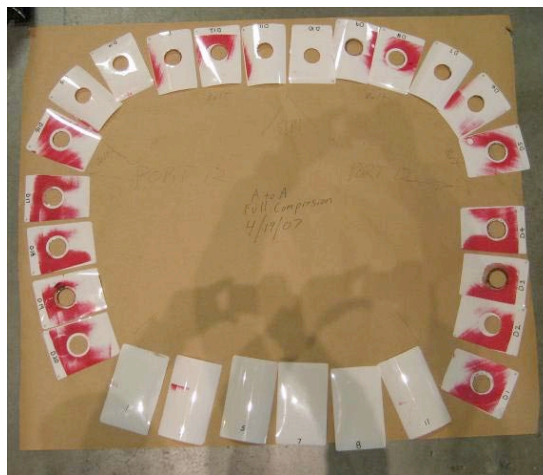
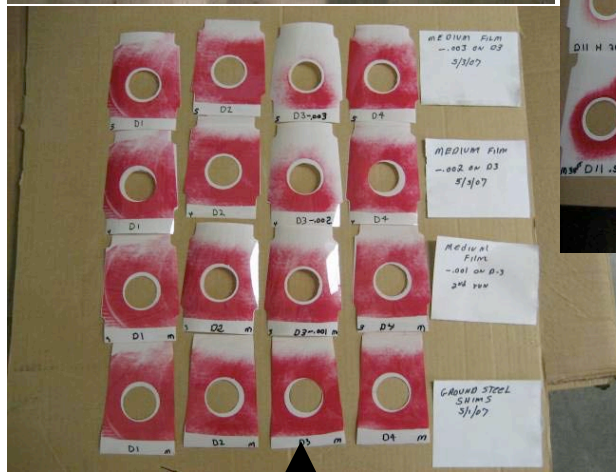
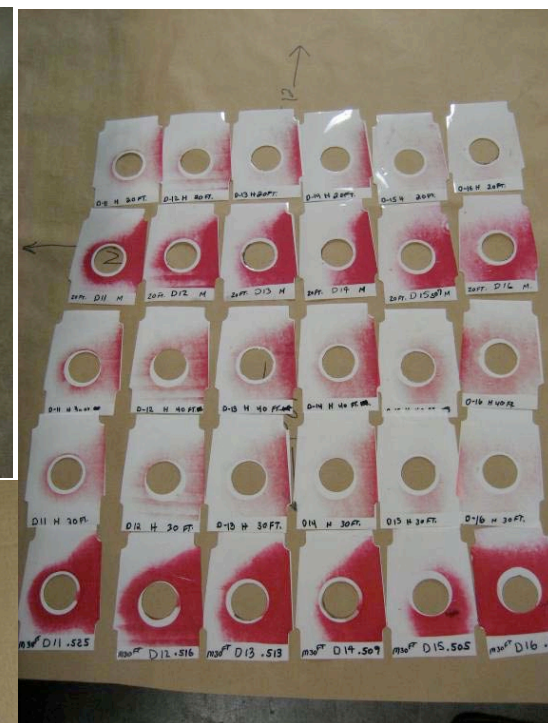
- Shims need to fit properly to work in shear
 - Accurate thickness
 - Sufficient surface contact

Effects of varied tension and film range

Varied single shim by 0.001"

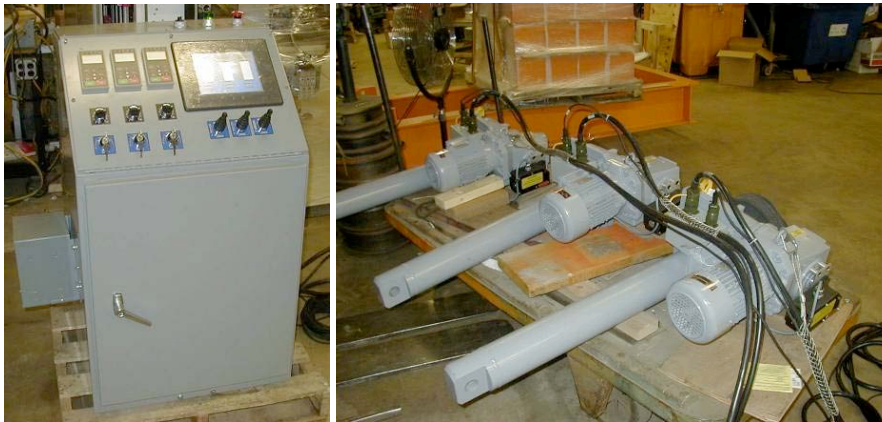
- Station 3 (install coils onto vacuum vessel using laser tracker)
 - Alignment and assembly trials are being developed at station 2
 - Actuators received for 3 legged manipulation of coils over vacuum vessel
 - Positioning demonstrated to be easily achievable using simple lasers with tracks
 - Each leg capable of full load plus 3:1 design factor

- Alignment and assembly trials are being developed at station 2
- Trial with 25,000 lb. block resolved main concern of installing coils onto vacuum vessel
- Complex installation mechanism replaced with simple 3 legged actuator system
