Energy Industries of Ohio

Contract # S005242-F

Modular Coil Winding Form

A-1 Documentation Package

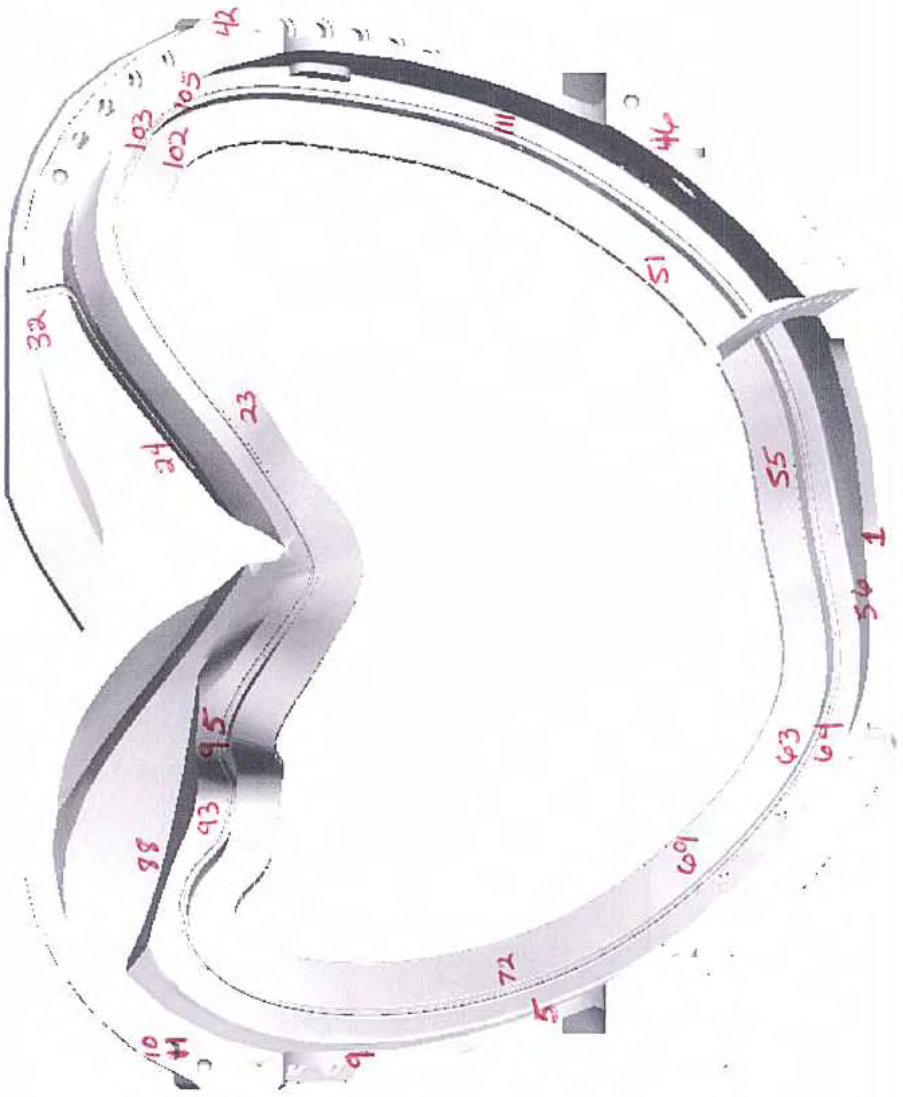
42
105
103
102
111
44
51
32
23
24
55
1
54
95
93
98
63
64
69
72
5
9
Front

A-1 COIL WELD MAP

Defect Number	Drawing View	Length Inches	Width Inches	Depth Inches	Over 20% wall Over 1 inch Over 10^2 inches Yes/No
295	BACK	11 1/2	4 1/2	3/4	Yes
296	BACK	6	4	3/4	Yes
297	Left	6 1/2	2 1/2	3/4	Yes
300	Left	11	9	1	Yes
304	Left	10	1 1/2	1	Yes
306	Left	8	6	3/4	Yes
308	Left	8 1/2	4 1/2	3/4	Yes
309	Left	4 1/2	4	1/2	Yes
313	Left	7	2 3/4	2 1/4	Yes
315	BACK	9	2 1/2	1/2	Yes
320	BACK	11	1 1/2	2	Yes
321	BACK	5	3	1/4	Yes
322	BACK	8 3/4	3	3/4	Yes
327	BACK	4	2	2	Yes
328	BACK	3	2	1	Yes
329	BACK	2 3/4	2	1	Yes
341	BACK	8	8	1/2	Yes
348	BACK	6	3	1/2	Yes
364	BACK	6 1/4	2 1/2	3/4	Yes
366	BACK	3 3/4	3 3/4	1	Yes
367	Left	3 1/2	~~2 1/2~~	Through	Yes
368	Left	7 1/2	3	Through	Yes
369	Left	5	4 3/4	1/4	Yes
155R1	Right	6	4 1/2	1	Yes
162 R1	Right	8	2 1/4	1 1/4	Yes
170 R1	Right	4 3/4	3 1/2	1 1/2	Yes
145 R1	Right	5 1/2	2 1/2	1 1/2	Yes
155R2	Right	7	5	1 1/2	Yes
170R2	Right	7 1/8	2 1/4	1 1/4	Yes
370	Right	3 3/16	2 3/8	1	Yes
371	Right	5	3 7/8	1 3/4	Yes
373	Left	6 7/8	1 3/4	3/4	Yes

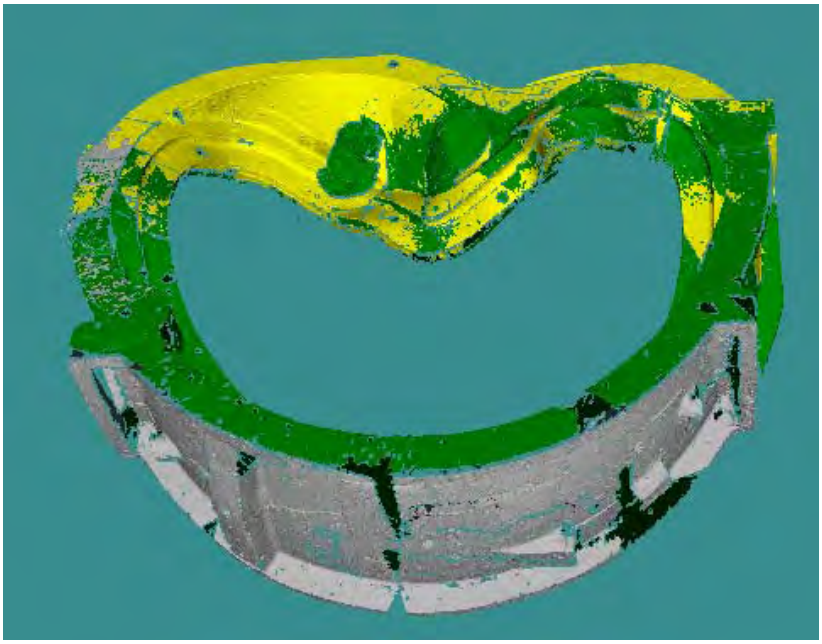
This letter is intended to document a tolerance loss observed during dimensional inspection of an A casting and the corrective actions that were used to recover satisfactory tolerances. The tolerance loss occurred due to an unforeseen set of circumstances and Standard Operating Procedures will be updated to prevent future problems even in such a rare occurrence.

The castings were scanned in three separate "sessions" as shown in yellow, green, and gray. Each session was scanned using a Konica-Minolta 9i/PSC-1 measurement system ISO certified to +/-0.05mm (0.002in).

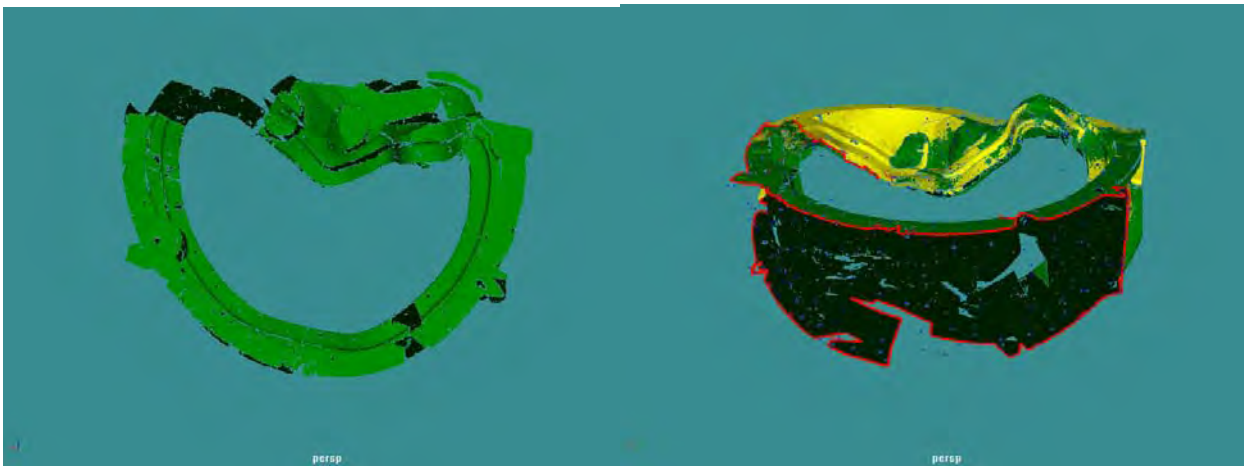
The problem encountered on this casting occurred when trying to locate the bottom session (in grey above) relative to the main session (in green above). The main session was taken with the part resting on the floor such that the entire grey surface was not accessible as shown in Figure 2.

Figure 2: The main scan was performed with the part in an upright orientation. This left the underside of the part un-scanned since it was facing the floor.

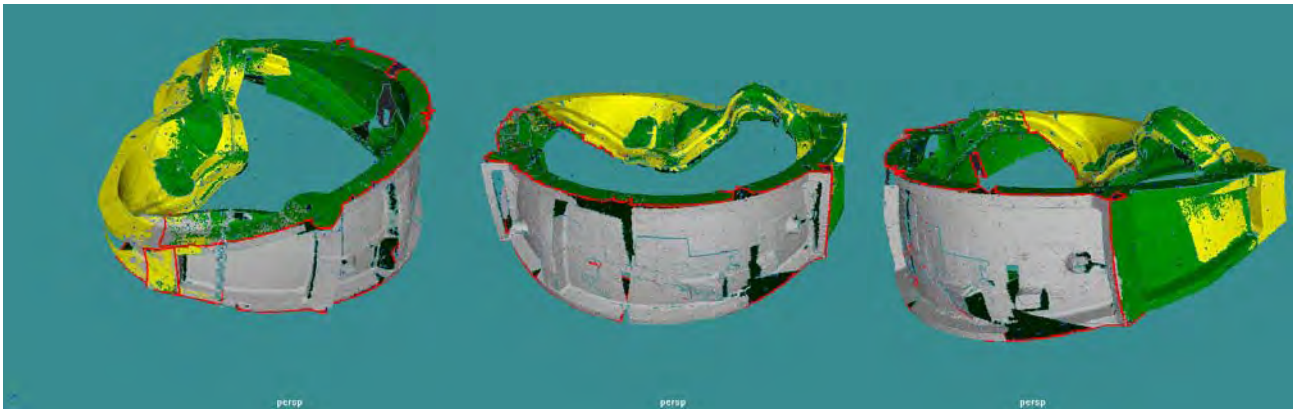
Typically the goal is to get enough overlap between any two sessions so as to enable a tight lock between them, as shown between the yellow and green sessions in Figures 2 and 3. When the part was layed down to scan the bottom (grey side) the problem was that the edge of the scan almost exactly matched the edge of the green session. There was some overlap on the left side but the lack of overlap on the right side caused a misalignment to occur that resulted in the grey session not being placed properly and thus producing error in thickness calculations in that area. The fact that the outlines (shown in red) matched so closely is a rare occurrence that caused an unforeseen problem.

Figure 3: The edges of the green and grey sessions are shown in red.

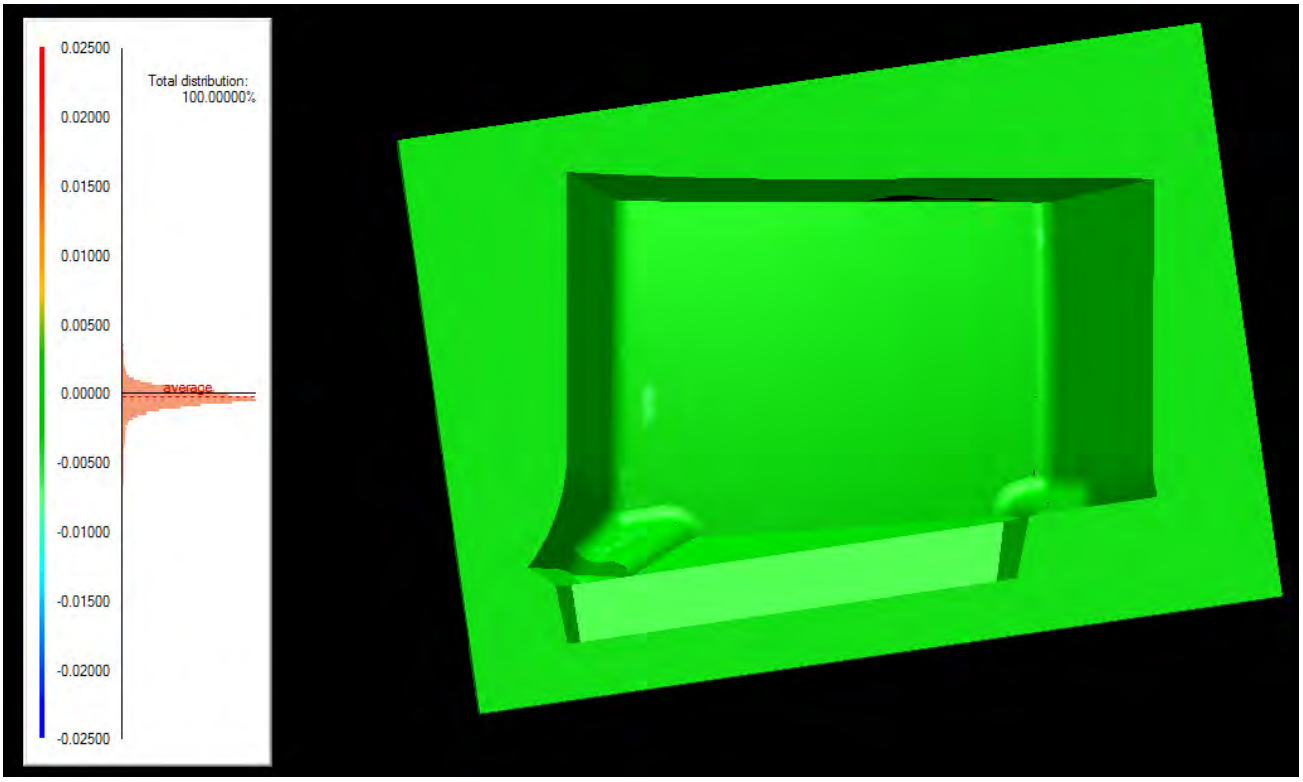
Box 1: 458125 data points

The color maps below show the deviations of scan data when compared to CAD. These are the same color maps as were in the original inspection reports. Shown here is also the histogram report, which shows how much of the data resides within each deviation band. For example 100% of the 428,125 points scanned for box 1 are within 0.025" and the majority are within 0.005".

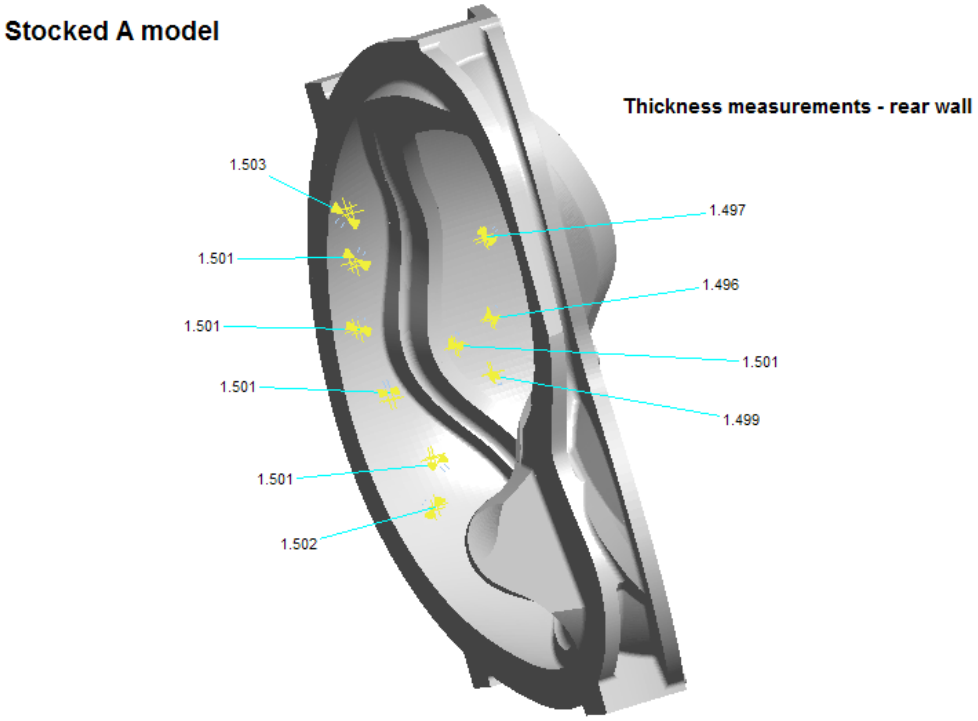
Evaluation of stocked A model for adequate stock

1. Measurements shown are through-wall thickness measurements of the stocked A model (no shrink) created by Lawton Patterns.

2. Measurements taken along wall where the A-1 casting is exhibiting thin wall conditions ranging down to 1.18”

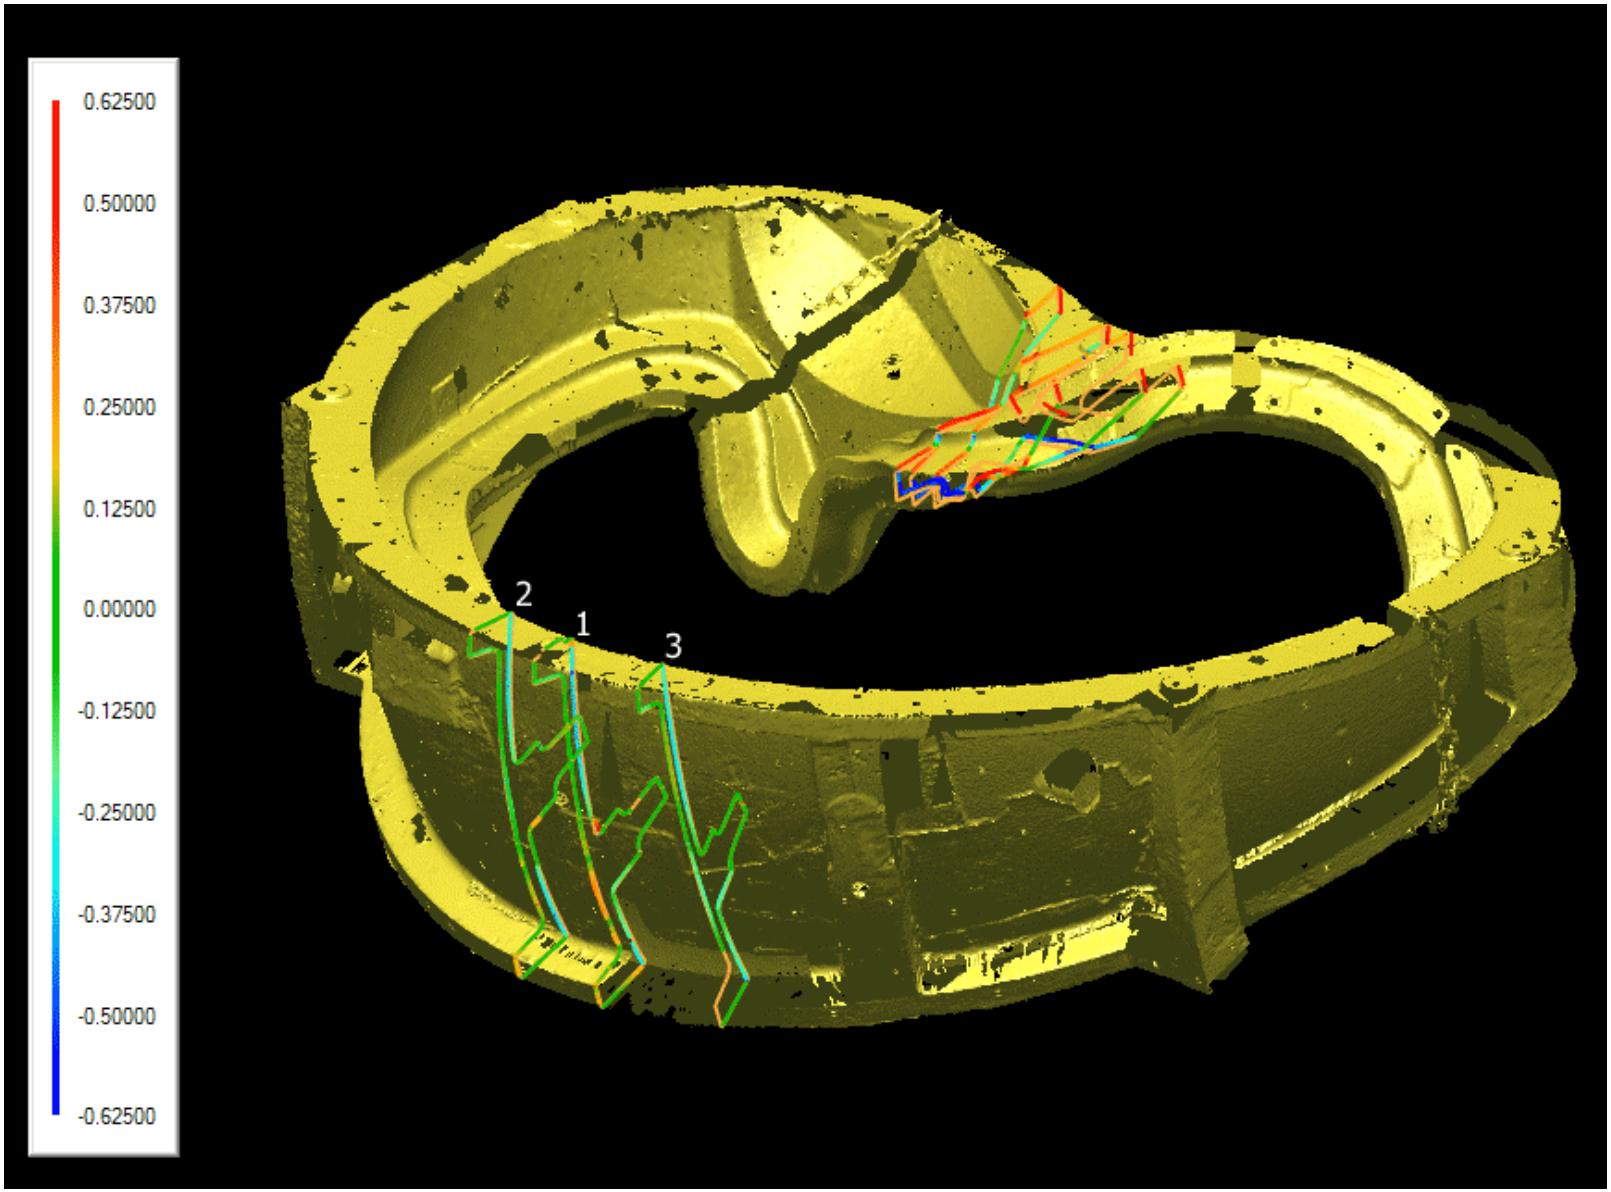
Location of 3 cross sections

- Dimensional data supports a under tolerance condition exists on an area of the shell
  - Limited options on increasing thickness on A1
- 3D Scanco data correlates to physical measurements taken by MetalTek on the A1
  - MetalTek dimension taken from shell at cut-thru
- Dimensional data supports that the A-B alignment will be achieved at the flanges, but may not align shells (no interference issues)
  - Root cause not confirmed
- Dimensional changes to A1 part are all long time period changes and involve extensive work to part and matching work on pattern equipment
  - Quickest path forward may be FEA and Waiver

- Energy Industries of Ohio Team requests that PPPL analyze this and respond with preferred direction to move forward
  - MetalTek can offer additional laser scanning for verification of shape/dimension
  - Lawton has offered transfer measurement as a means for direct measurement of thickness, MetalTek has experience using similar technique
  - Component is on process hold pending resolution. Time is of the essence.

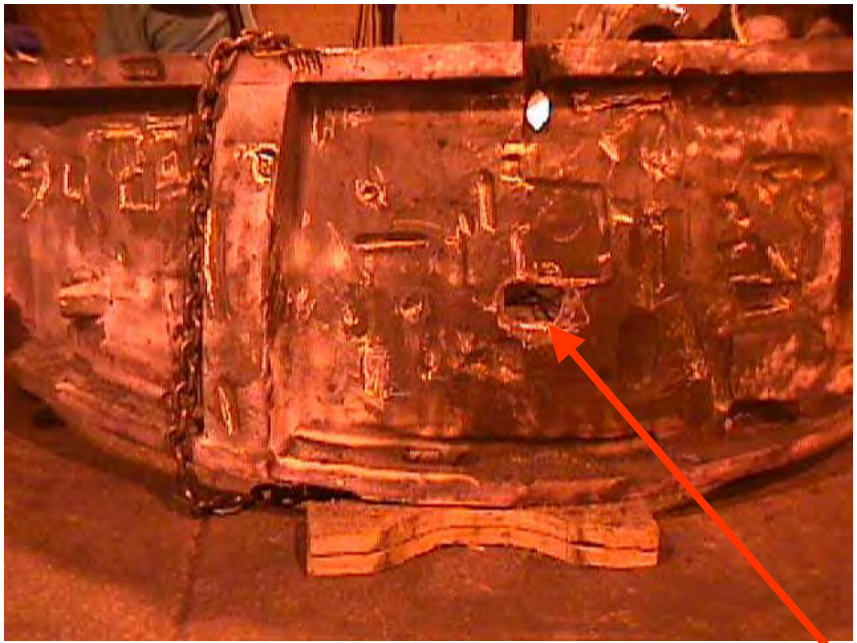
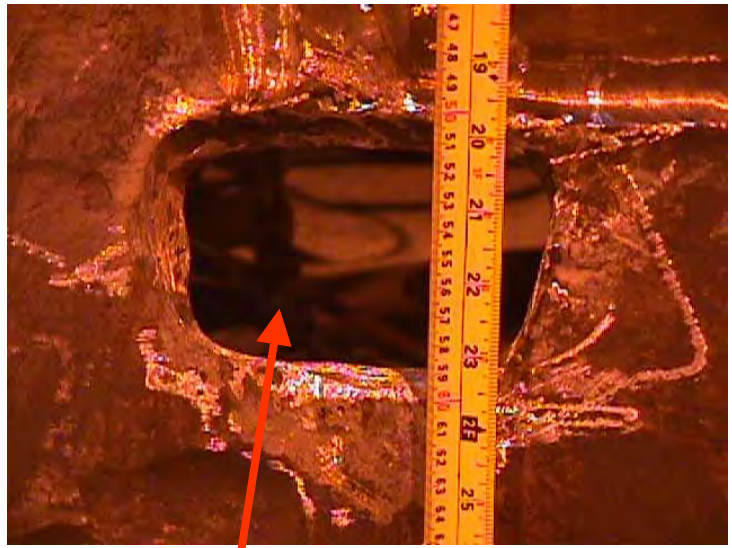
MetalTek Verification

Excised hole for dimensional verification (1.24-1.27”)

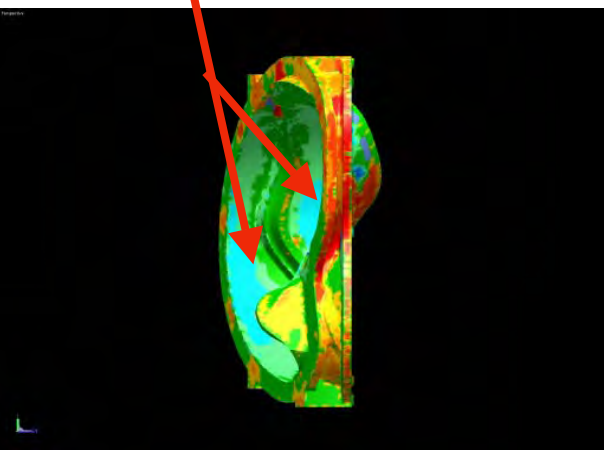
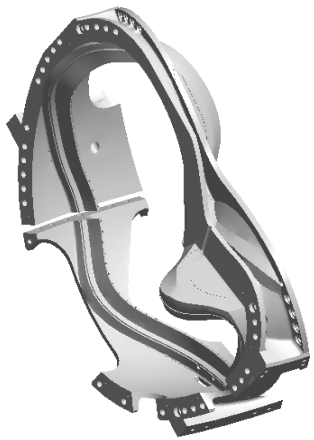
Thin Wall Areas in the A1 Casting

thin areas In light blue

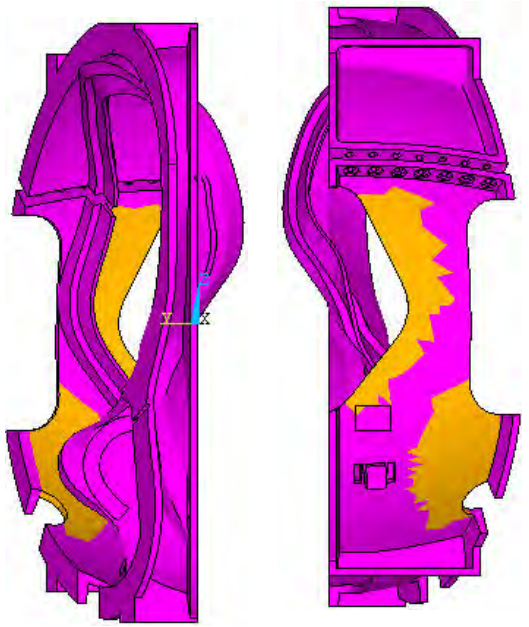
Machined Casting

FEA model – thin areas are tan.

Note That Much Of the Thin Area is Machined Away, Lessening its Effect

- Since the thin section of A1 has virtually no affect on stresses or deflections of either the coil or shell, the NCR for A1 with the thin region having a minimum thickness of 1.18” will be dispositioned to “Accept As Is”.
- Pending the root cause analysis and EIO’s recommendation, if necessary, based on these analyses, we have the flexibility to allow the wall thickness IN AN AREA SIMILAR TO A1 for all future Type A Castings to be a minimum of 1.050” and a maximum of 1.375 +0.250 =1.625” (which is the same as the upper limit currently specified).

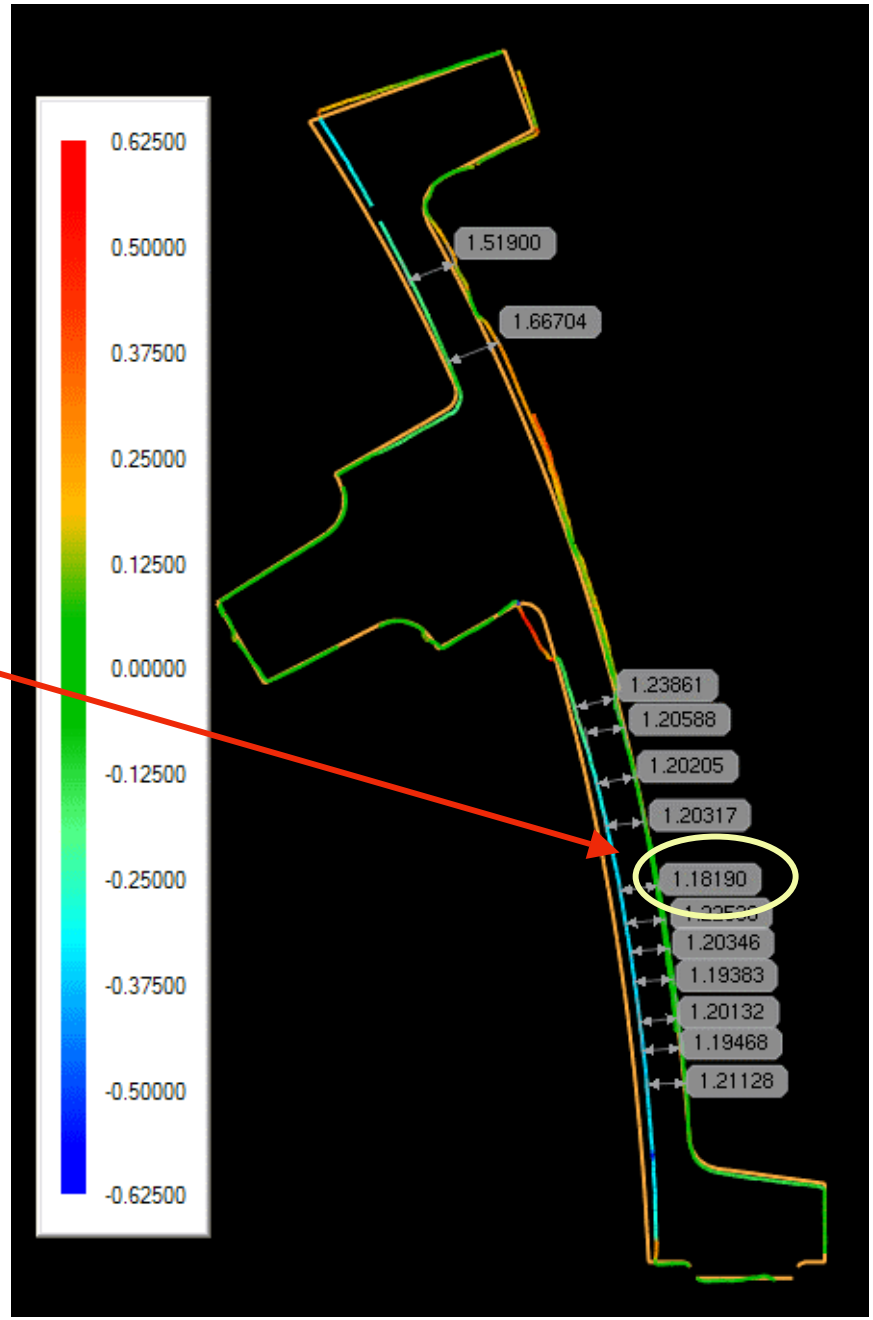
Thinnest actual section is 1.18”.

“Guesstimate” is the thin area is 15% of the wall area.

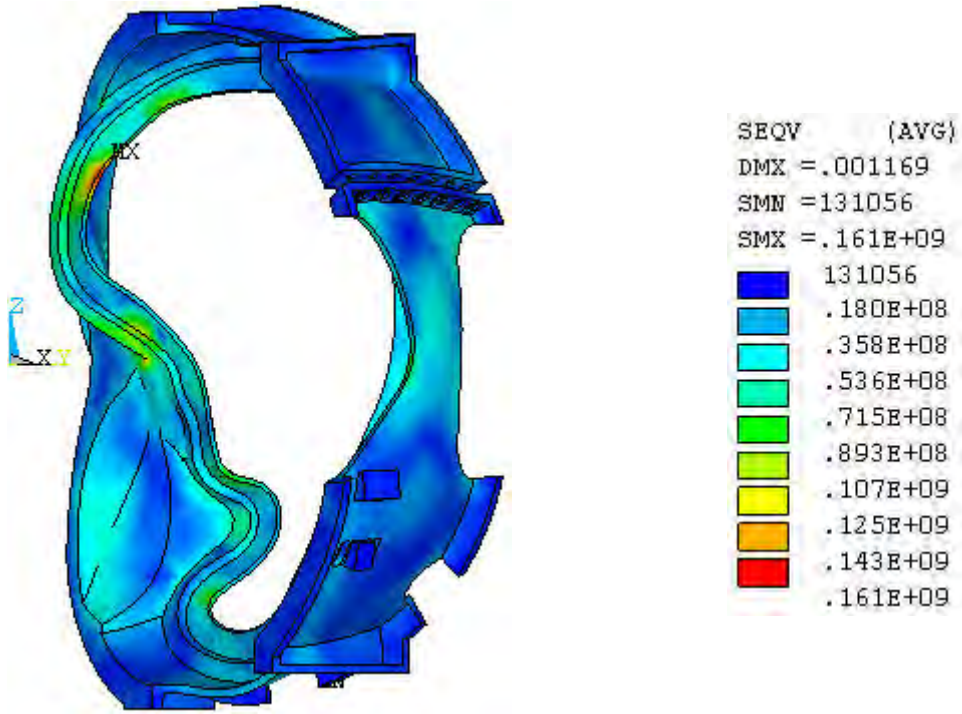
This model reflects the updated E and also thin shell regions in A1 with wall thicknesses t=1.18". Stresses in Shell Type A for Run No. 6

- E=145 GPa except E(thin wall region)=124 GPa

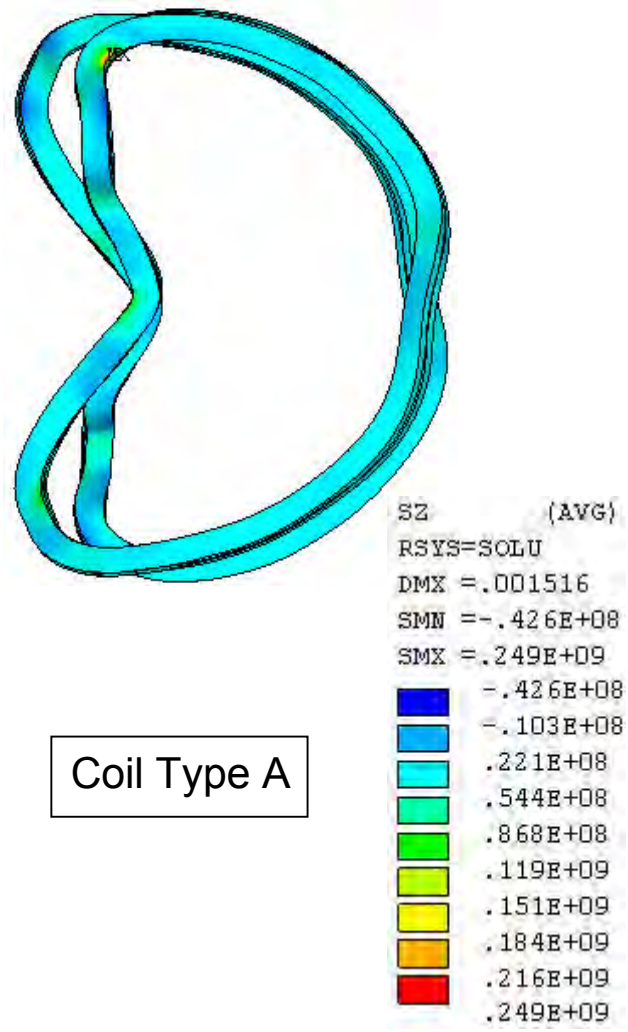
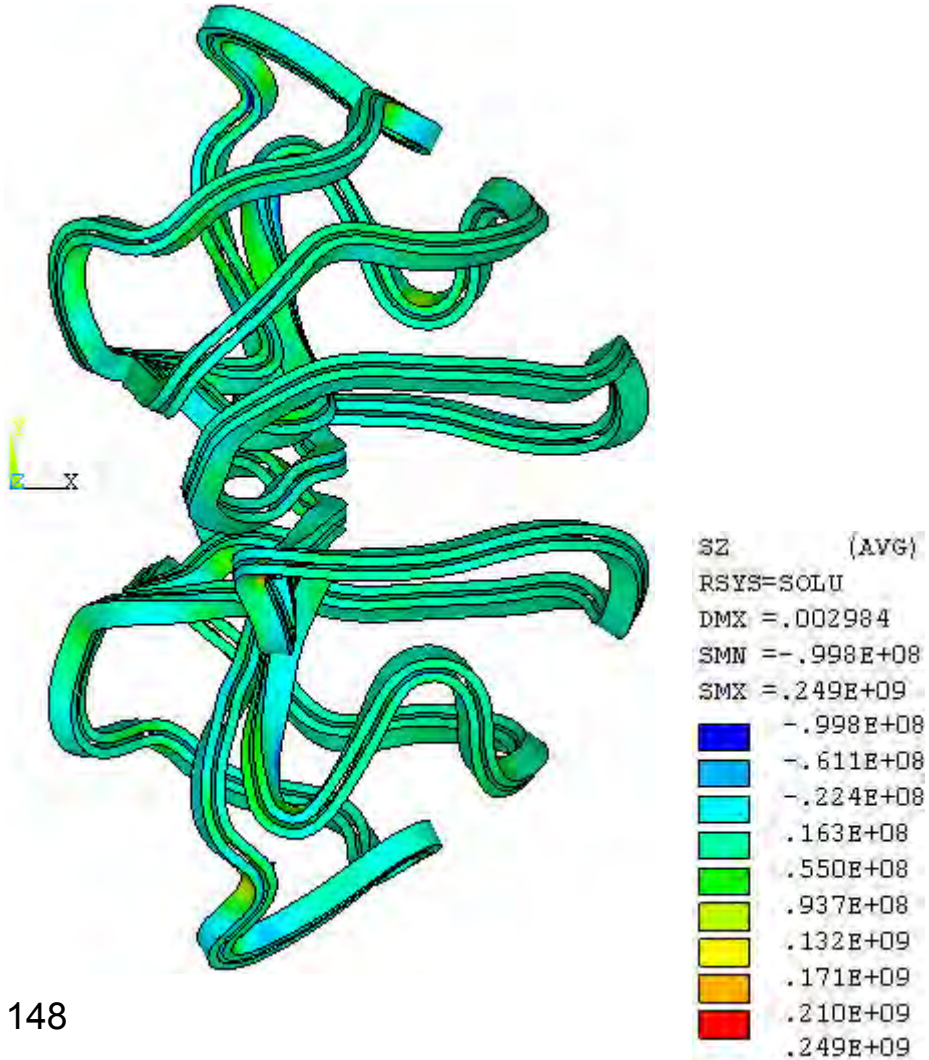
This model reflects the updated E and also thin shell regions in A1 with wall thicknesses t=1.18". Axial Stresses in Modular Coils for Run No. 6

- E=145 GPa except E(thin wall region)=124 GPa

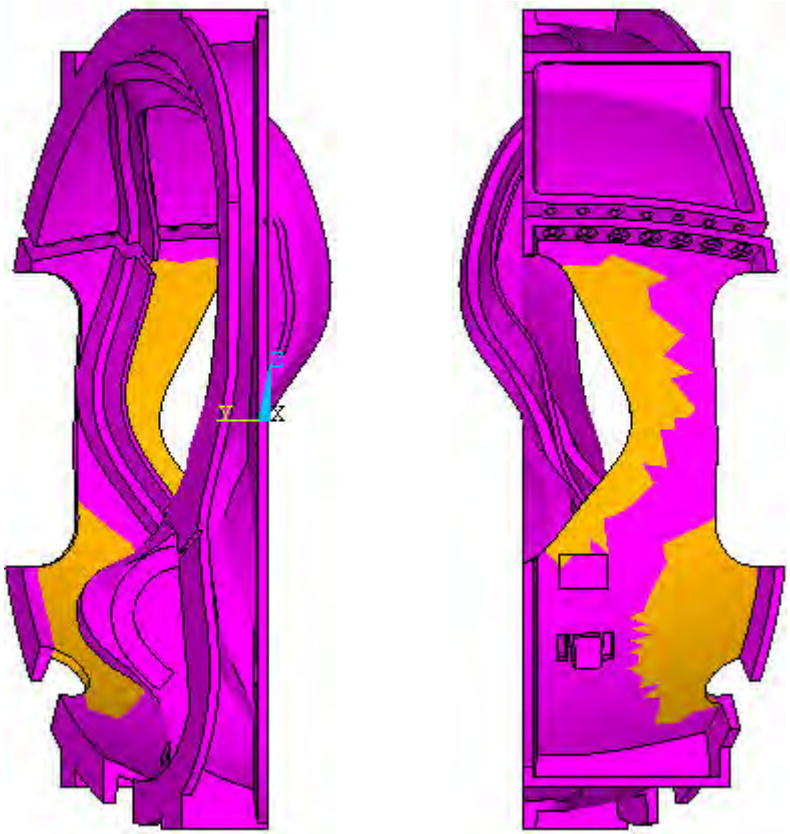
This model uses a corrected E and models All Type A Castings as Having A Thin Region Like A1 but t=1.05”

Modulus of Elasticity in Shell Type A for Run No. 4,

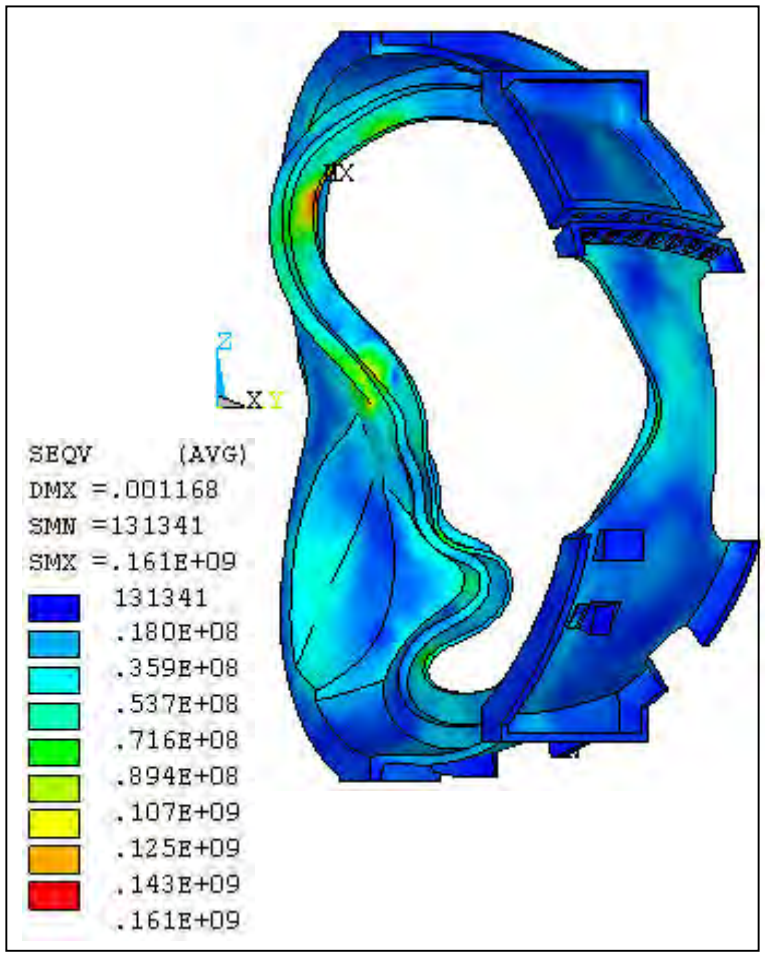
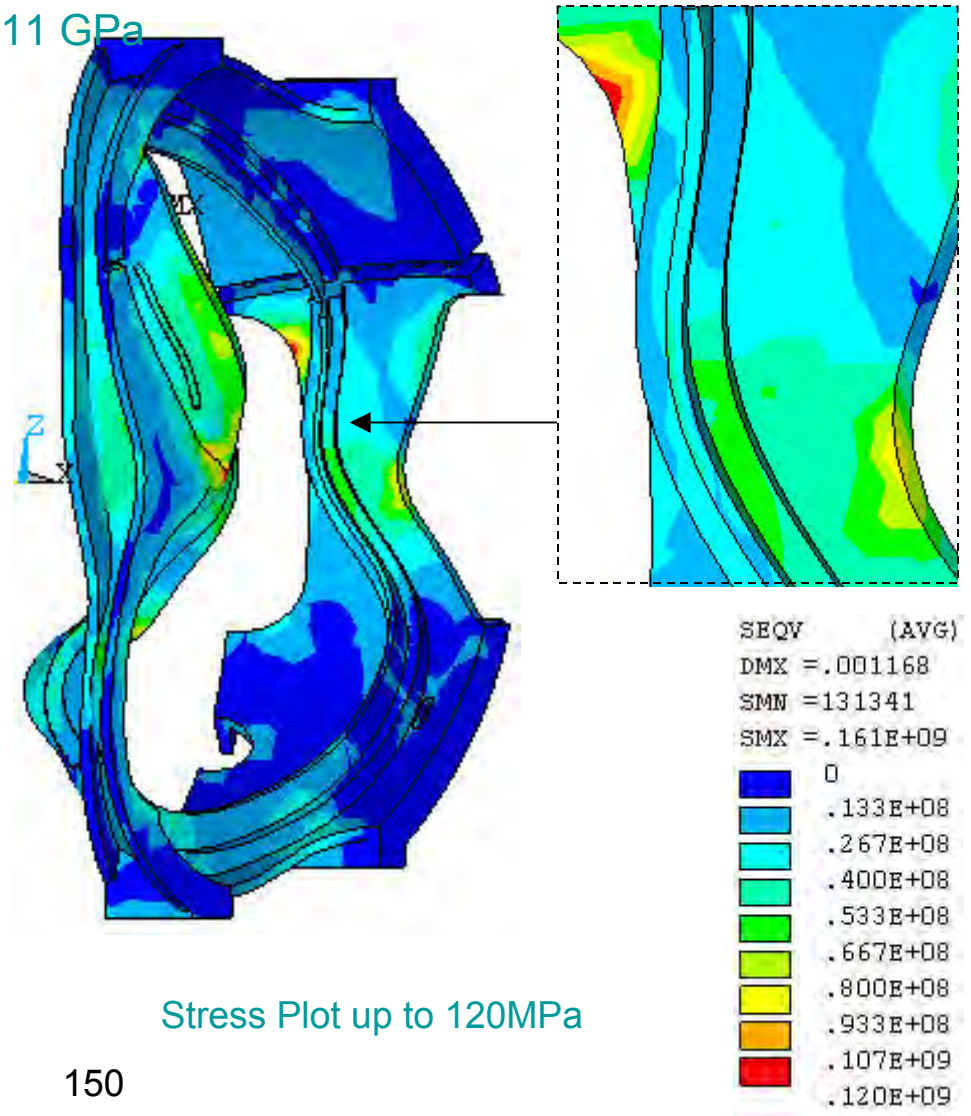
Stresses in Shell Type A for Run No. 4

- E=145 GPa except E(thin wall region)=111 GPa

Stress Plot up to 120MPa

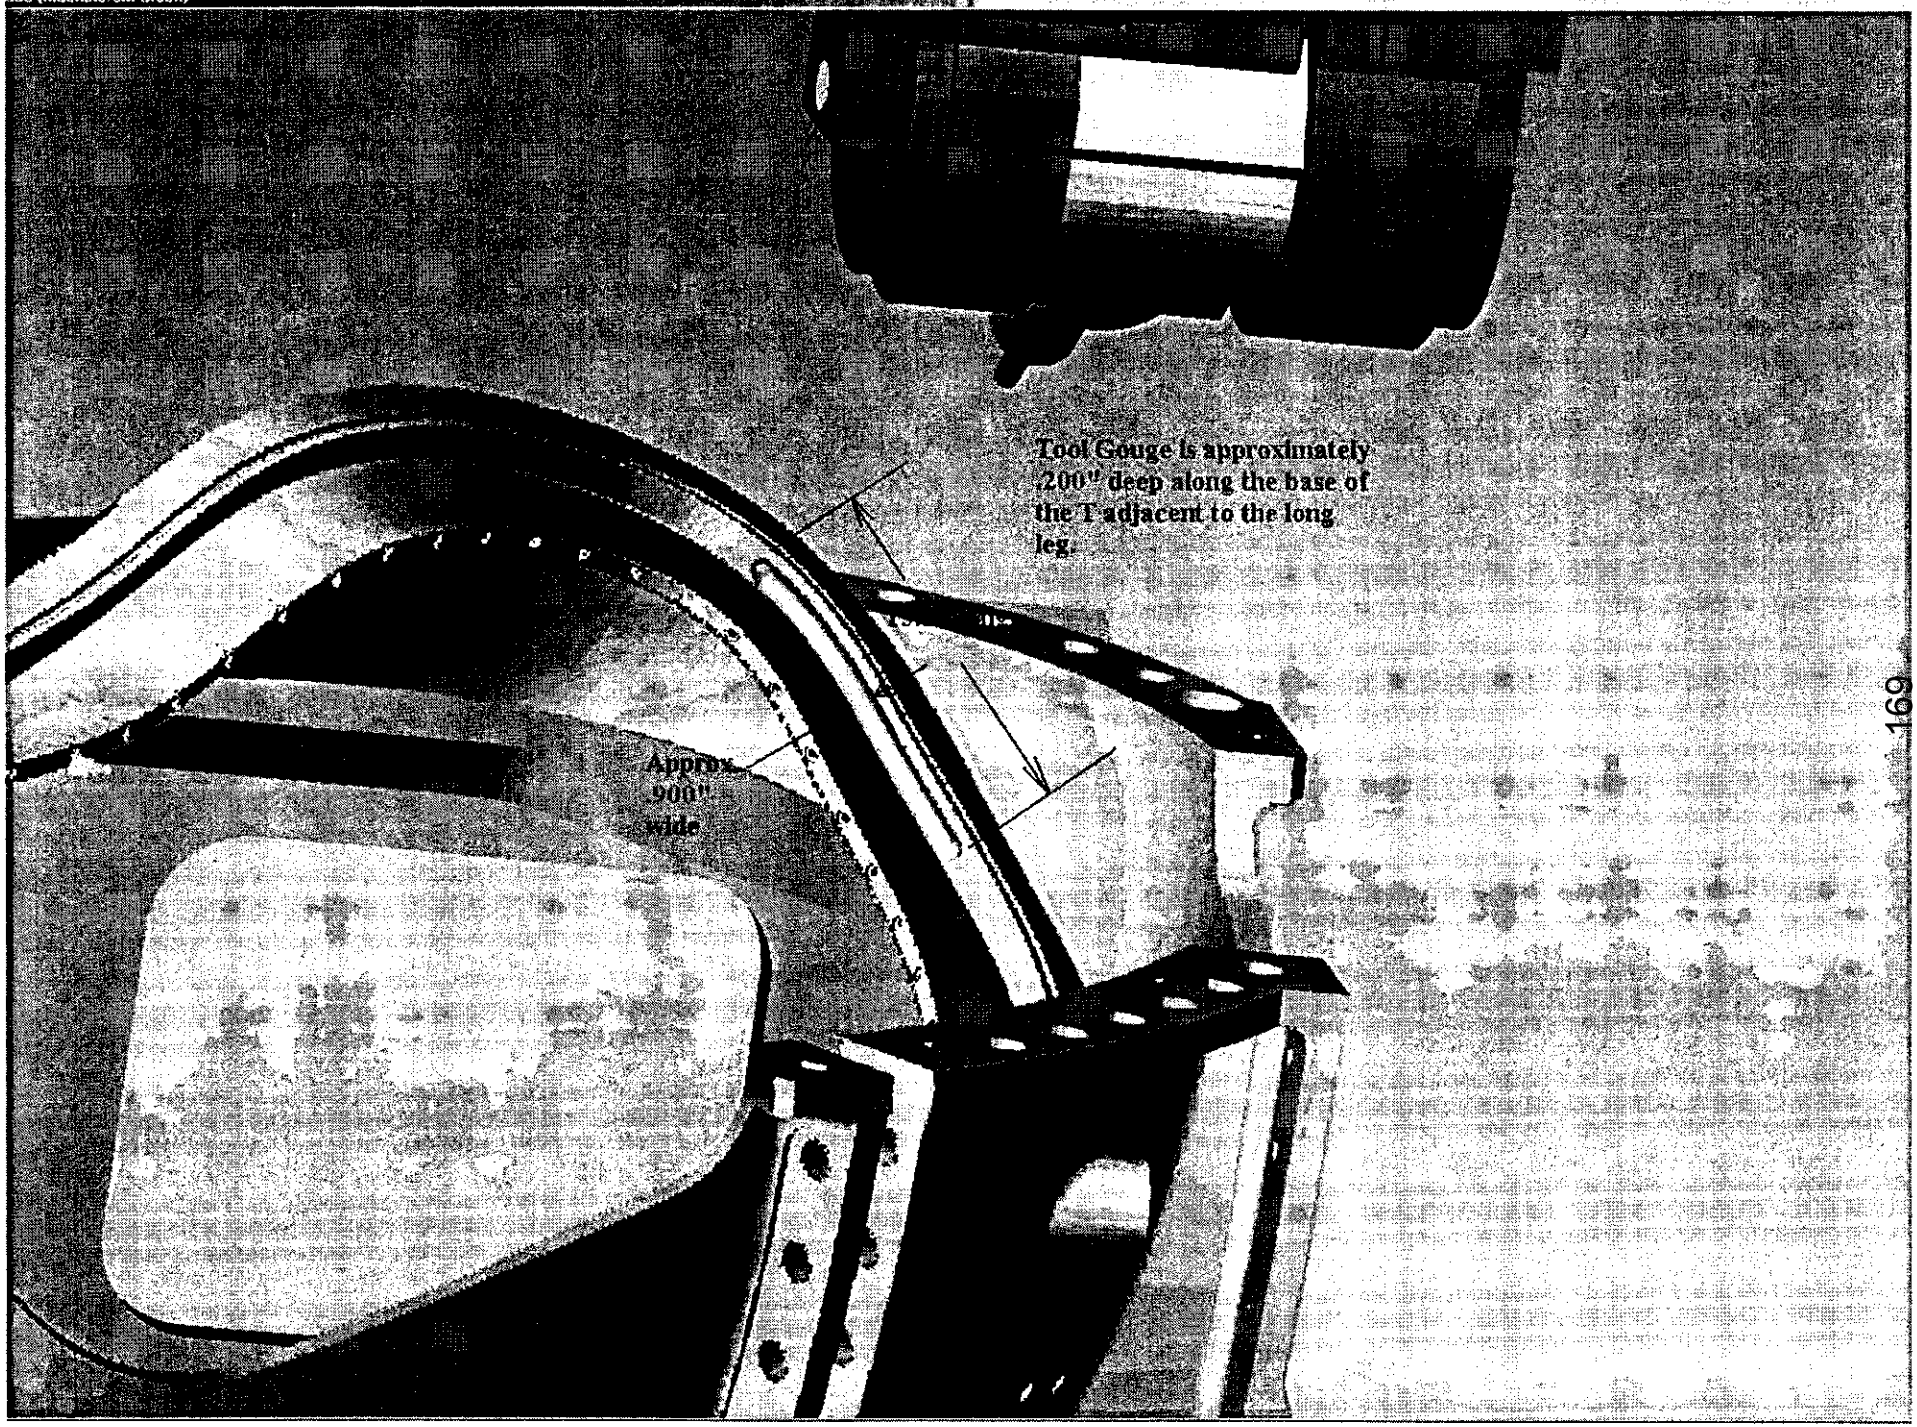
Tool Gouge is approximately .200" deep along the base of the T adjacent to the long leg.
Approx. .900" wide

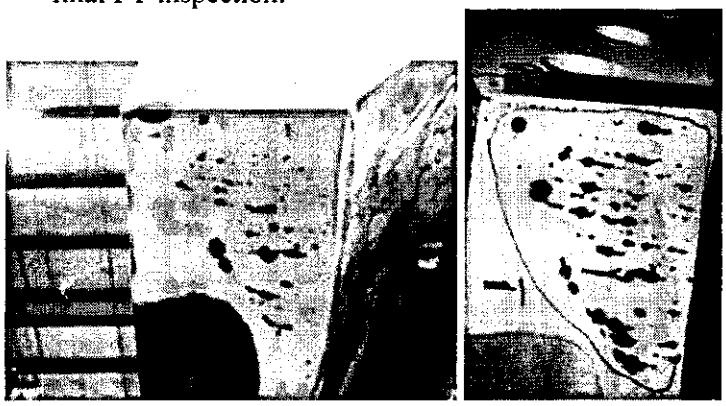
1. Cluster of linear indications – longest is 2". Reference dwg. Sheet 4, zone G6. The indications are on the edge of the large cutout. These indications were previously reported (see the picture to the left). The photo on the right is of the final PT inspection.

Please refer to NC19891, since as noted in the Proposed Disposition above, these rejections are the same as reported in that NCR based on the die penetrant inspections. As noted in the disposition of that NCR, the defects were reviewed and accepted as is.

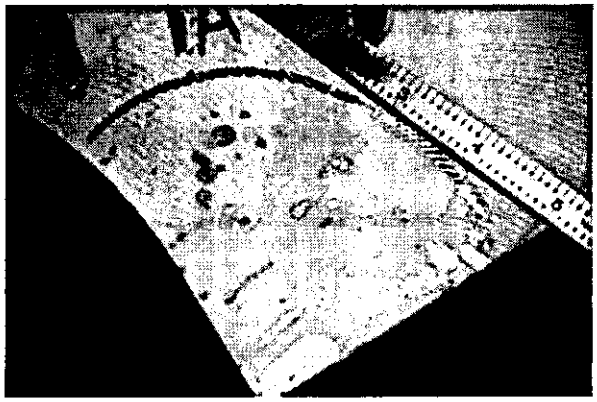
1a. Cluster of linear indications. Longest is .600". These indications are adjacent to the area shown in #1 but are on the face of the foot. See dwg. Sheet 3, zone F4.

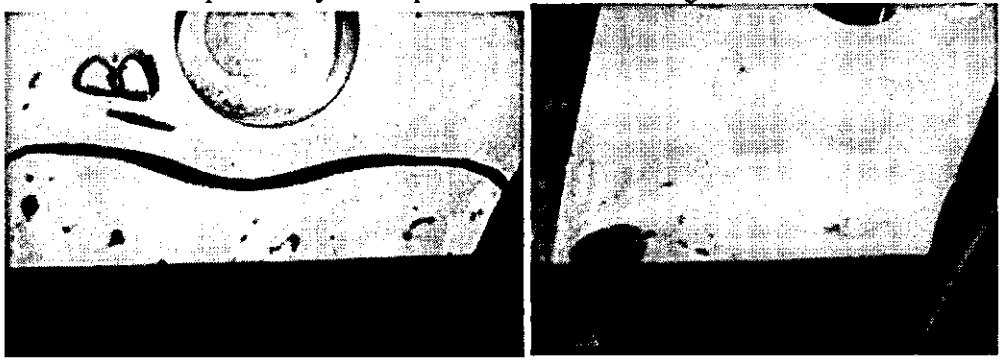
1b. Rounded and linear indications. Longest is .400". These indications are also adjacent to #1 but are on the Datum D flange face. The picture on the right is of the indication when previously noted prior to final machining.

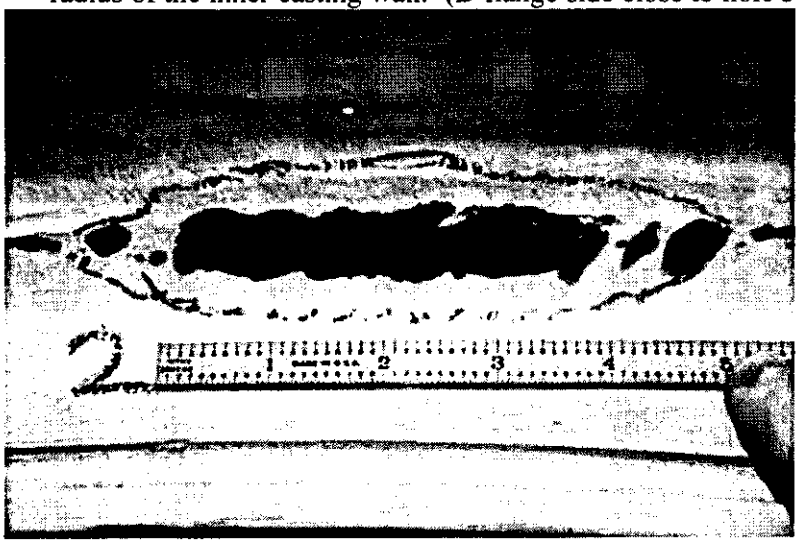
2. Linear indication, 3.6" in length. Indication is beneath the VPI groove in the radius of the inner casting wall. (D flange side close to hole 30).

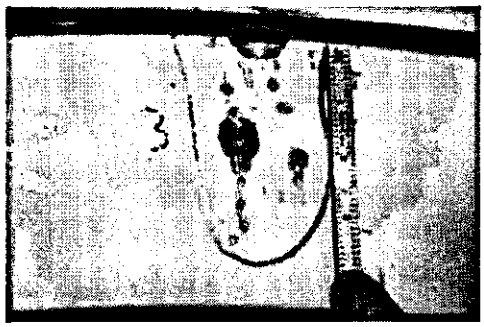
3. Linear and rounded cluster, longest is 2". Located on D flange side close to hole 30. Along both the long and short legs.

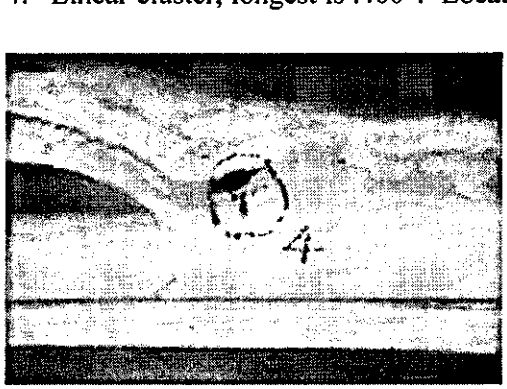
4. Linear cluster, longest is .400". Located on D side close to hole 34. Beneath VPI.

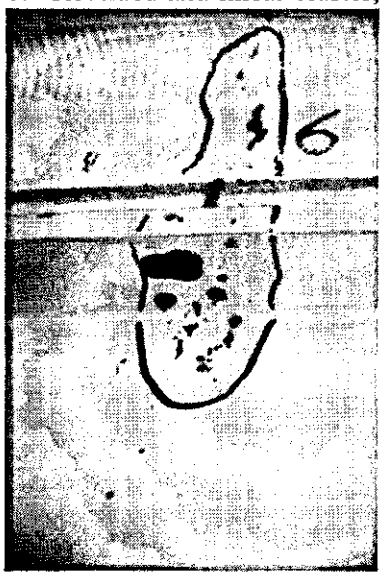
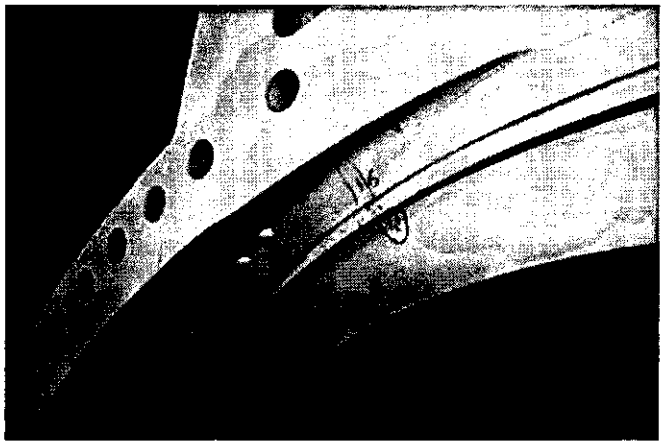
6. Rounded and linear cluster, longest is .750". Located on E side close to hole 28.

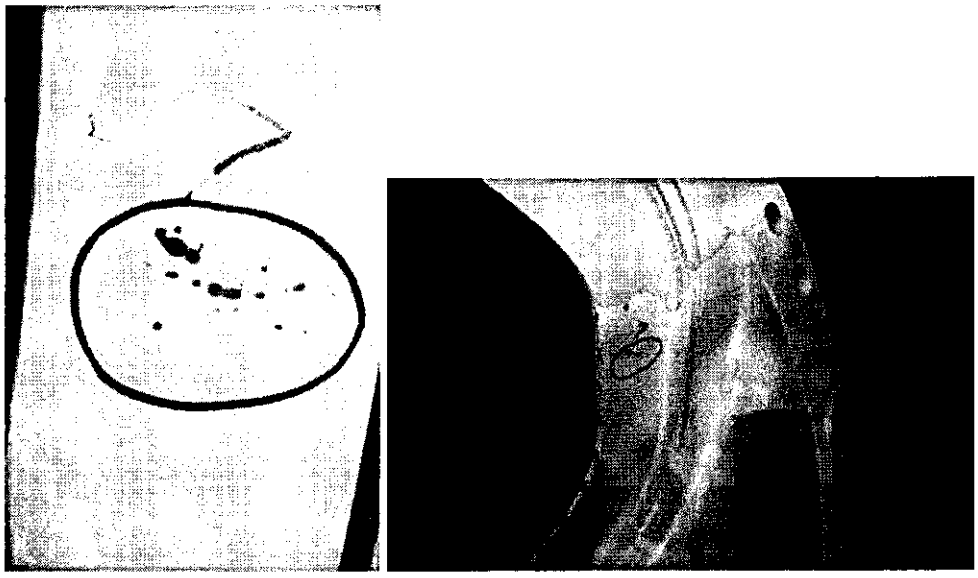
7. Rounded and linear cluster, longest is .500". Located on E flange side close to hole 43.

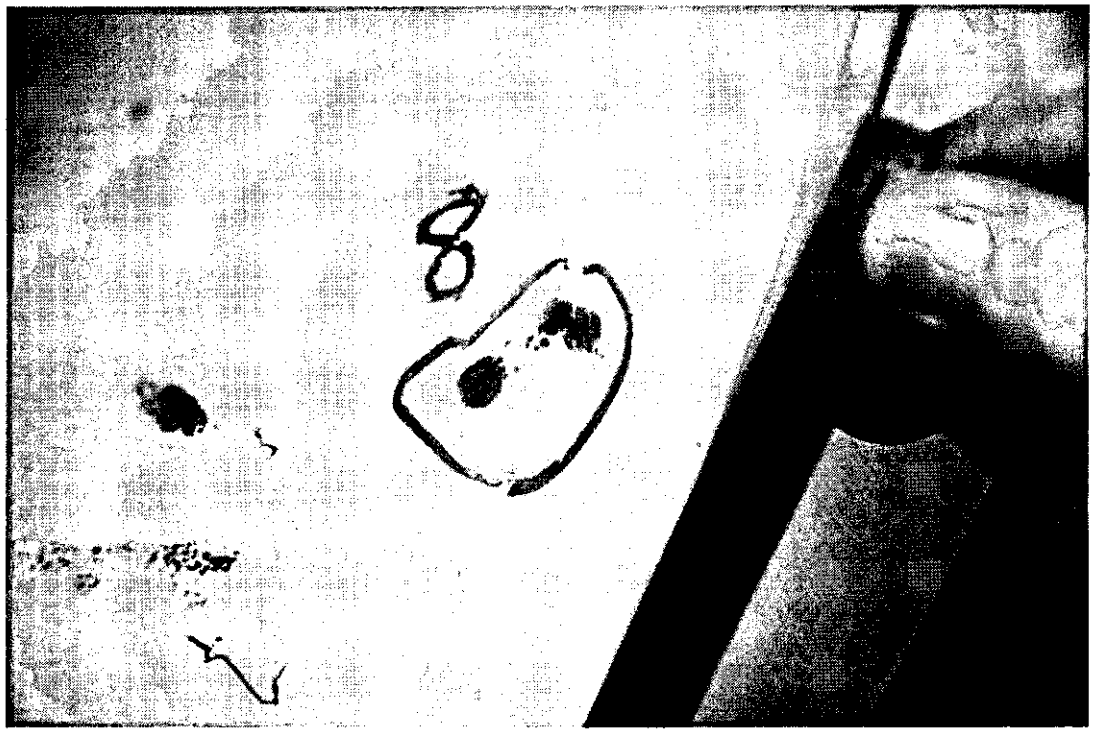
8. Rounded and linear cluster, longest is .300". Located on E flange side close to hole 76.

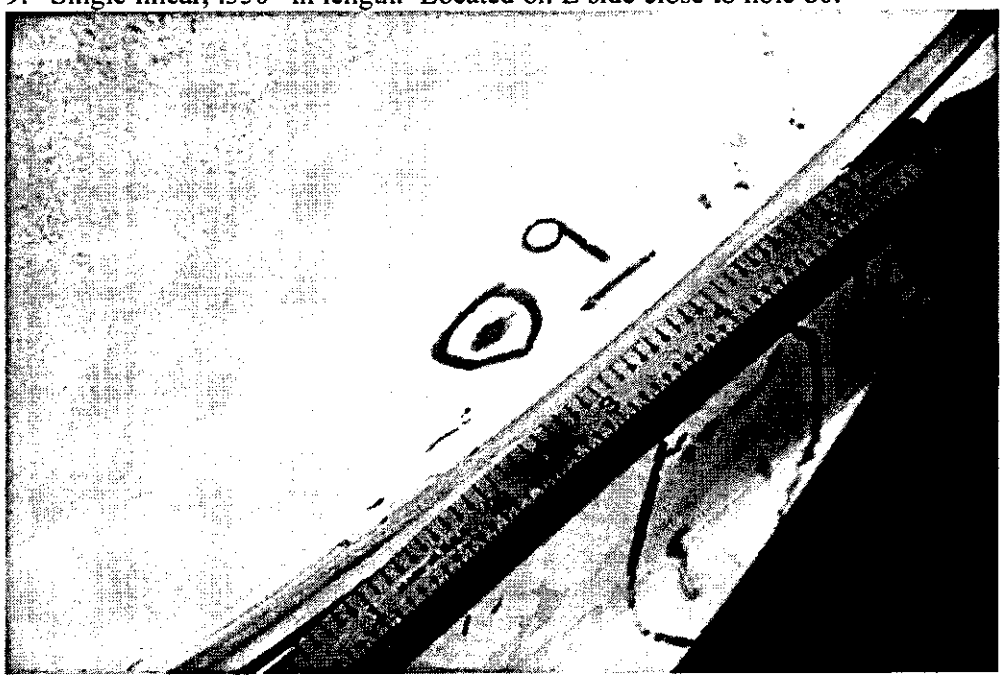
9. Single linear, .350" in length. Located on E side close to hole 80.
