Energy Industries of Ohio

Contract # S005242-F

Modular Coil Winding Form

A-1 Documentation Package

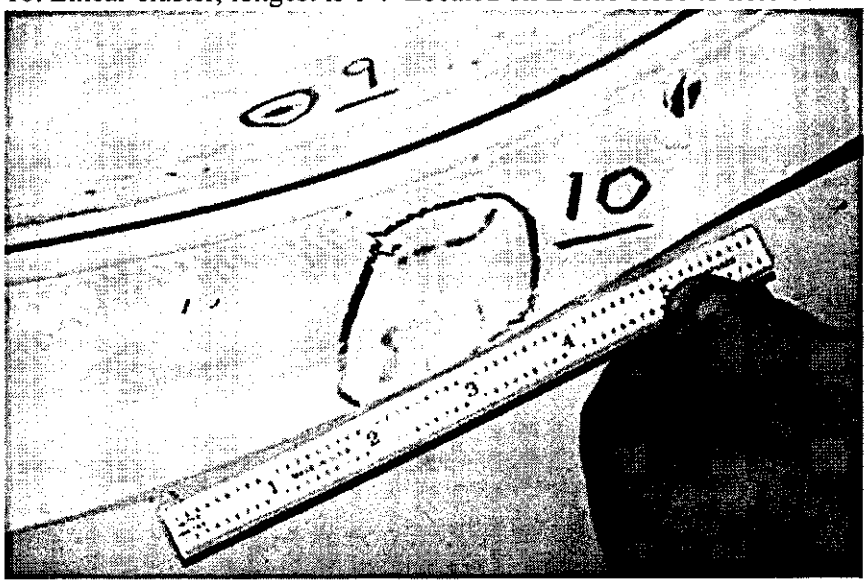
10. Linear cluster, longest is 1". Located on E side close to hole 80.

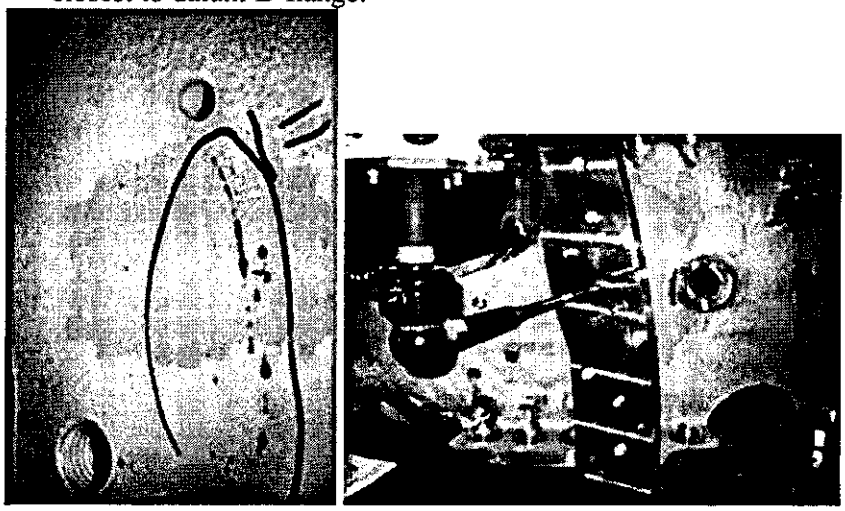
11. Linear cluster, longest is 1.9". See sheet 3, zone C4. On face of foot, located closest to datum D flange.

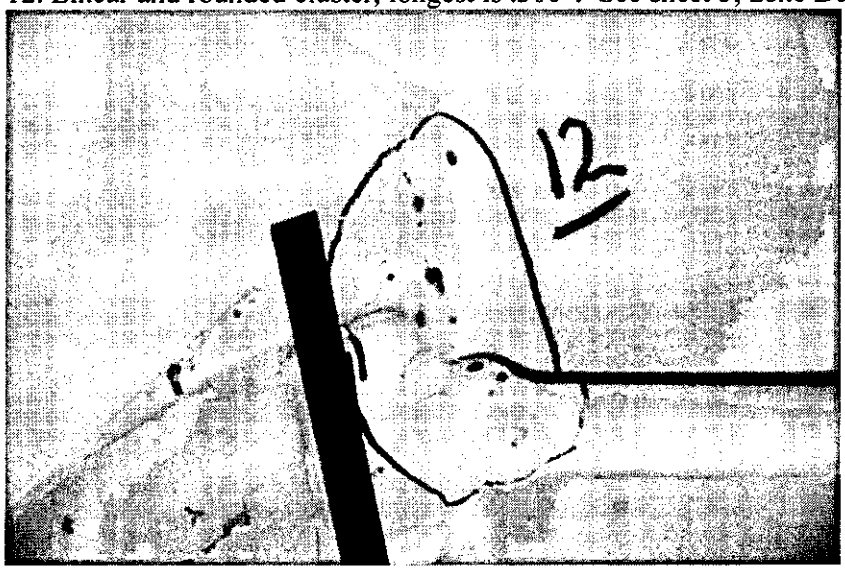
12. Linear and rounded cluster, longest is .300". See sheet 5, zone D5.

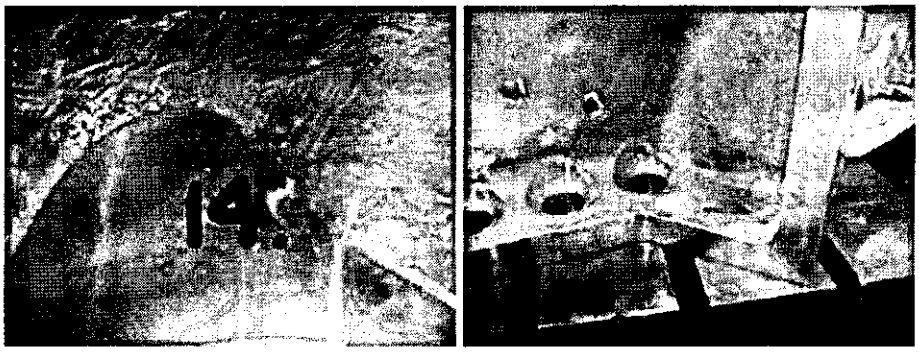
14. .700" long linear in counterbore relief. Located on sheet 5, zone G6, 40.28" from Datum A.

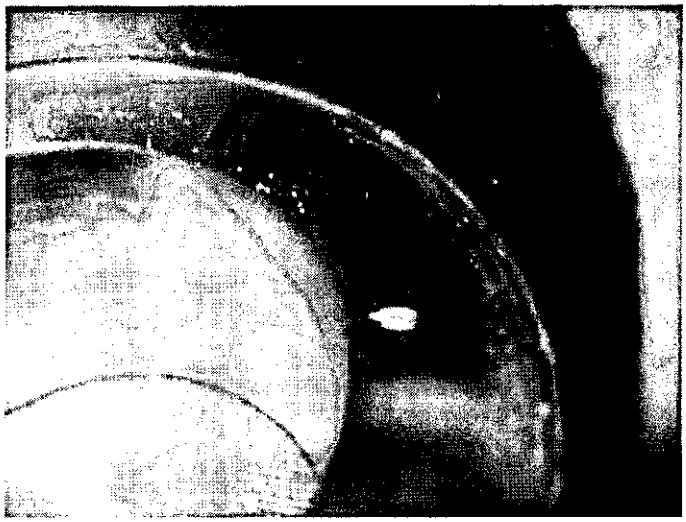
15. Indication with a total length of approx. 1.700". Indication starts at edge of relief, travels down the side approx. .700", along the face approx. .5" and down the wall of the hole approx. .500". Located on sheet 5, zone G6, 43.40" from Datum A.

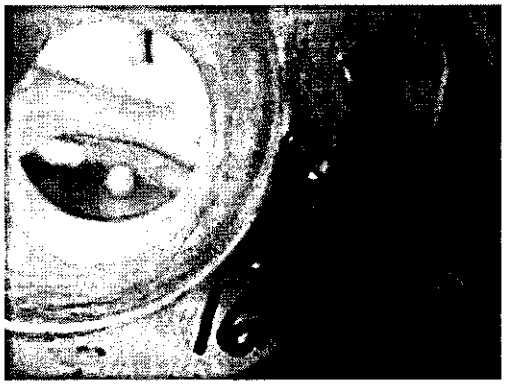
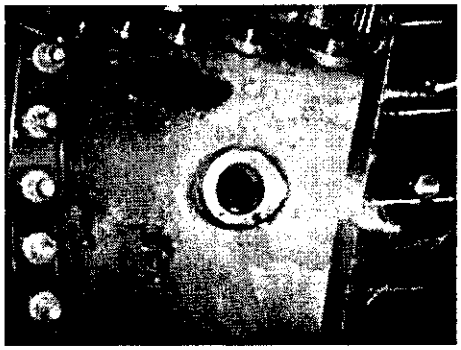
16. Linear cluster on 4.0" diameter boss, longest is .600". Located on Sheet 3, zone F4.

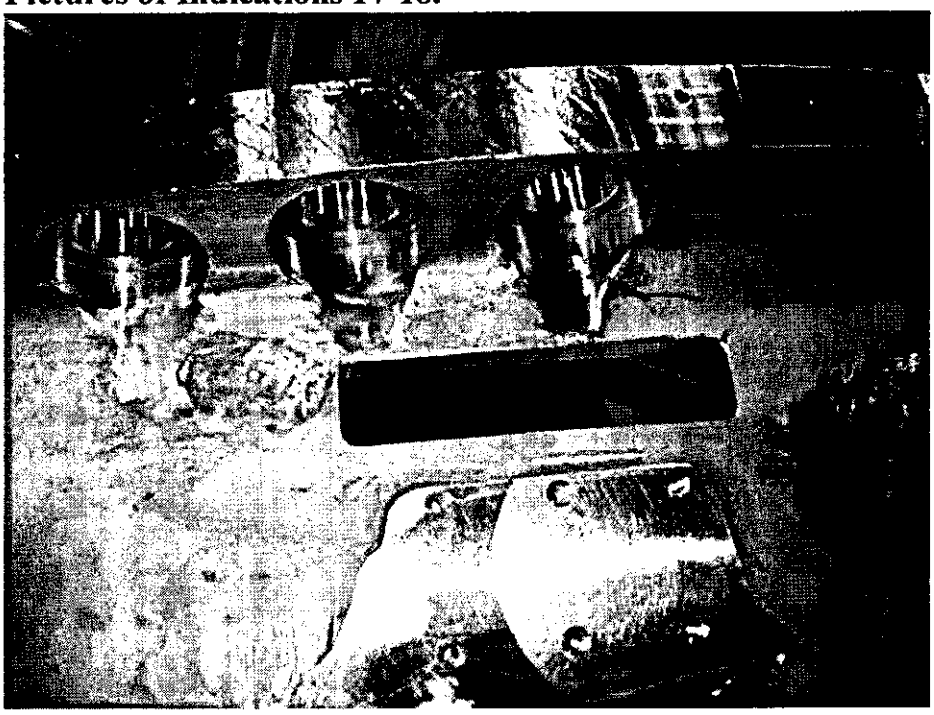
Pictures of Indications 17-18.

17. Rounded cluster, largest is .130". Located on sheet 4, zone D5, 32.35 from datum A.

18. .200" rounded indication. Located on sheet 4, zone C5, 35.37 from datum A.

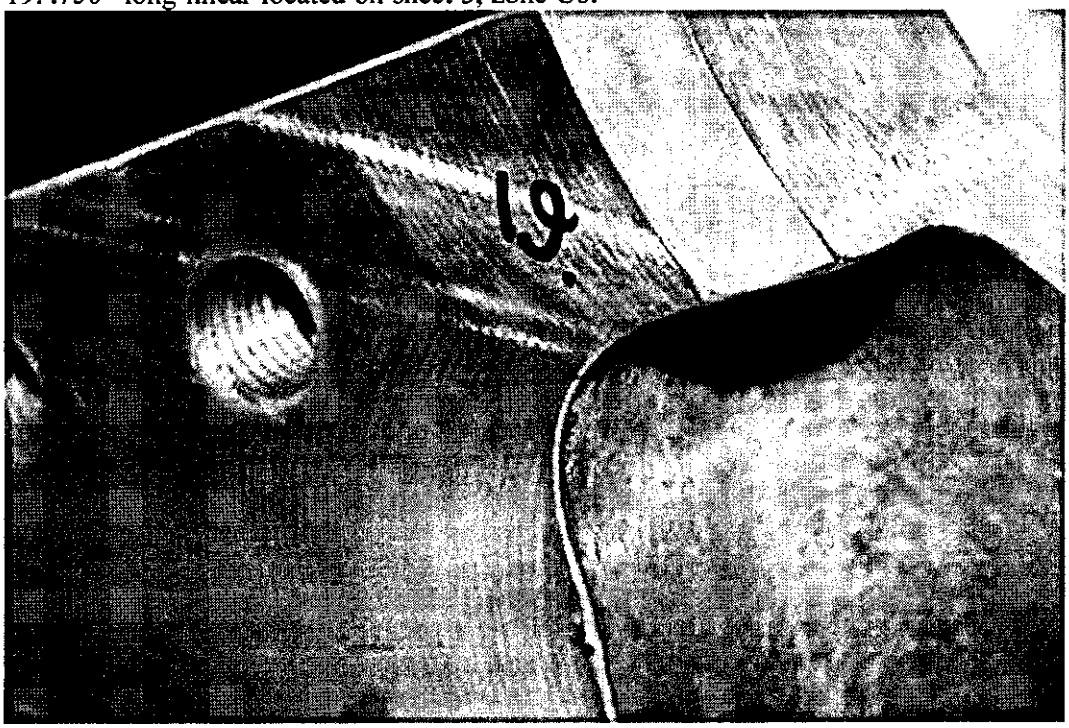
19. .750" long linear located on sheet 3, zone C6.

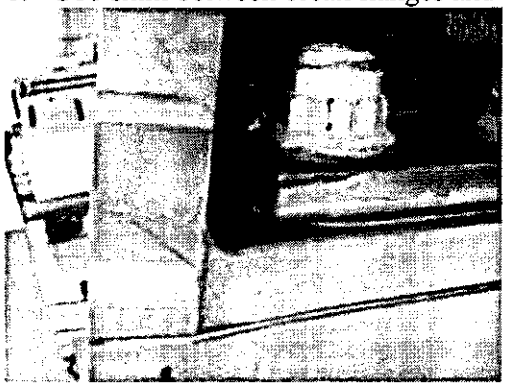
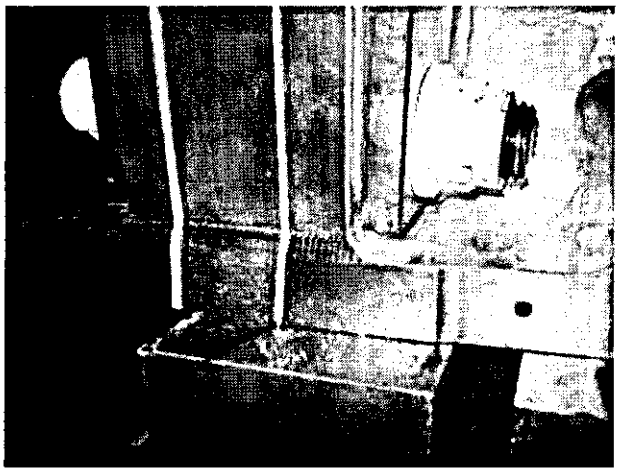
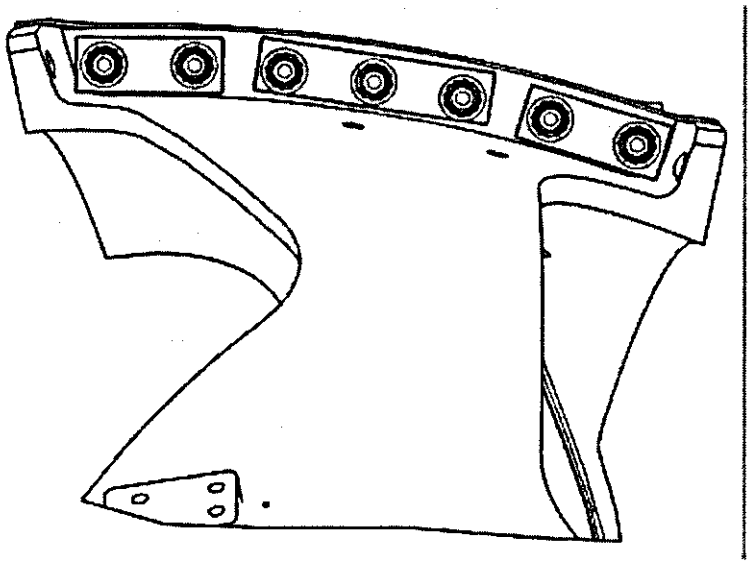
1. G11 shim between break flanges and bearing plates.

G11 shim has a full radius on both ends. The drawing shown below shows only the radius toward the inside cast wall.

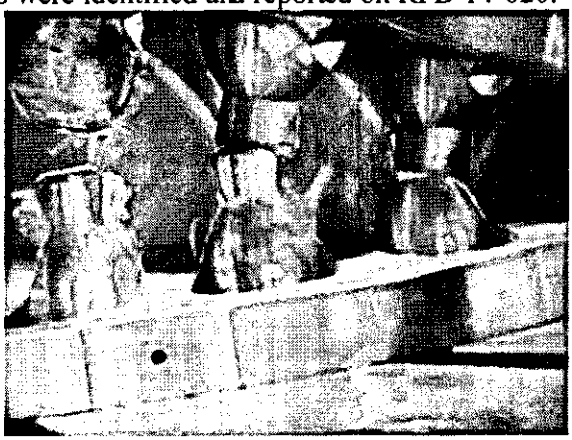
2. Photo below shows areas where counterbore clearances were cut heavy into the casting wall. These areas will not accept the 3" diameter clearance gage. These areas and others were identified and reported on RFD 14-020.

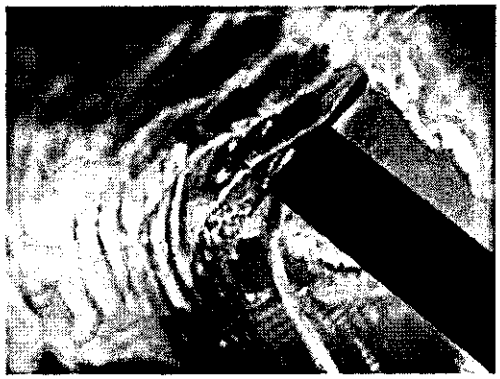
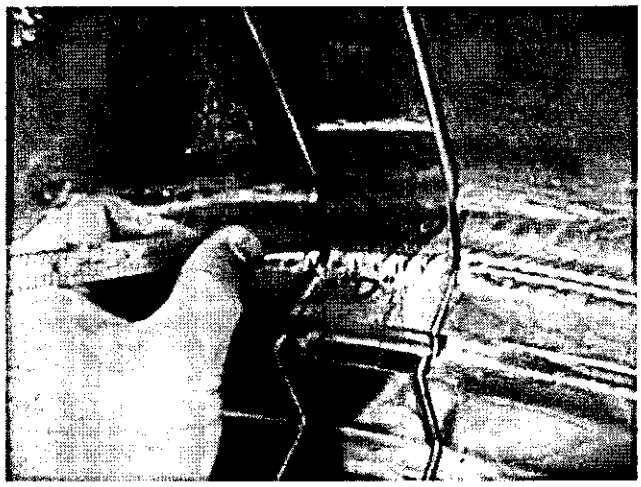
3. Poloidal Break, Datum D side. Casting radius between T section and inner wall extends beyond the G11 shim approximately .300" on each side.

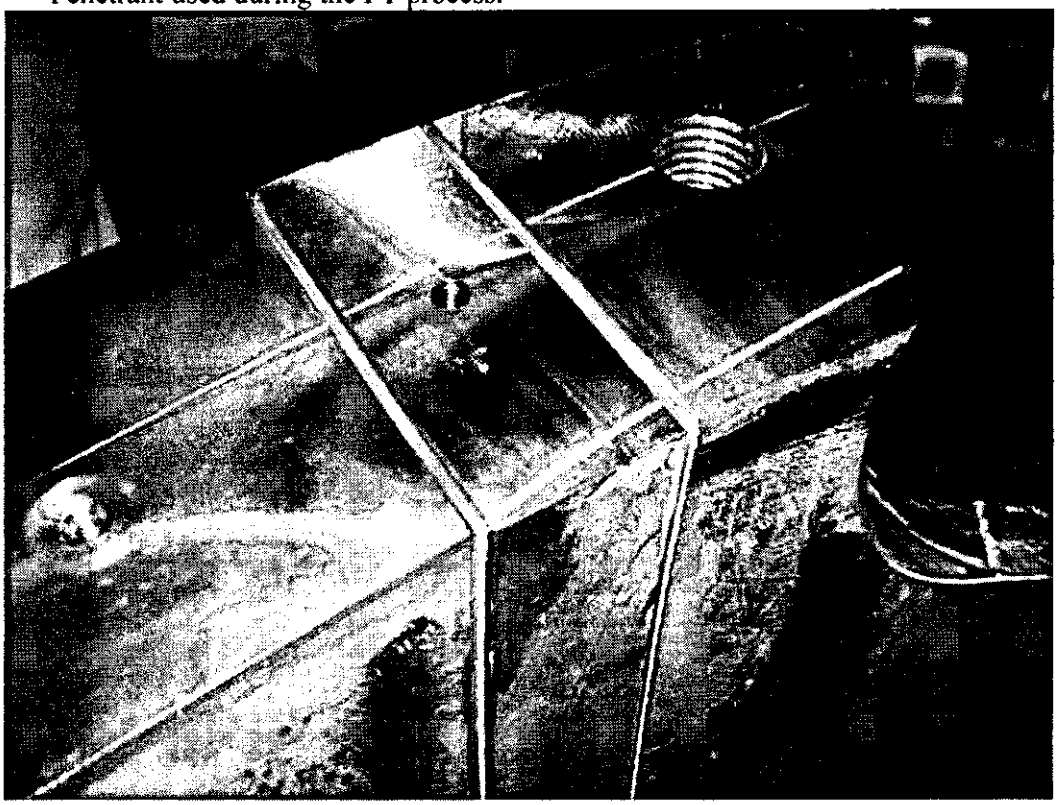
5. One of the G11 shims from the Datum D view is contaminated with the Liquid Penetrant used during the PT process.

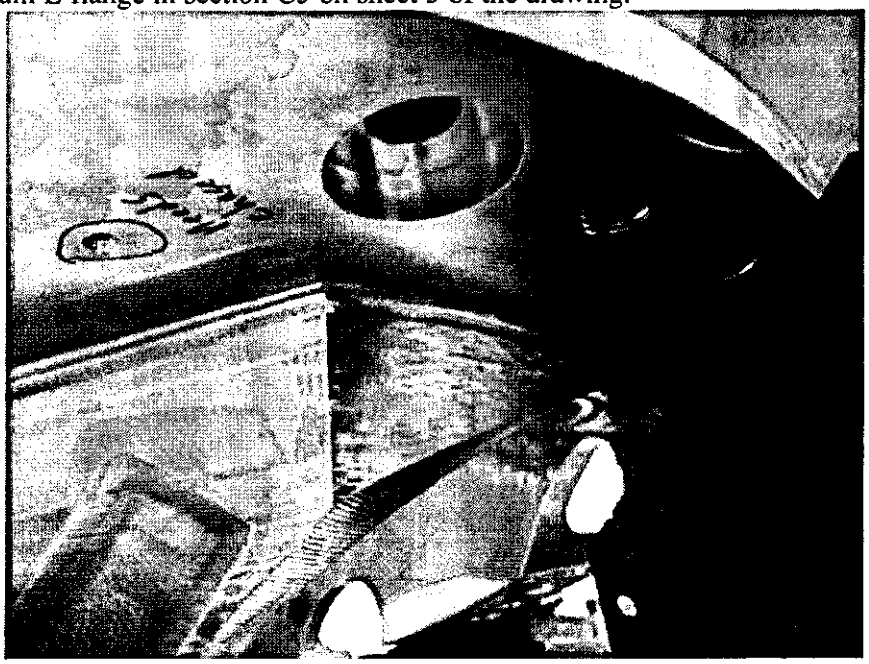
6. Tool gouge on datum E flange. Gouge measures .038" deep by 3.25" long by .50" at its widest point. Radial gouge from 6" face. The gouge is located on the datum E flange in section C5 on sheet 5 of the drawing.

#5-Accept as is. PPPL will verify that dye will not degrade G-10.
#6-Accept as is.
#7-Accept as is.
#8-Accept as is.
#9-Accept as is.
#10-Accept as is.
#11-Accept as is.

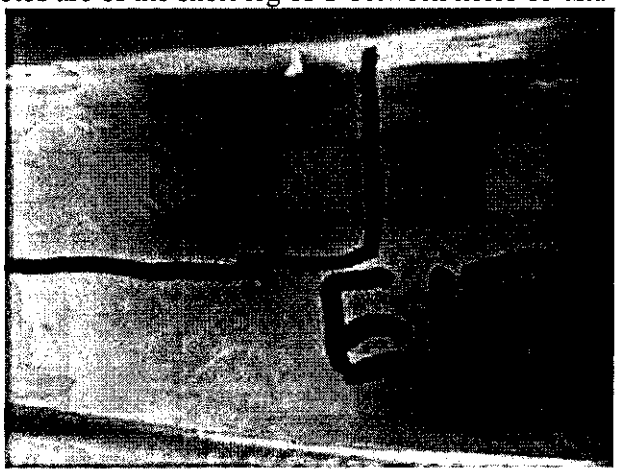
The following photos are of the short leg of T between holes 15 and 19.

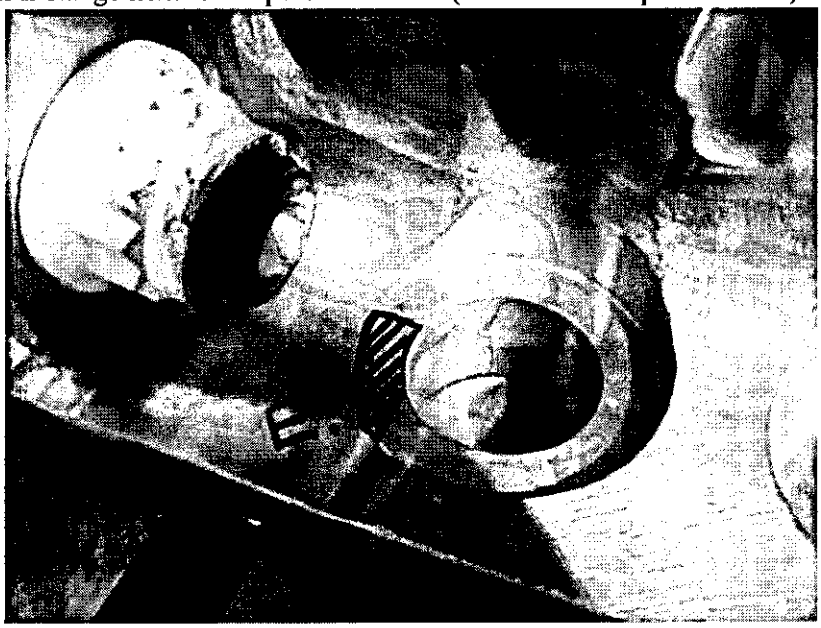
9. Approx. 20% of counterbore did not clean up to 100%. Hole is located on the datum E flange next to the poloidal break. (area shaded in photo below).

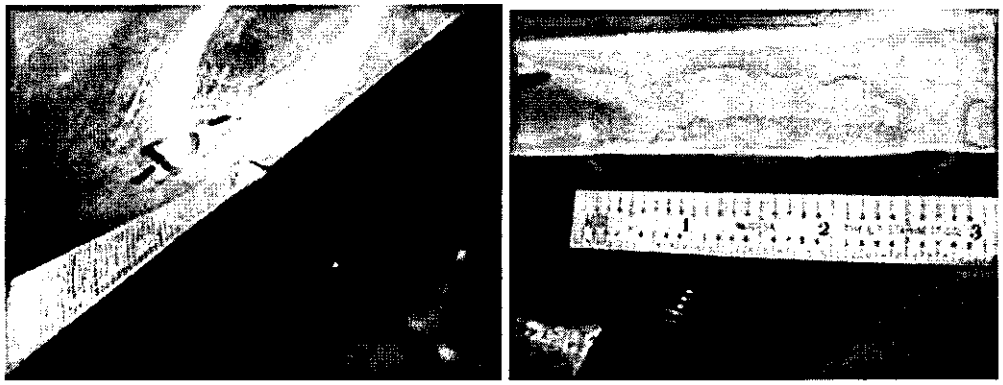
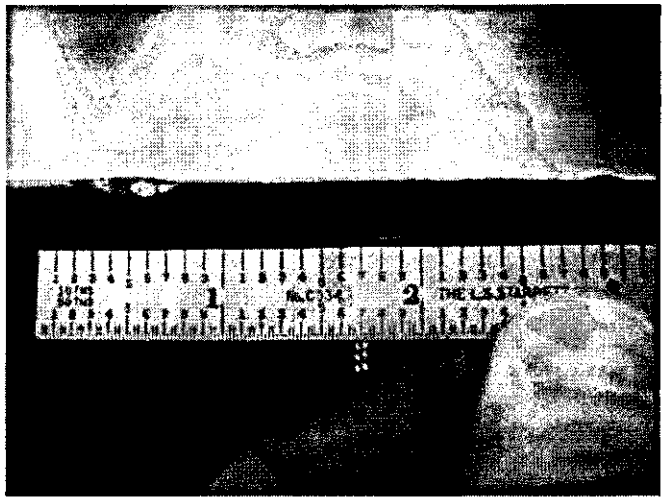
12. Various dings on the datum flange edges. Dings are being caused by swivel hoist rings when lifting the parts. Any raised metal around the areas have been polished flush to the surrounding surfaces.

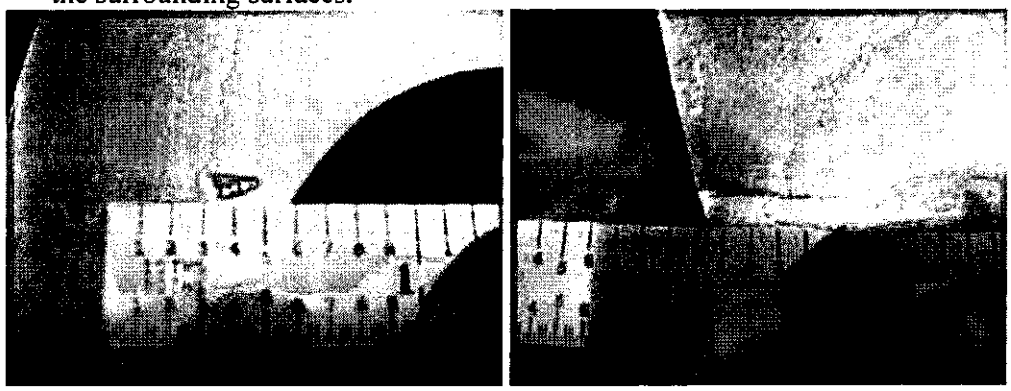
13. There are two impressions on the datum E flange face that were caused by handling damage. Any raised metal around the areas have been polished flush to the surrounding surfaces.
