Final Test Report
for
Purchase Order PE005392-W

Through-Thickness Insulation and Copper Tensile/Adhesion Tests

November 19, 2004

Prepared by:
Composite Technology Development, Inc.
2600 Campus Drive, Suite D
Lafayette, CO 80026

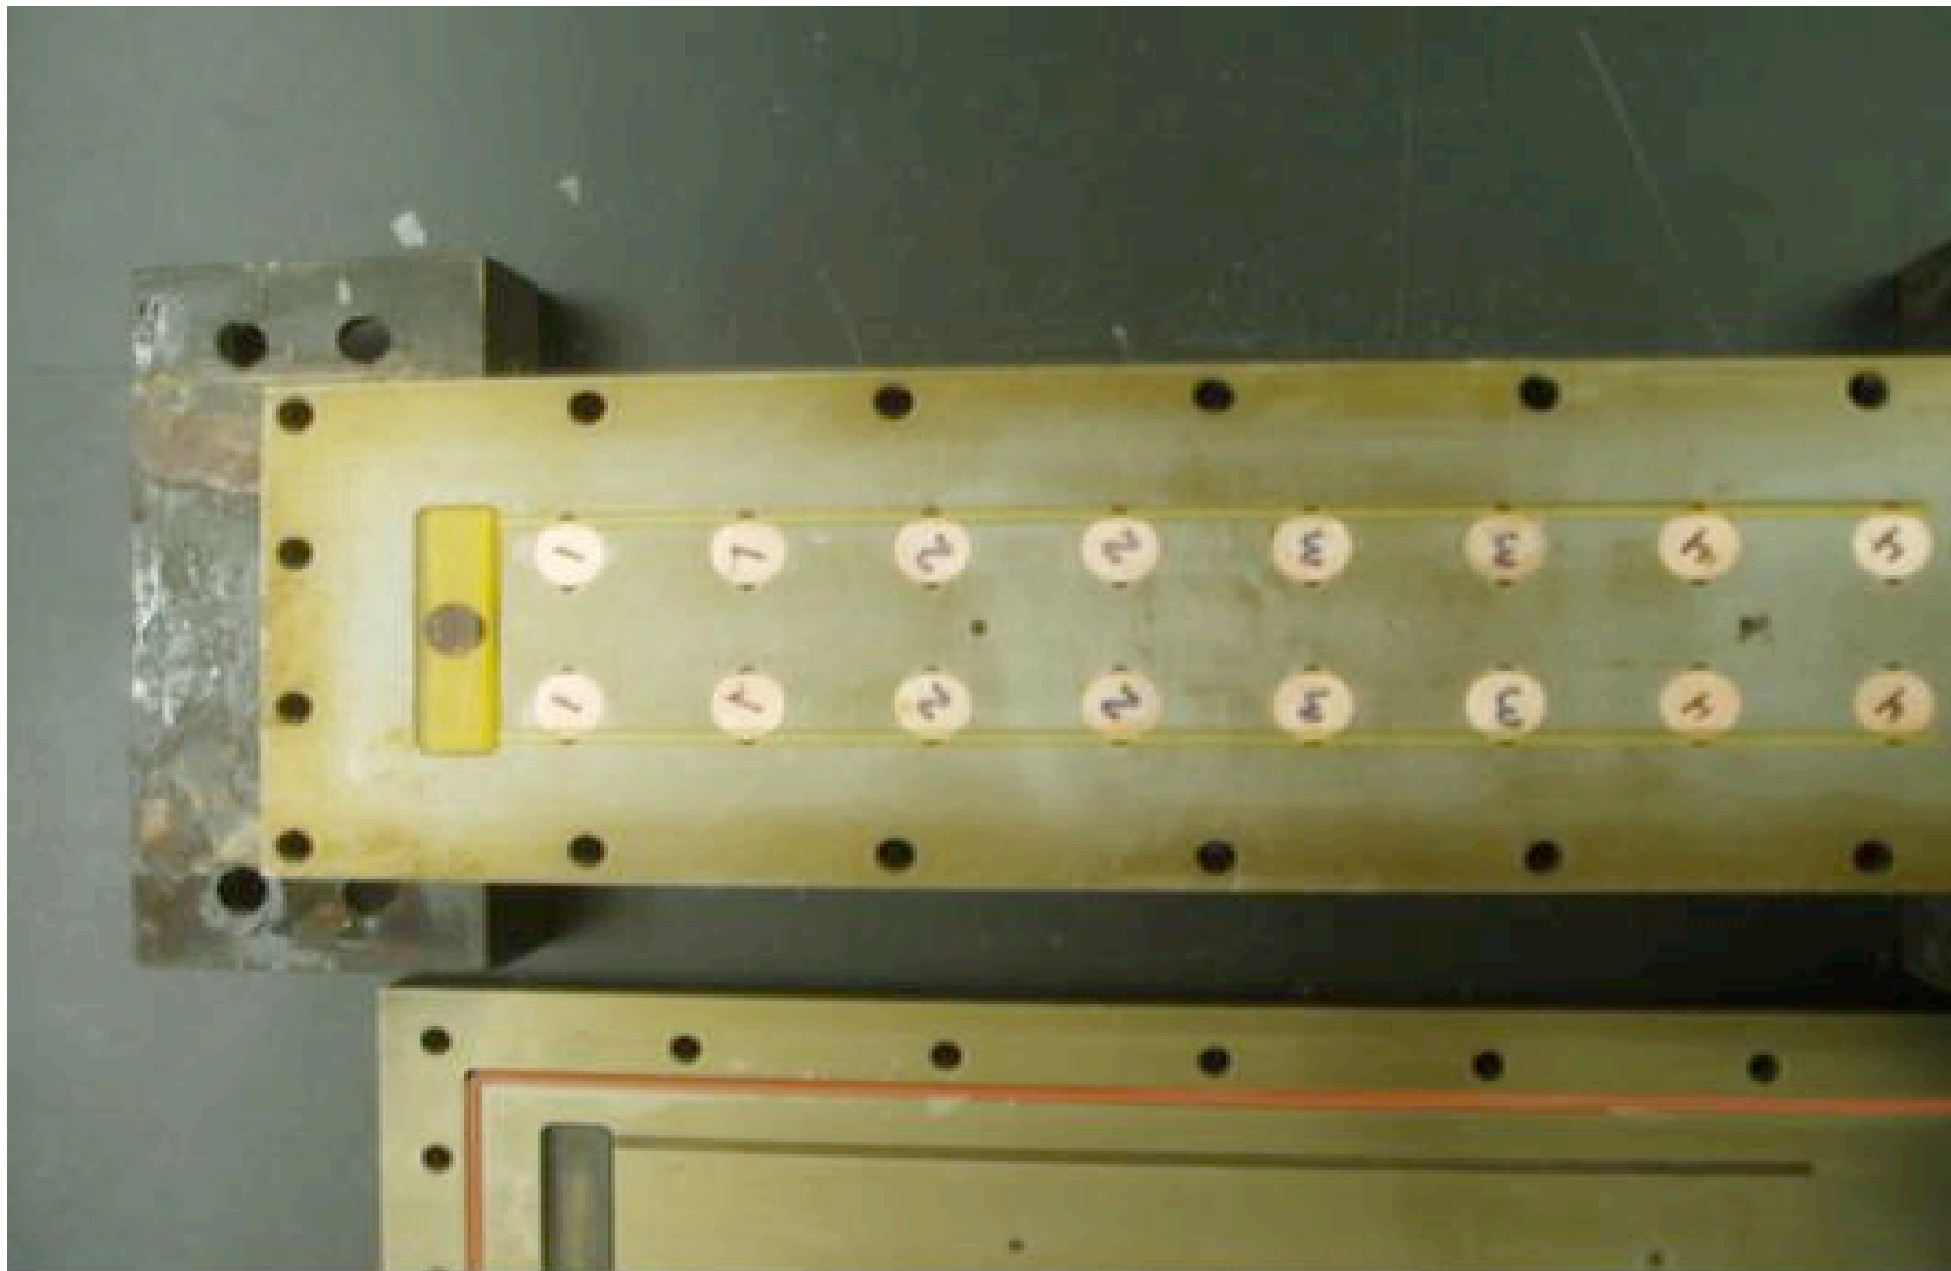
Figure 2. Cu/composite specimens in mold following VPI.

During cure, a positive pressure of 20 psi of nitrogen gas was maintained in the mold to minimize the formation of bubbles or void. Figure 2 shows the mold and specimens following cure. Specimens were removed from the mold by a press, pushing vertically. Figure 3 shows a completed specimen after cleanup of excess resin.

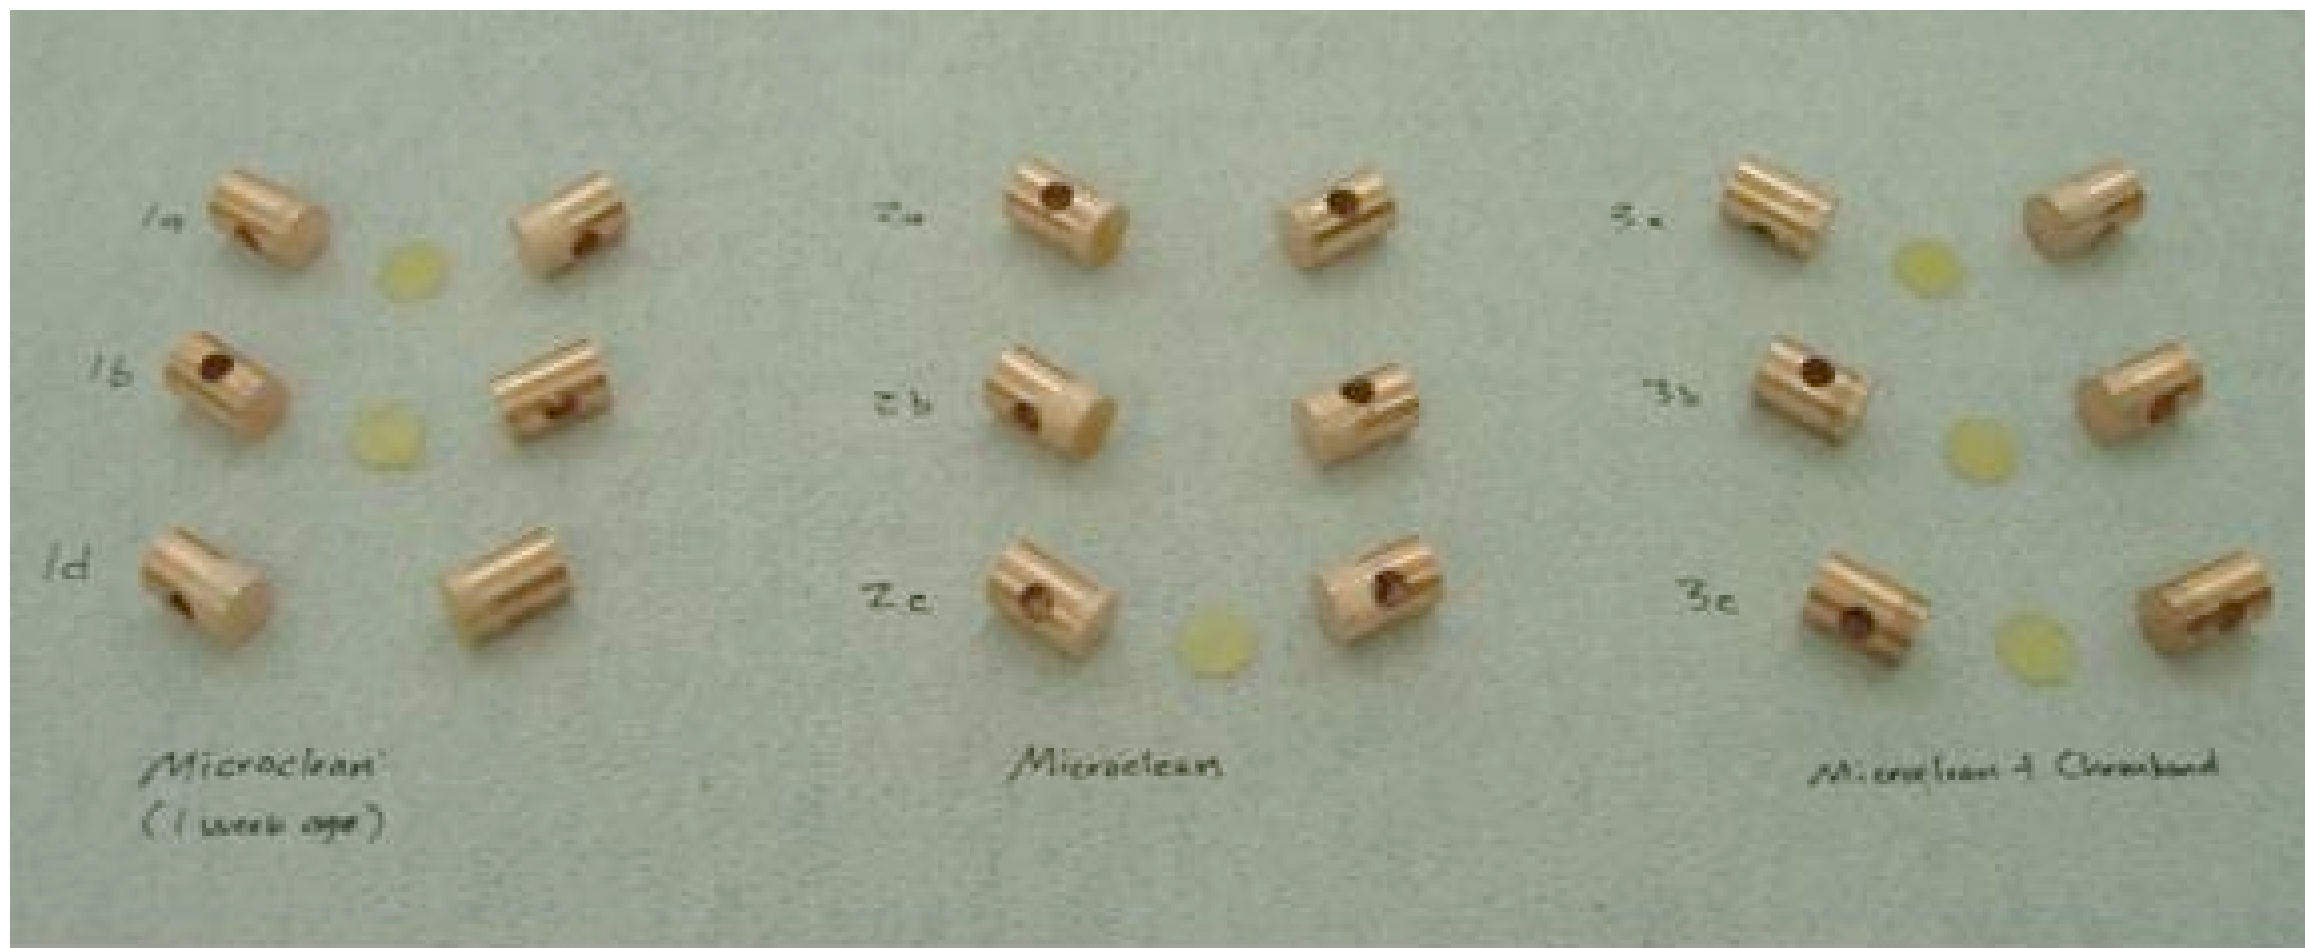
Two of the specimens in Set #1 and one of the specimens in Set #3 had surface adhesion failures while being pressed out of the mold. Further surface adhesion failures became apparent when the excess CTD-101K resin was removed from the outside of each sample. Additional specimens from Sets #1, #2 and #3 experienced surface adhesion failures during the resin removal process. Figure 4 shows some of the failed specimens that were not tested.

Figure 4. Failed specimens from Sets #1, #2, and #3 after removal from mold.

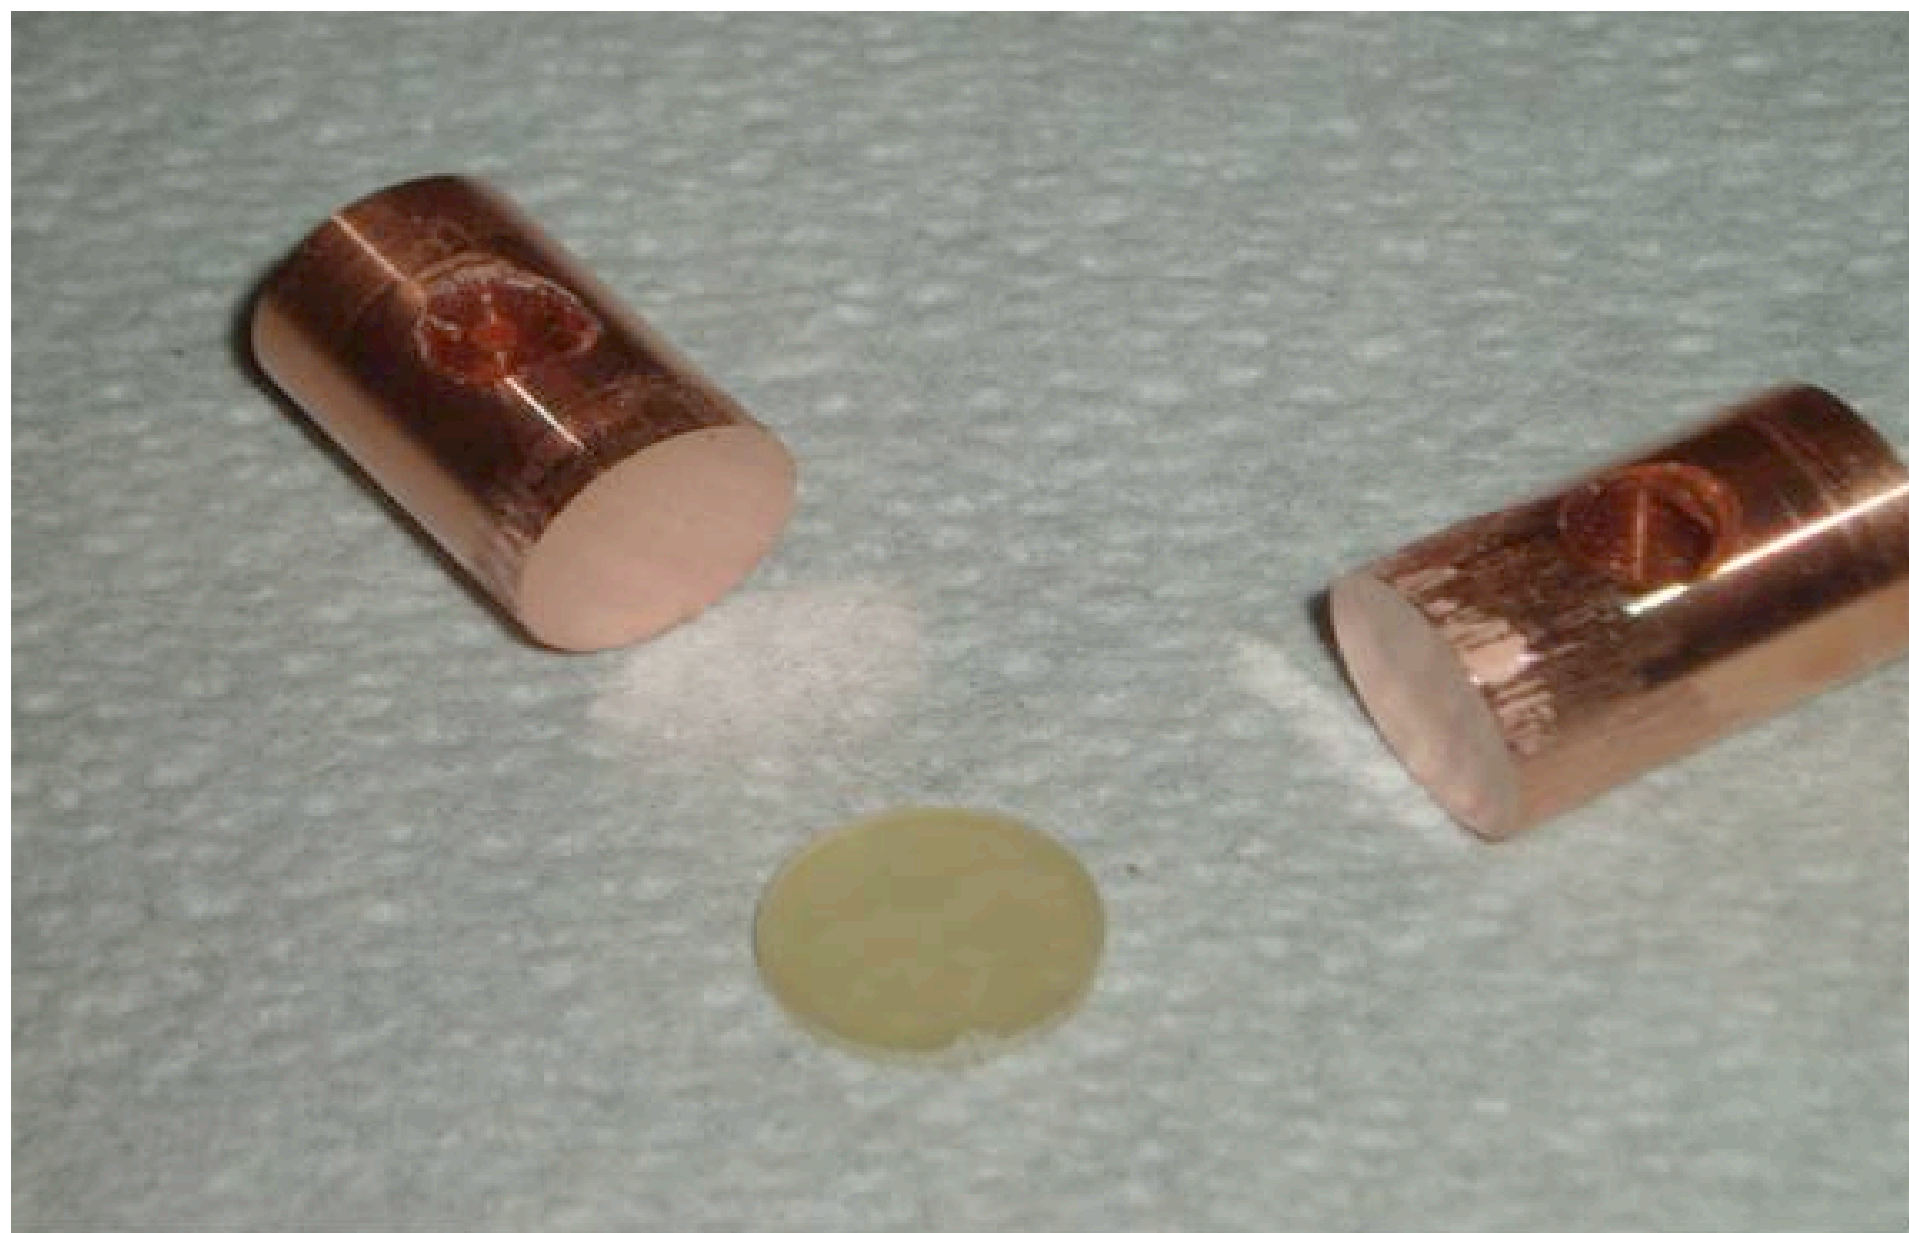
Adhesive-type failures at the metal surface are shown in Figures 5 and 6. Set #4, which was the only set to use a grit blasted surface, was the only complete set of samples without pre-test failures. Figure 7 shows the difference in surface roughness between a grit blasted and non-grit blasted copper surface. Additionally, only one specimen from Set #2 was available for testing.

Figure 5. Typical adhesion to metal surface failure.

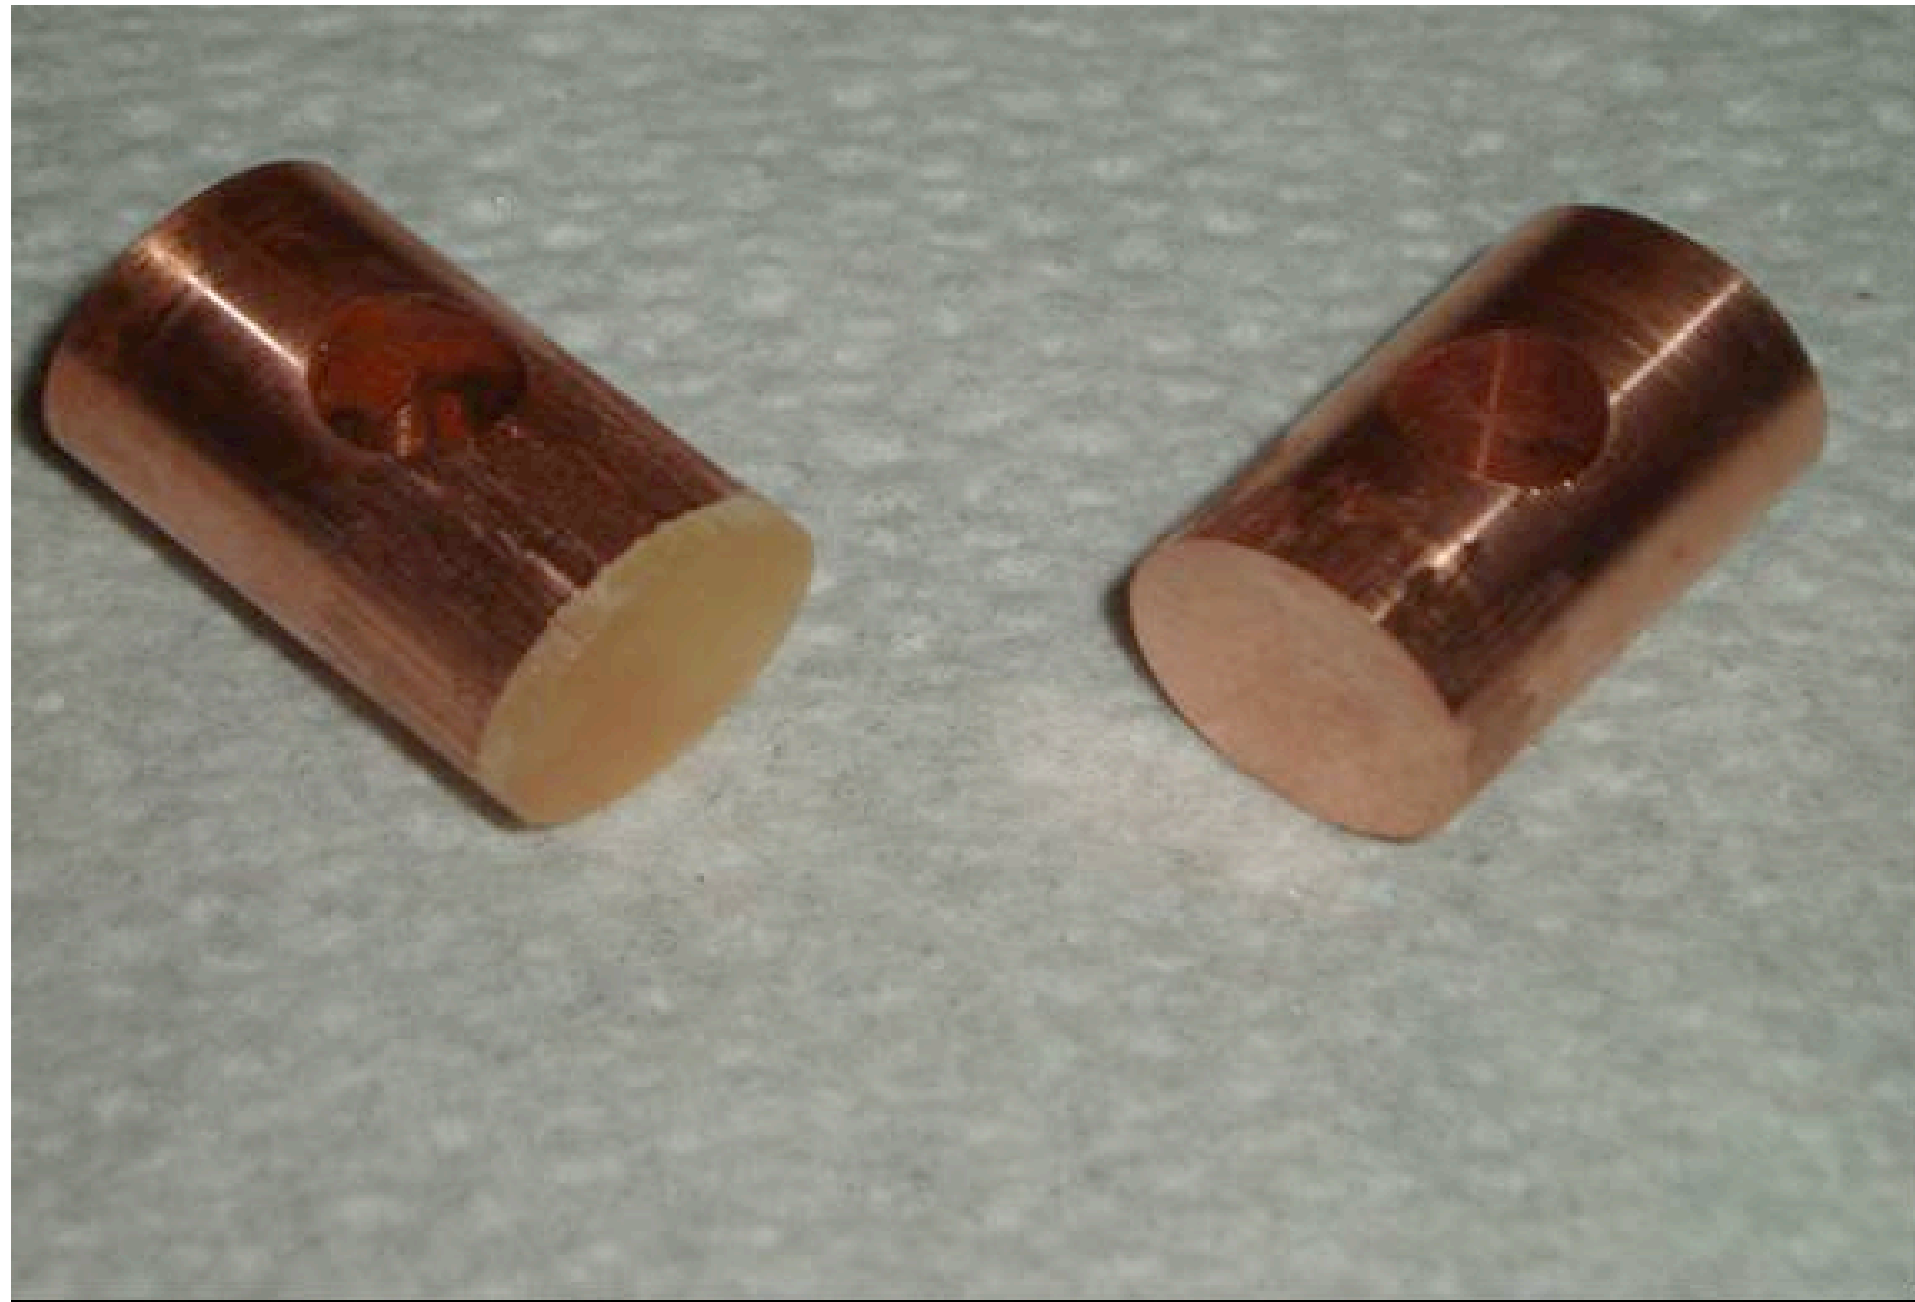
Figure 6. Adhesion to metal surface failure.

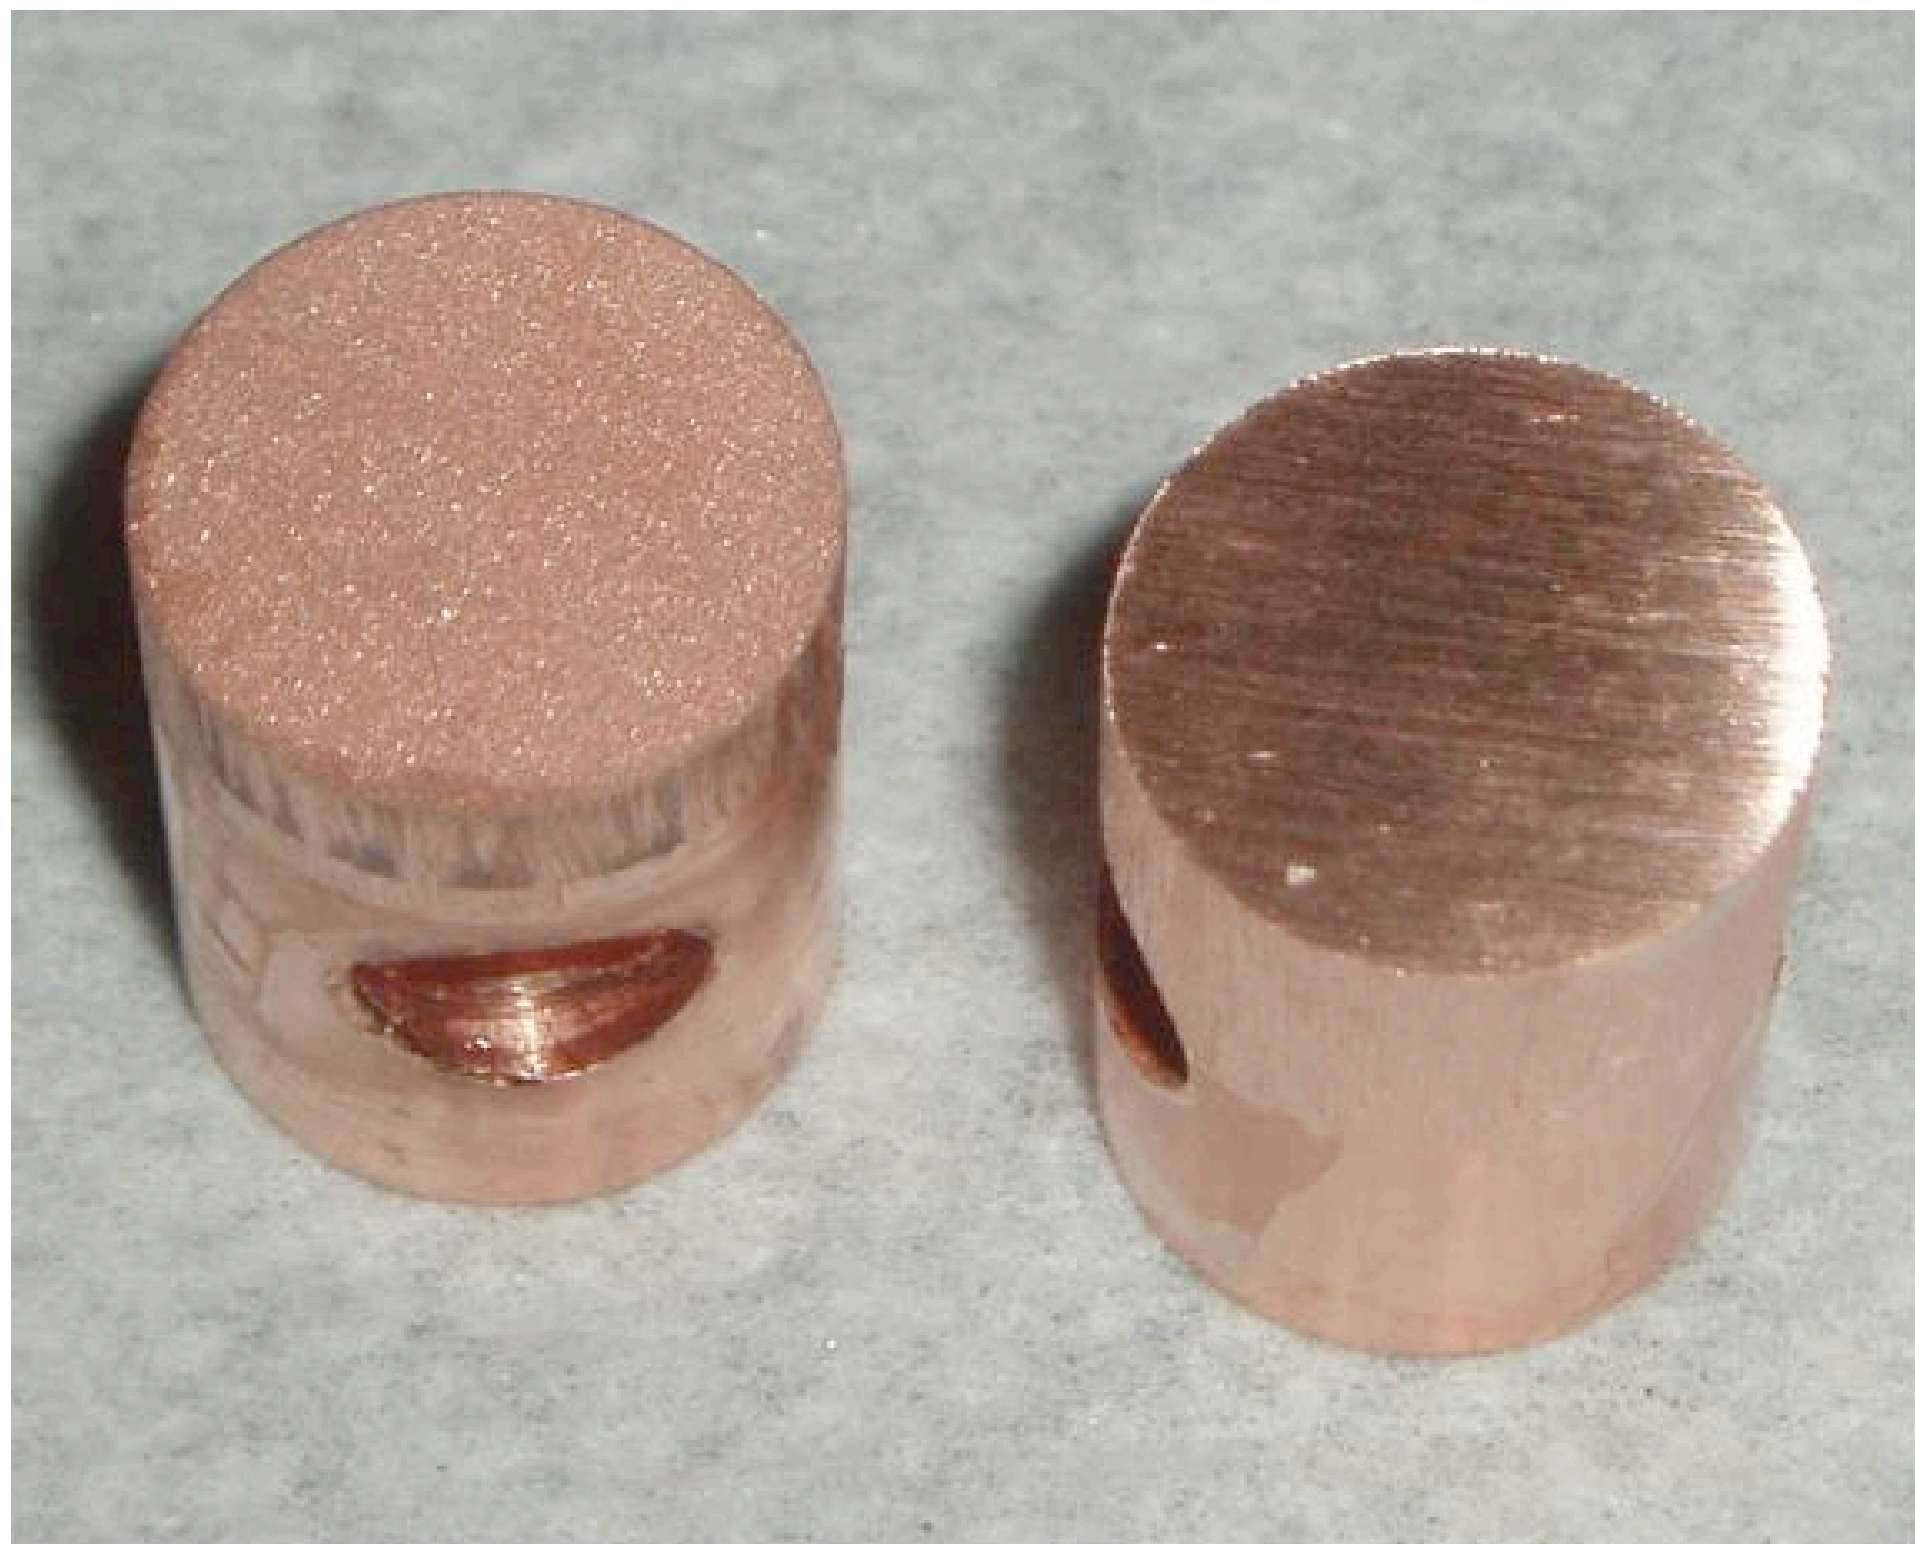
Figure 7. Copper surface comparison. Grit blasted (left), Non-grit blasted (right).
