Part: SE141-116 / MODULAR COIL WINDING FORM TYPE

Problem: NON-CONFORMANCE 1

Attachment I: Disposition of NCR # 18715 for MCWF C-2

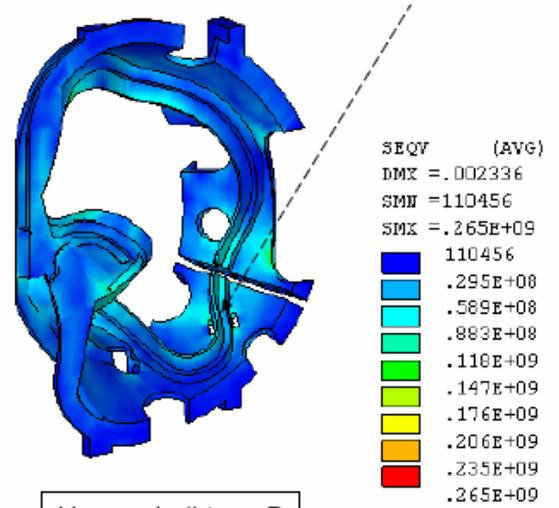
Unit of stress in pascal

NCR#2: Disposition: Accept AS IS. This indication is in a region where the stress is low – in the range of 60 MPa (see the figure below – virtually all of the leg region is ~60 MPa). The fatigue curve shown for NCR 1 is for a pre-existing crack to grow through a 3/4” thickness and, as in NCR1, the 60 MPa stress is far to the left of the vertical axis. It is in a heavy overcast area near the region where the leg, shell, and flange all come together; consequently, this indication can be accepted as is. The thickness that the flaw would have to “grow” through is significantly bigger for this flaw: the leg is ~1 3/8” thick; the shell is ~1 3/8” thick; the flange is 1 1/4”
