**Part: SE141-114 / MODULAR COIL WINDING FORM TYPE**

Drawing ID: MCWF TYPE-A XRAY MA Revision: 1  
W/O Links: 1-Type:W: 65709/5.0 Sub: 1

**Problem: X RAY FAILURE ON:**

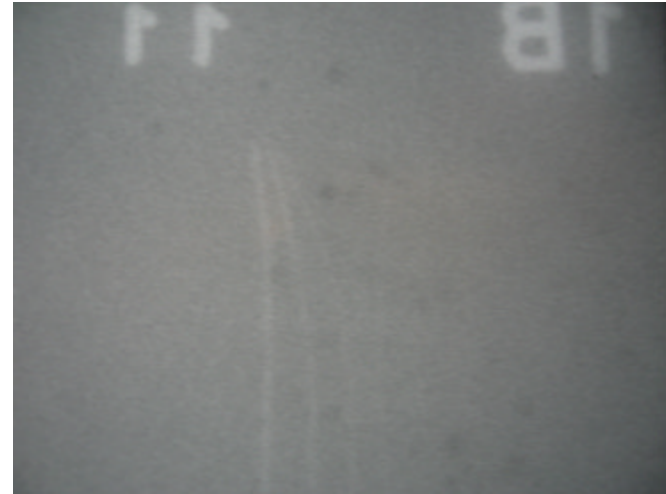
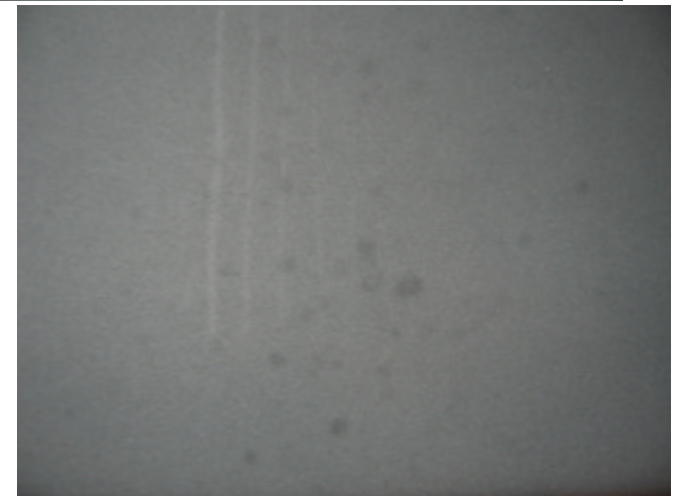
"T AREA", VIEW 41-45, POROSITY CLUSTER, LARGEST PORE MEASURES .090", AVERAGE PORE SIZE .060". APPROX. 15 PORES IN A 1 INCH CIRCLE. LOCATED BETWEEN TAPPED HOLE 43 AND 44. STRING OF POROSITY LEADING OFF OF CLUSTER APPROX. 4 INCHES.  
(see attachment)

View above is of a cluster of porosity between holes 43 and 44. The largest was sized at approximately .090”.

**Customer Disposition:**    ☒ Use As Is    ☐ Rework    ☐ Repair    ☐ Scrap    ☐ Replace

The attached RT indications were reviewed by D. Williamson and discussed during a conference call attended by J. Chrzanowski, L. Sutton, F. Malinowski, L. Dudek, D. Williamson, T. Brown, and P. Heitzenroeder on 2/28/07. Dave notes that the stress in this region varies from 9-20 ksi. (62-138 MPa). As can be seen in the fracture plot, the region will meet the fatigue life criteria with these flaw sizes. (max. size is 0.090" : 1.5 mm)
