NC20920 – B3 Visual Review

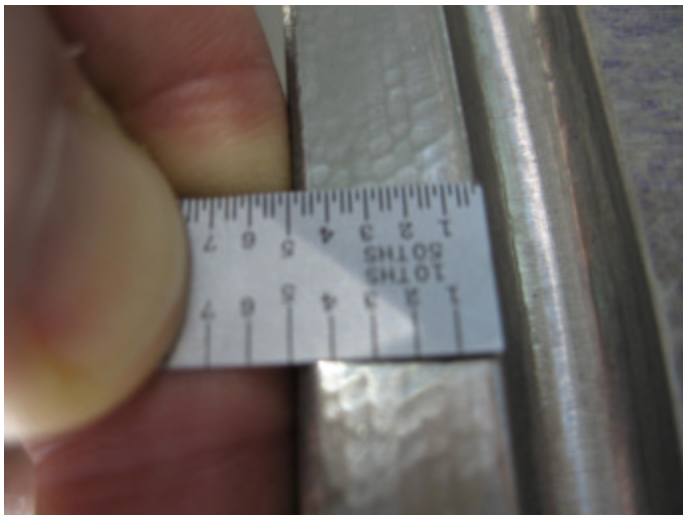
.400" distance from short leg to
VPI groove (sheet 2, zone G7)

There is an area on the Datum D side from T
hole 81 to 86 that checks as small as .300".
The transition has been blended smooth.

There is an area on the Datum D side from T
hole 70 to 73 that checks as large as .506".

(SEE NC20917 step 110)

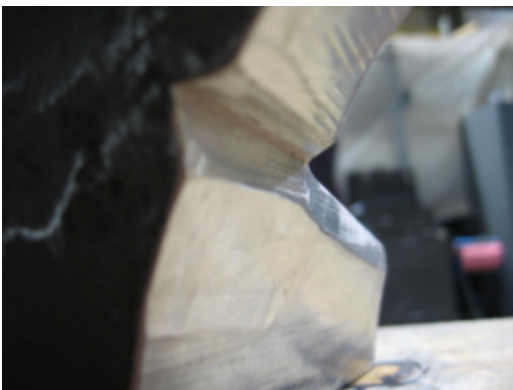
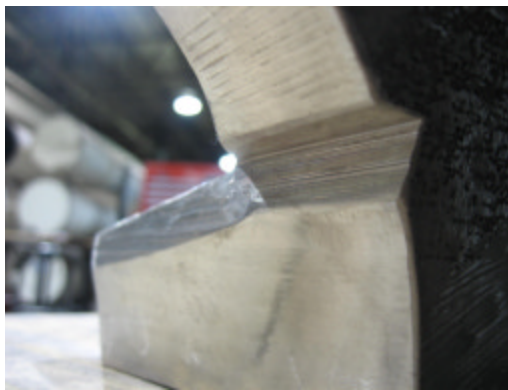
The picture to the left is of the port opening on the Datum D flange just beneath the Lead Block pad.

A programming error resulted in too much material being removed during the rough machining operation. An area on both sides of the port did not clean up.

One area measures approximately .25" x .25" and the other is .35" x .35". Both cutter marks extend through the opening the thickness of the casting wall.
