Part: SE141-115 / MODULAR COIL, TYPE B

Problem: SEVERAL ITEMS NOTED DURING VISUAL REVIEW OF CASTING. SEE ATTACHMENT.
Rev. 1 - added pages 9 & 10 to the attachment. (1-2-07)

NC20920 – B3 Visual Review

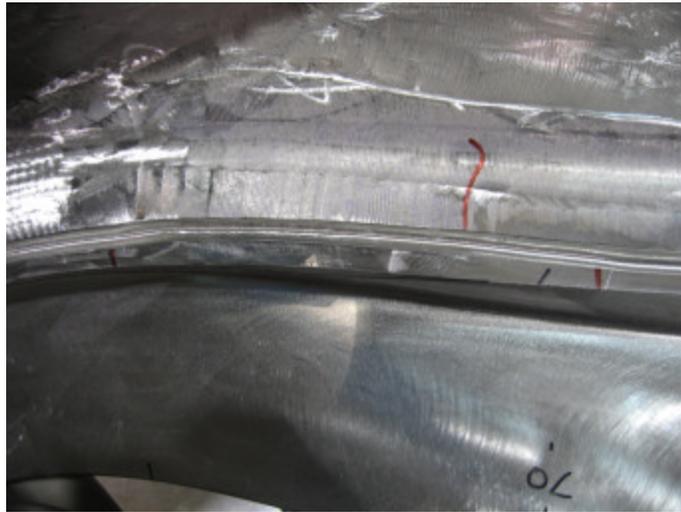
.400" distance from short leg to VPI groove (sheet 2, zone G7)

There is an area on the Datum D side from T hole 81 to 86 that checks as small as .300".
The transition has been blended smooth.

There is an area on the Datum D side from T hole 70 to 73 that checks as large as .506".

(SEE NC20917 step 110)

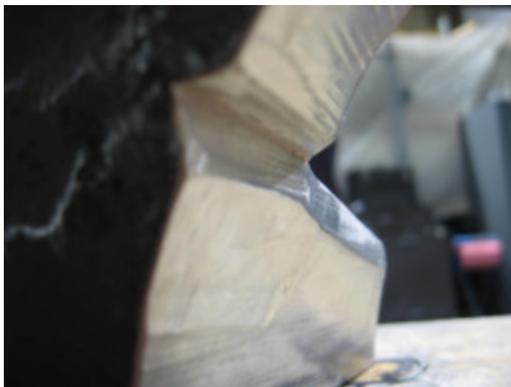
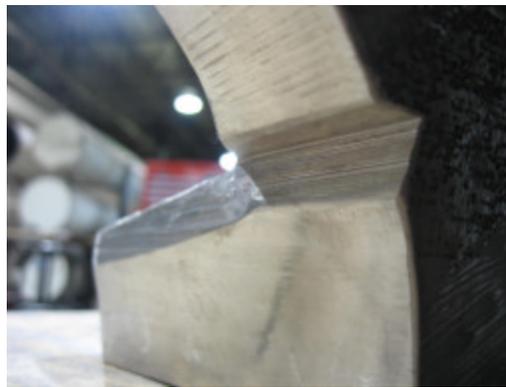
From the orientation shown, the 1-8" hole pattern was shifted .25" down. This hole pattern, per the model, was not centered about the 2.5" hole prior to this shift.

(EIO, MTM) Provide documentation of completion of corrective action for EIO CA 090606(NCR) for B-3 & B-6 Vacuum Vessel support pads deviations.
Status: (Open) MTM confirms that the center hole position is fixed but the tapped hole pattern is being shifted as needed (applies to all Type B castings). EIO/MTM will provide proposed shifted locations prior to drilling. On B3 & B6 it's likely that one hole cannot be drilled (corner missing). The CA will remain open until after B6 is completed.
