MTM N/C: 21265

Customer:	ENERGY INDUSTRIES OF	FOHIO	
Contact:	NANCY HORTON		Telephone: 216-496-2314
E-Mail:	NKHFlowen@aol.com		Fax: 216-328-2001
Part:	SE141-114 / MODULAR CO	DIL WINDING FORM TYPE	Customer P.O.: S005242-F/Ln:5
W/O Links:	1-Type:W: 65709/5.0 Sub: 0	Revision: 5	Senai No./Qty: AS
Reported By:	MIKE GRIFFITH		Telephone: 317-636-6433
E-Mail:	il: mGriffith@MajorTool.com		Fax: 317-634-9420
Problem:	Visual review of A5 identified several tool marks on T section and other miscellaneous items. See attachment for details.		
Proposed Dispo	sition:		
	MTM Proposes to accept devi	ations as-is.	
Number of additional pages: 9 page attachment

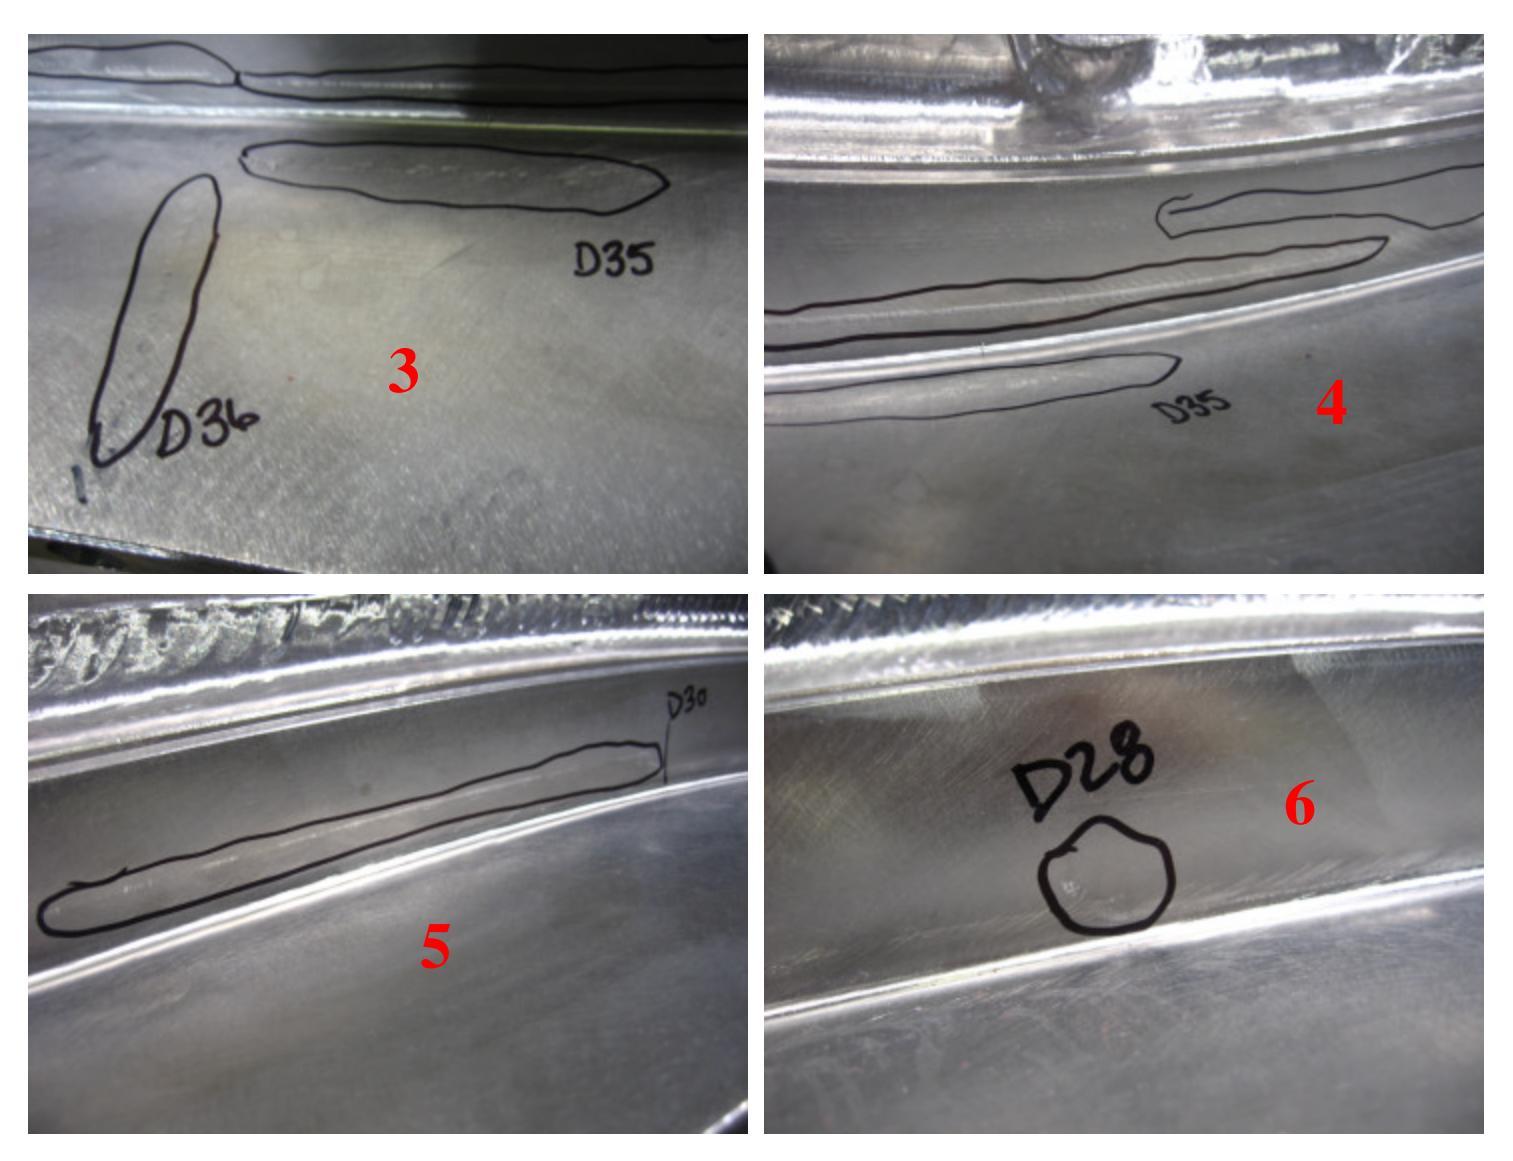
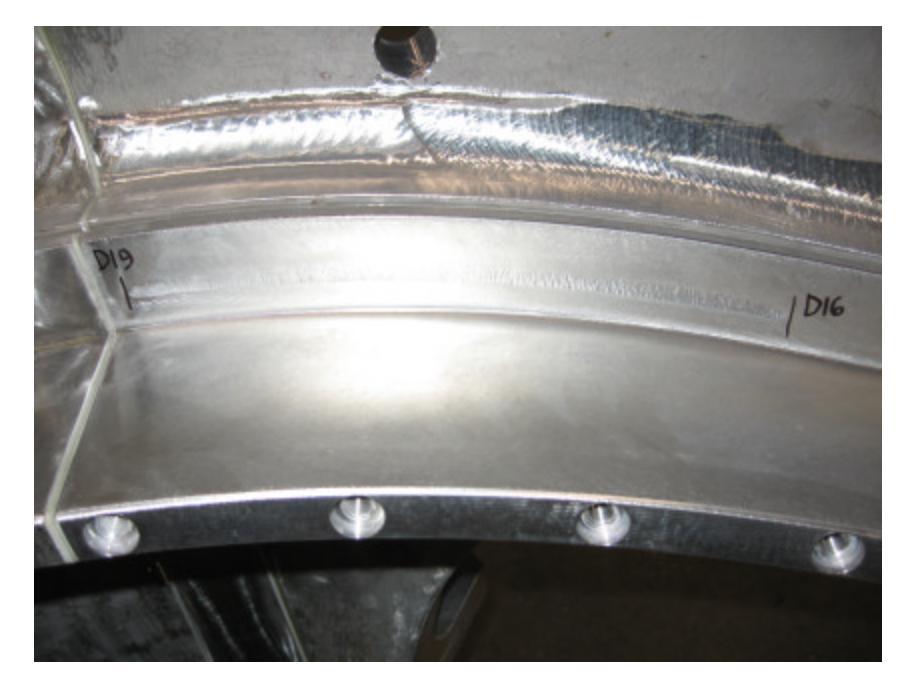
There are several shallow tool marks (<.010") on the datum D side between T holes 28 and 40. These are shown on slides 1 and 2.

The attached list was reviewed during a conference call attended by J. Chrzanowski, L. Sutton, F. Malinowski, L. Dudek, D. Williamson, T. Brown, and P. Heitzenroeder on 2/28/07. The surface defects are shallow (<0.010") and therefore are not an issue. During the call it was noted that the lead pad offset caused by a less than optimal choice of initial casting best fit location brought the pad uncomfortably close to the lead slots; MTM resolved this by grinding a 0.5" chamfer immediately (see attachment). The break-out of some of the bolt threads were also discussed, but there is adequate thread engagement beyond this so it is accepted as is.

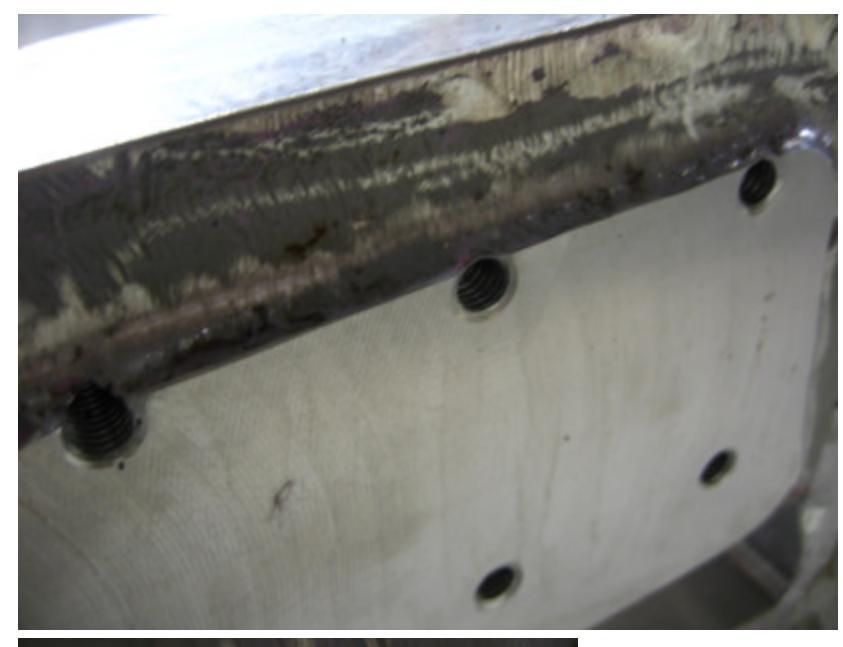
It appears that the casting stock was not balanced as well as it could have been when the casting was qualified on the 1st roughing operation at MTM. A rotation of approximately .400" near the lead block area would have improved this condition. This resulted in a thicker flange on datum D and a thinner condition on datum E (as reported in previous slide). This also affected the lead pad and the cast stock around the 2.5" holes (see next slide).

The picture above and the one in the previous slide show how the hole is shifted relative to the cast stock.

The 1st 2 ¹/₂ threads break out the edge of the hole. This hole (and the other five) checks good with a thread gage.

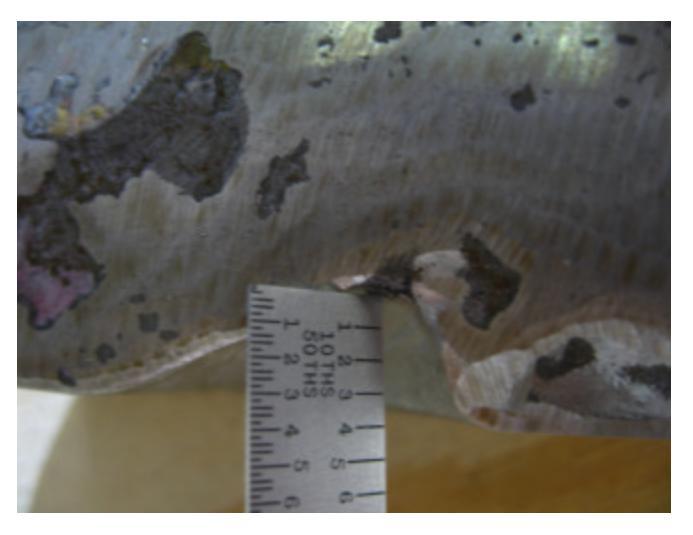
Tool Gouge on perimeter of Datum E flange, approximately 1" wide by .50" deep.
