Part: SE141-115 / MODULAR COIL, TYPE B

Problem: SEVERAL ITEMS NOTED DURING VISUAL REVIEW OF CASTING. SEE ATTACHMENT.
Rev. 1 - added pages 9 & 10 to the attachment. (1-2-07)

NC20920 – B3 Visual Review

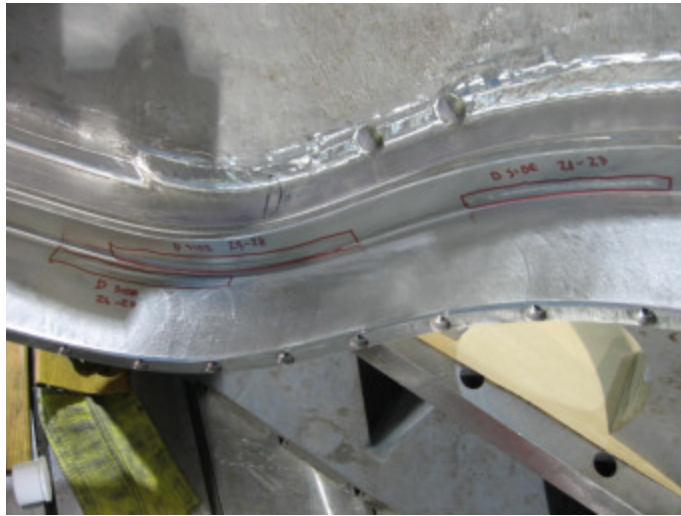
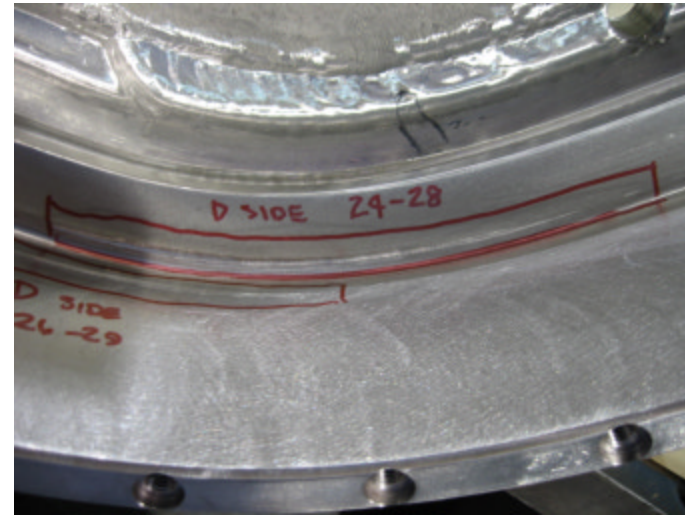
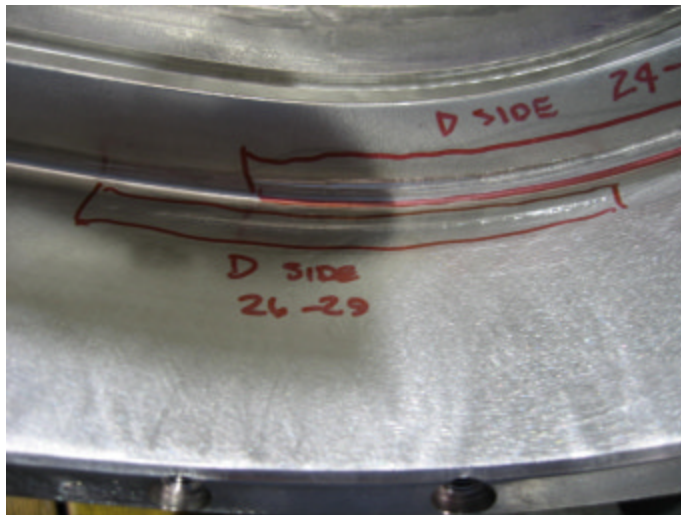
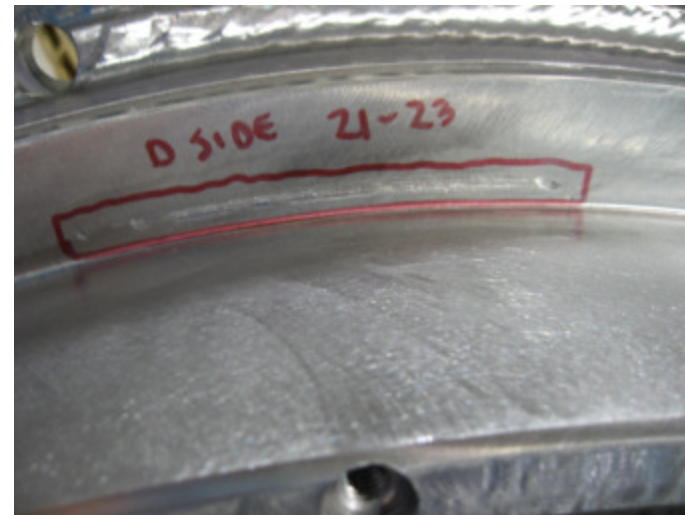
Tool Gouges on D side Long and Short Legs near radius

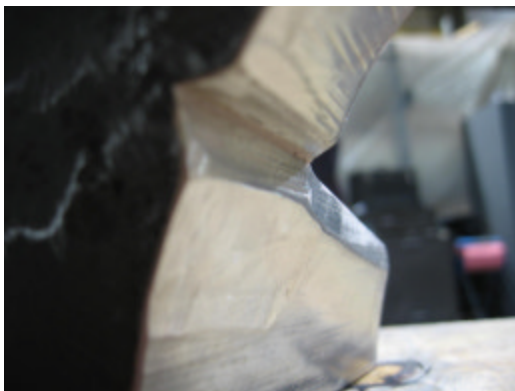
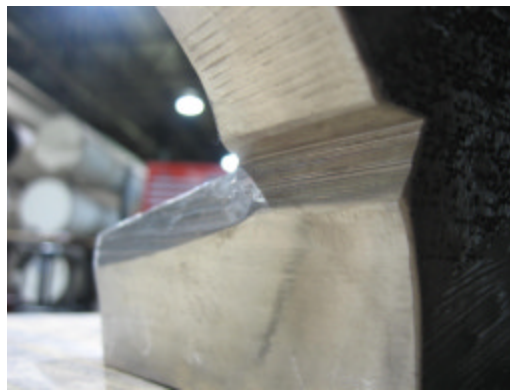
The picture to the left is of the port opening on the Datum D flange just beneath the Lead Block pad.

A programming error resulted in too much material being removed during the rough machining operation. An area on both sides of the port did not clean up.

One area measures approximately .25" x .25" and the other is .35" x .35". Both cutter marks extend through the opening the thickness of the casting wall.
