PPPL NONCONFORMANCE REPORT NO: 3735    Open Date 11/15/07    Rev #: 1 , 12/20/2007

Status	1 - Eng Dept Head Concur Required	Trend	05-Design Interference
Department	NCSX	Division	WBS 142
Source/Org	Fabrication, Operations & Maintenance		
Item Dwg/Part#	b1_mtm_data_check.asm	Procurement #	WPF-1224
Cost Center	WBS/Other	00/00/00	
RAP#	3304	Job Doc #	WPF-1224
		Vendor	
RAP Title	Coil to Coil Assembly Trials

Review of “B1” to “C1” interface  
Response to NCR 3735  
and  
Deviation Request to Address  
Remaining B-C Coil Interfaces

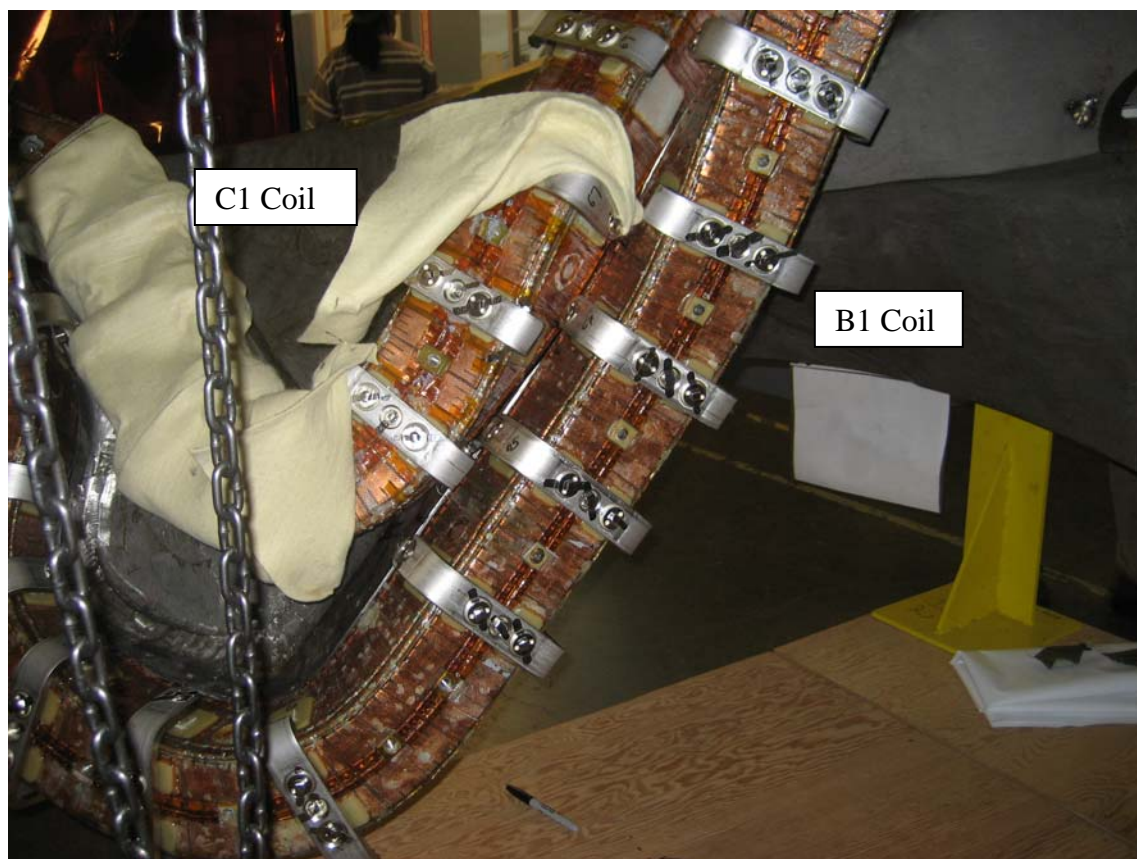
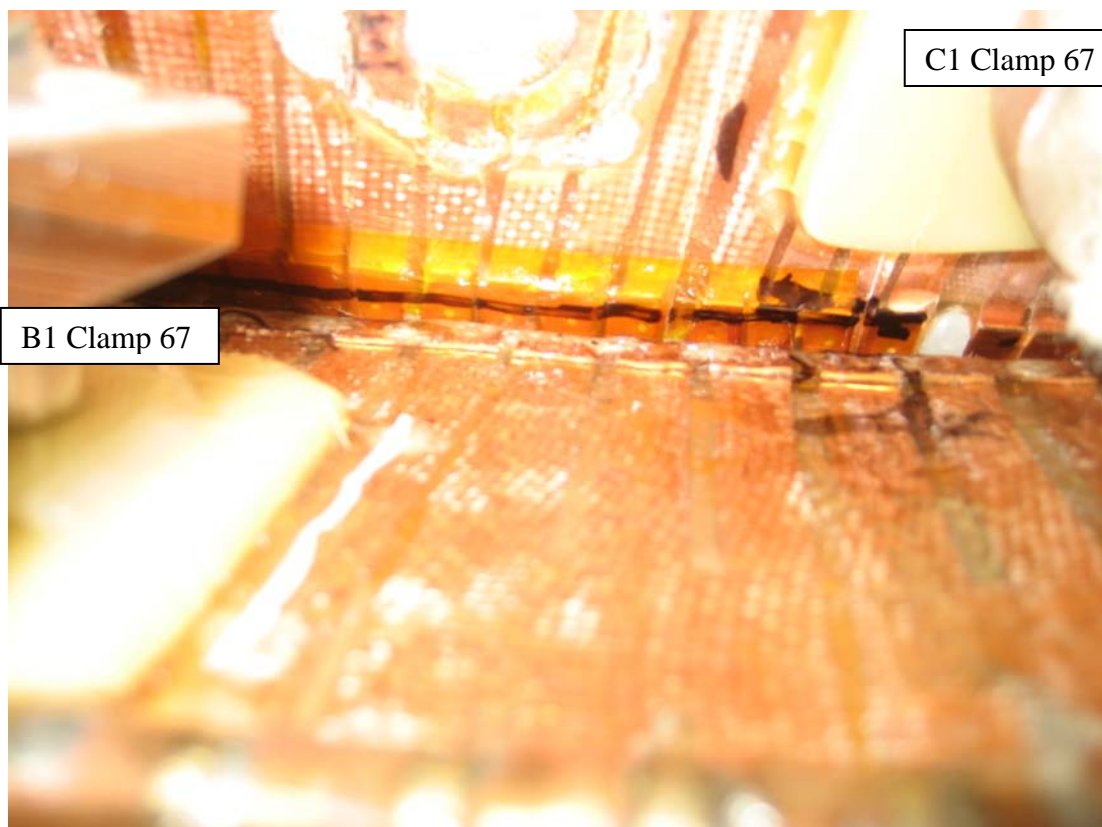
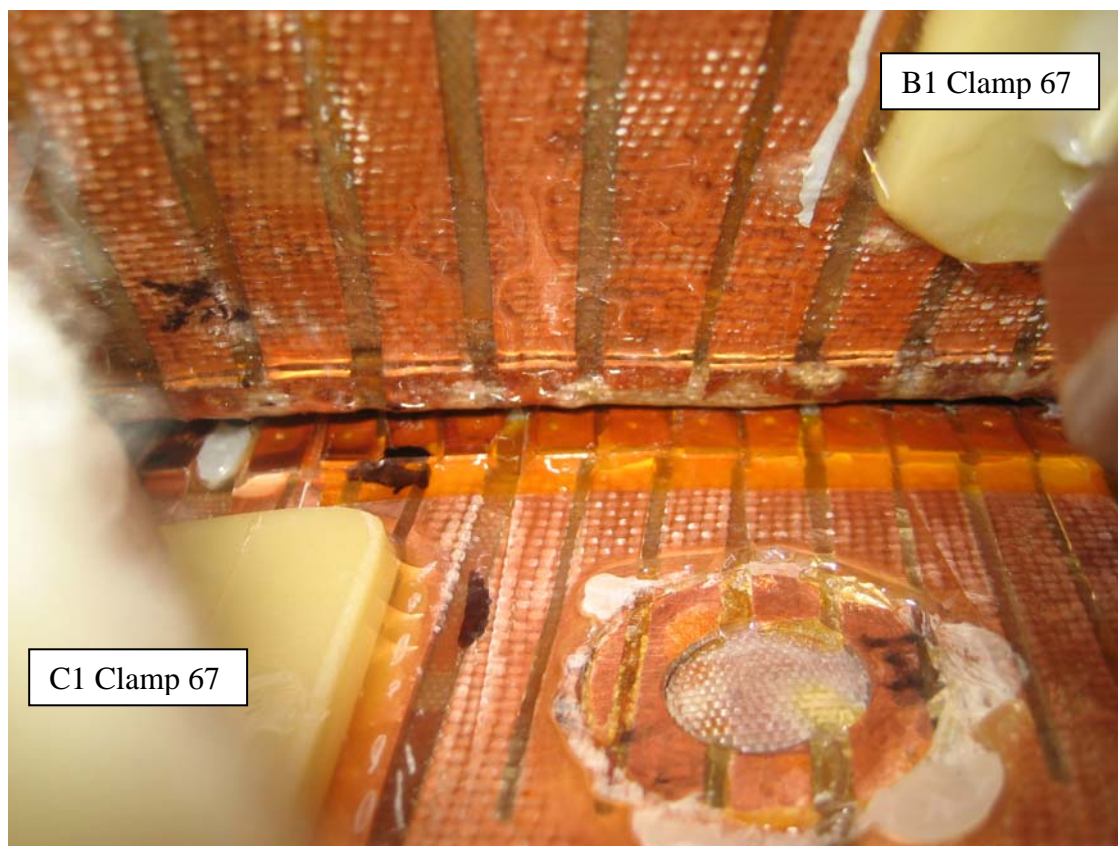
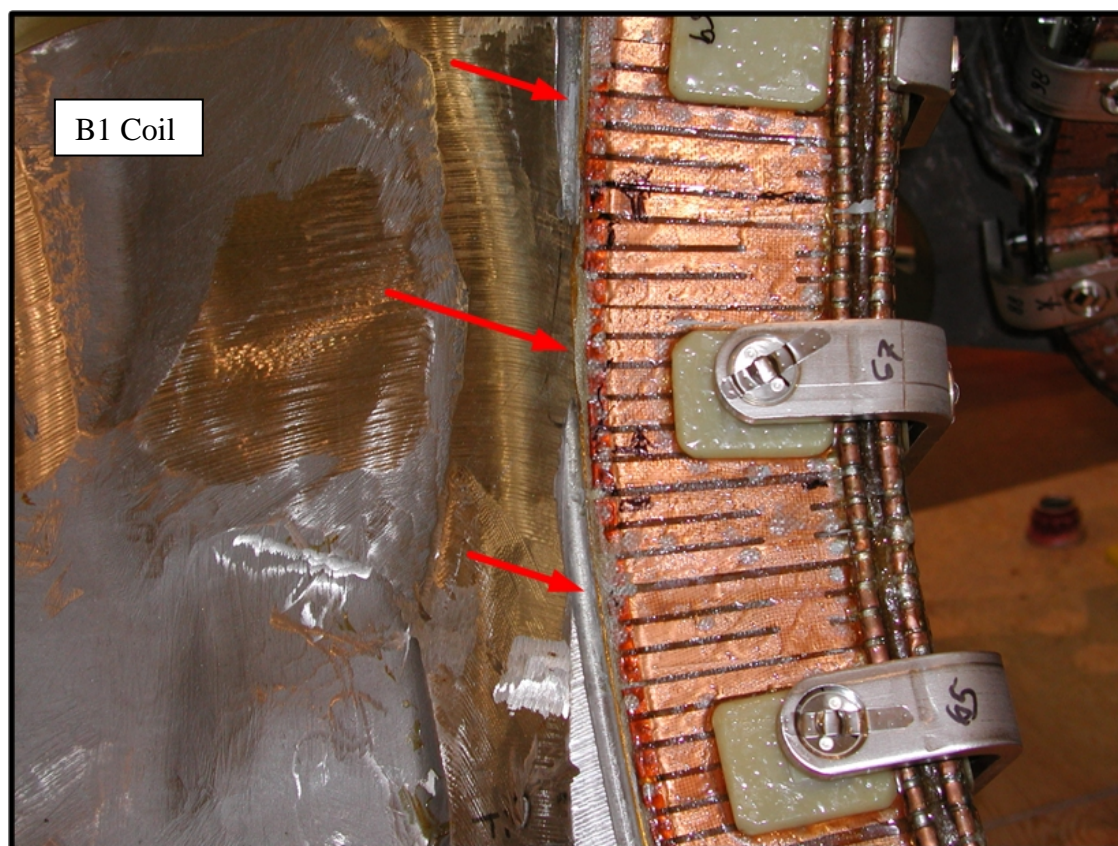
MCWF B1 & C1; During the trial fit-up of the B1 and C1 NCSX modular coils an interference was discovered in the vicinity of winding clamp #67. The interference is between the copper chill plates of each coil just above the VPI groove where the vertical chill plates are attached to the horizontal or base cladding, see attachment 1 for details.

Portion of master machine model identified as "b1\_mtm\_data\_check.asm" which brings together the top level MC assemblies, sel41-102 and -103 which include the MC Type-B and Type-C details.

- Modify the copper cladding on B1 and C1 as shown on page 3.
  - The slides which follow this are given for reference.
- Resolve interference between MCWFs as shown in the following slide set, and as detailed in the grinding table shown on slide 17.
- Verify clearance as given below (Requirement on clearance).

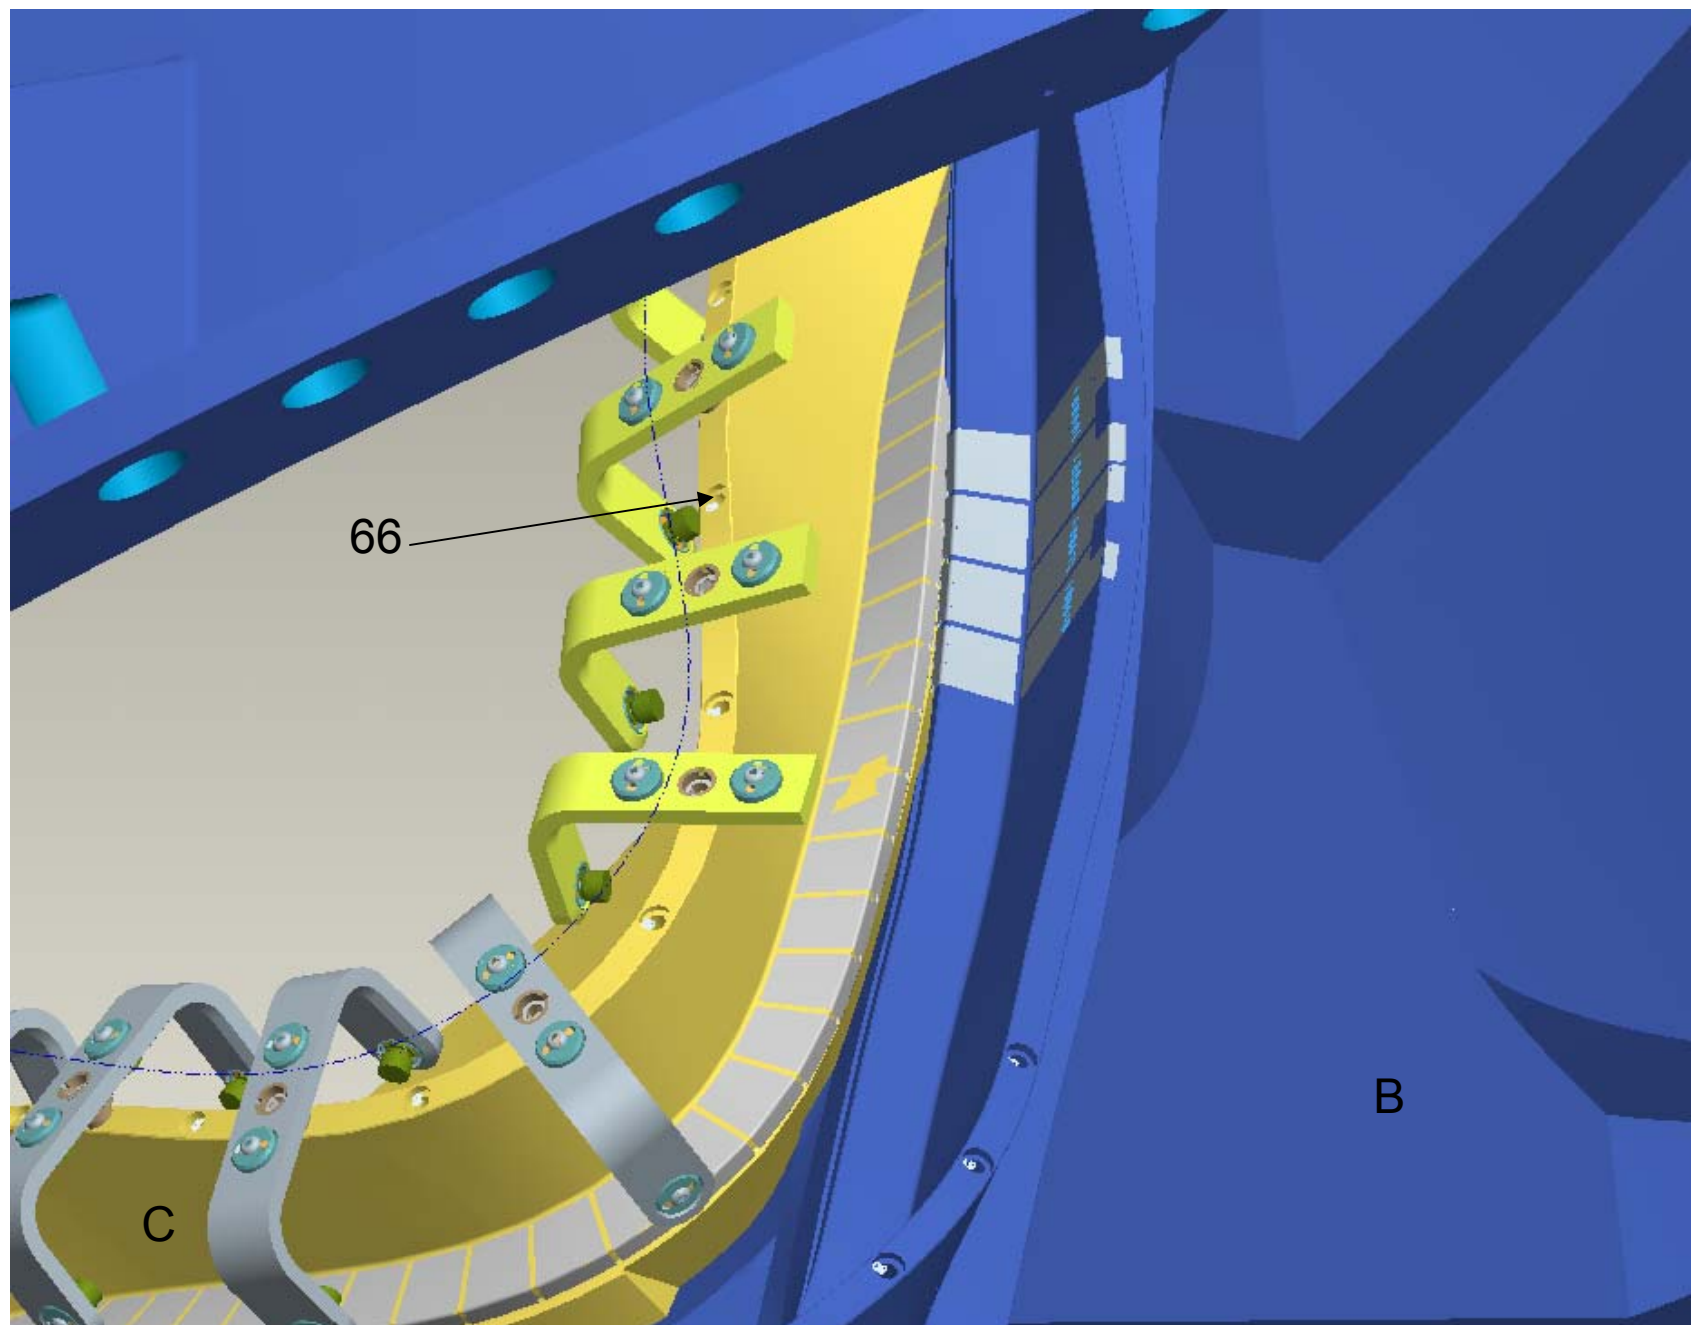
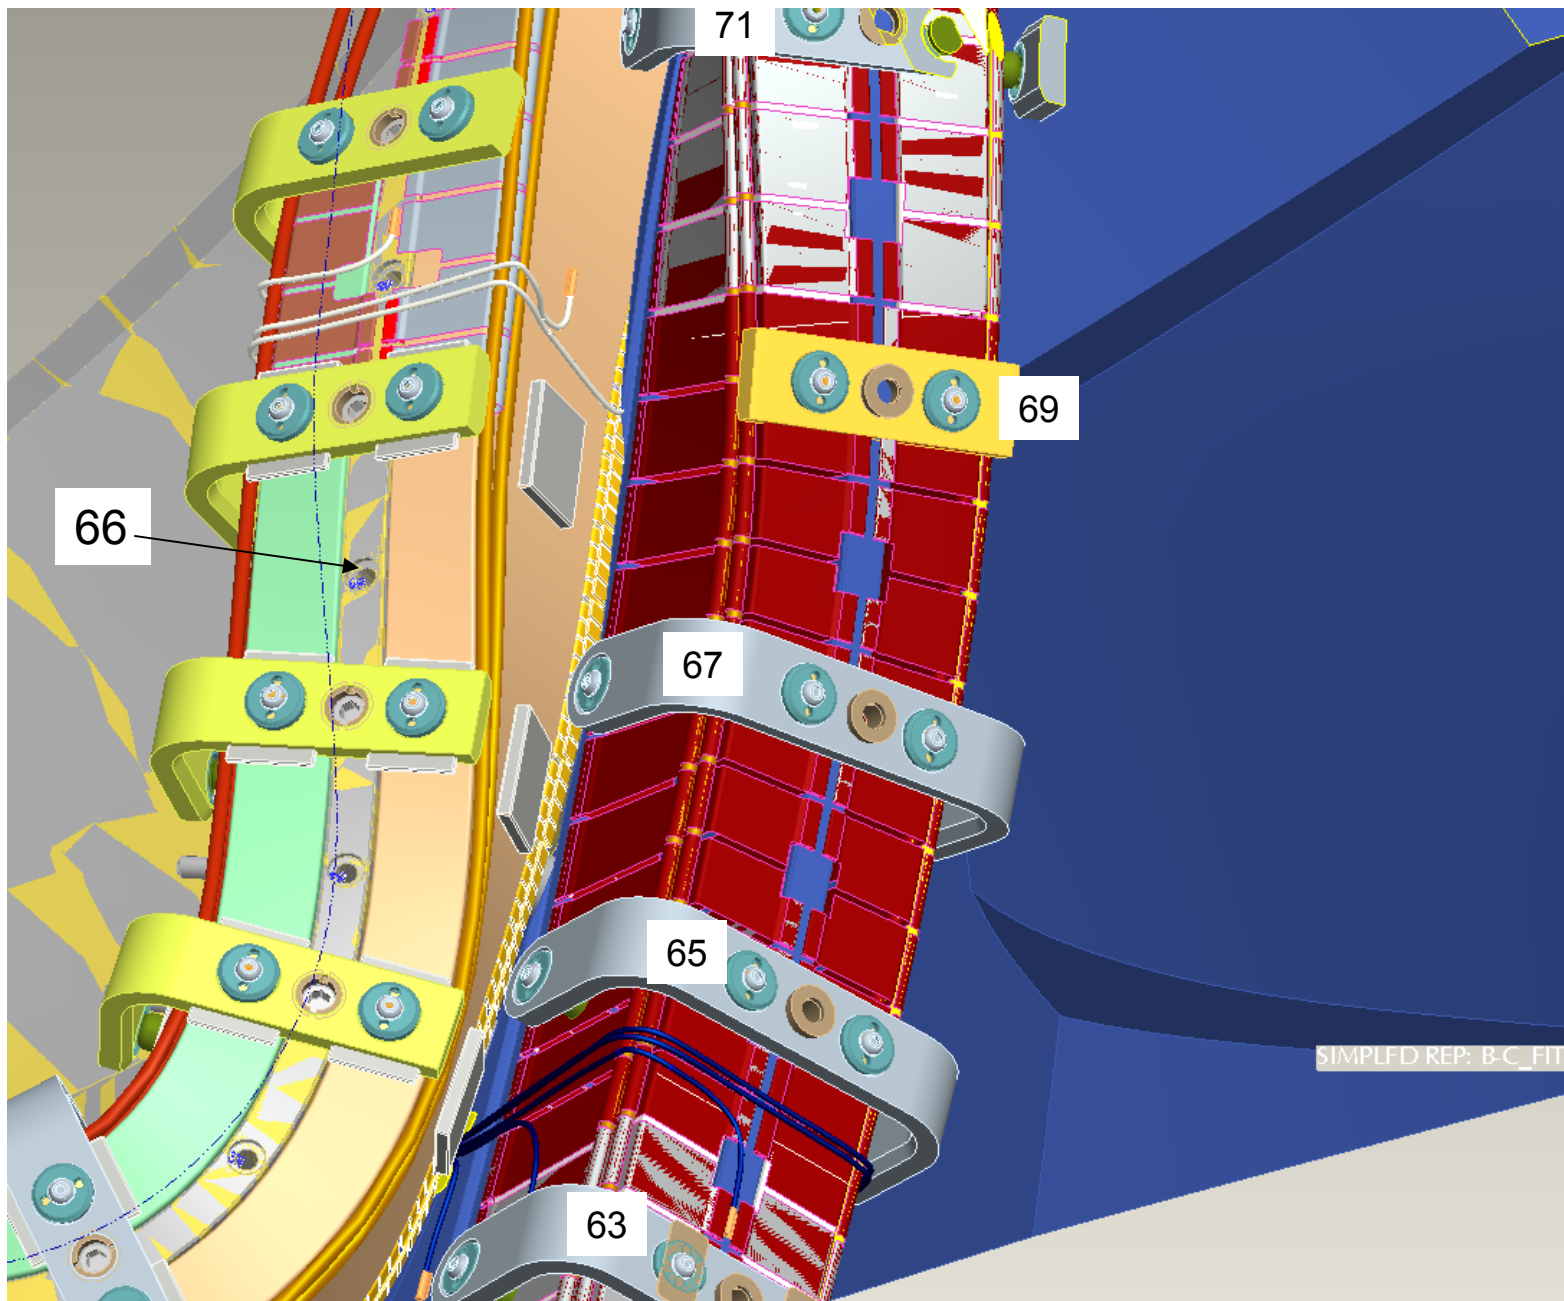
BT - CT Fit-up 12/16/07

There is a large area of interferences.

The "B" and/or "C" cladding needs to be modified as shown below in red in this area

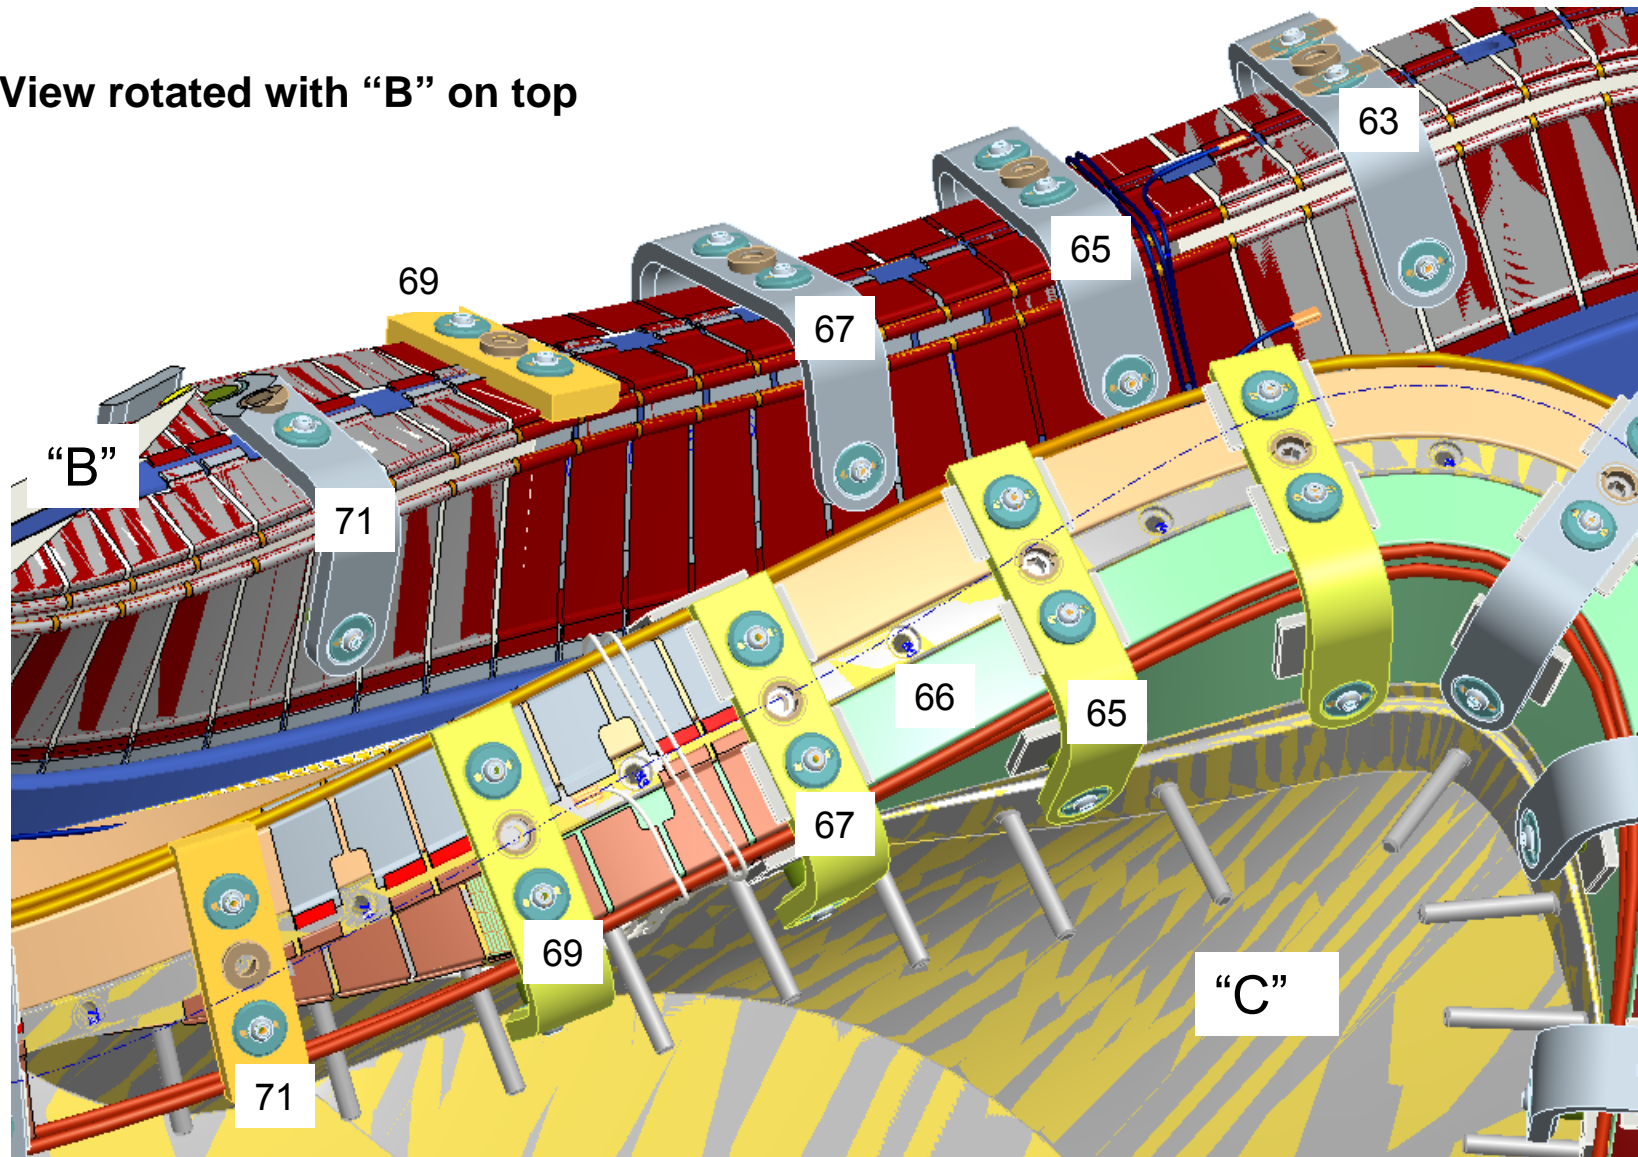
**“B” on top with “C” cladding shown**

View rotated with “B” on top

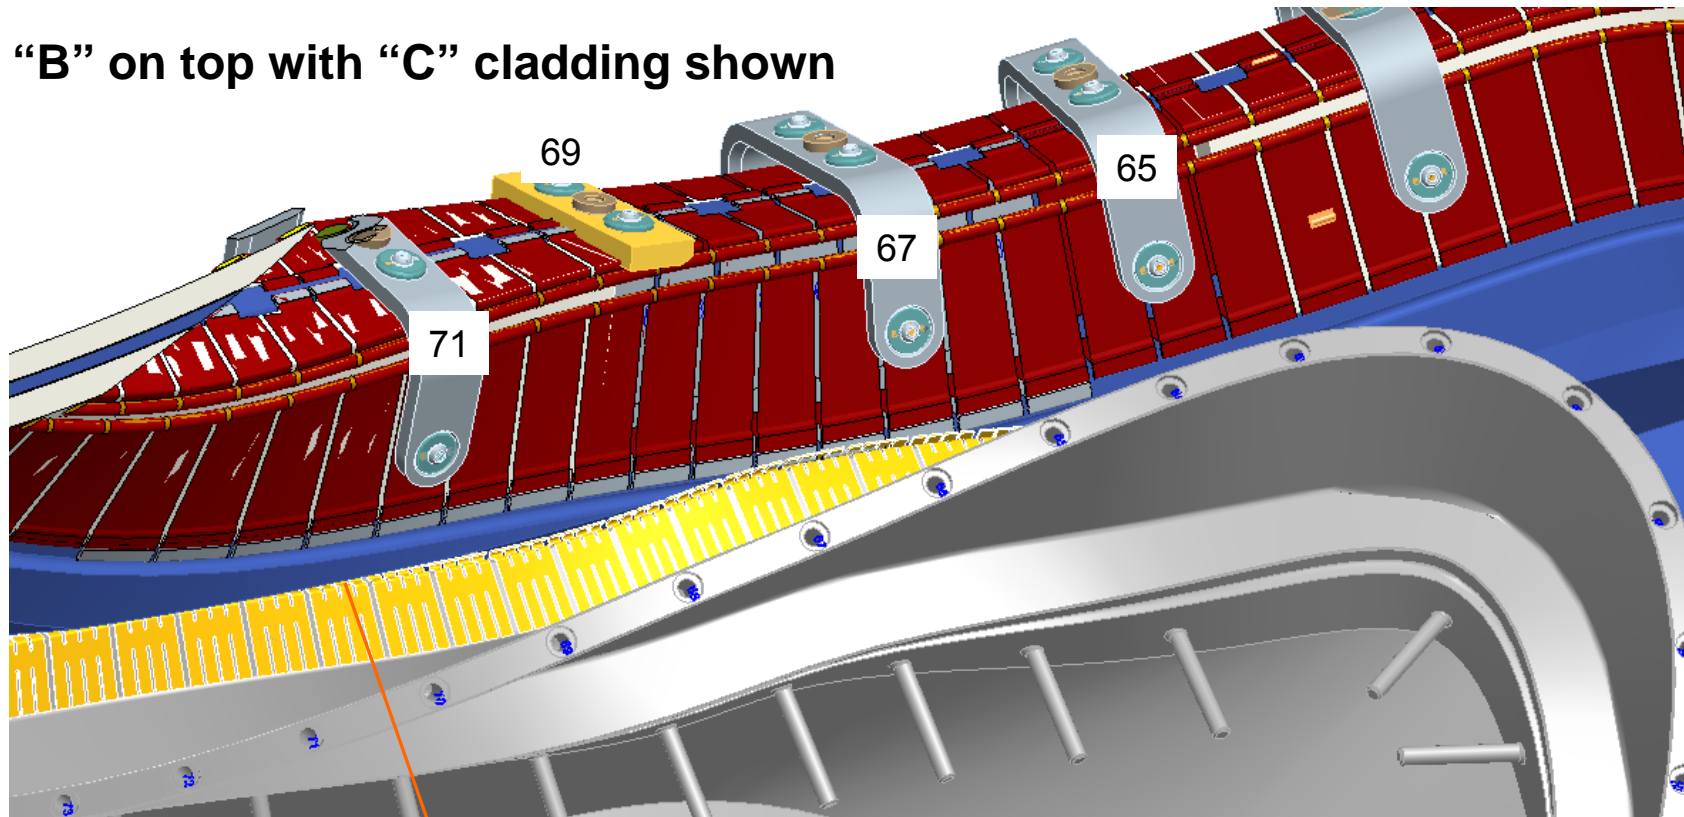
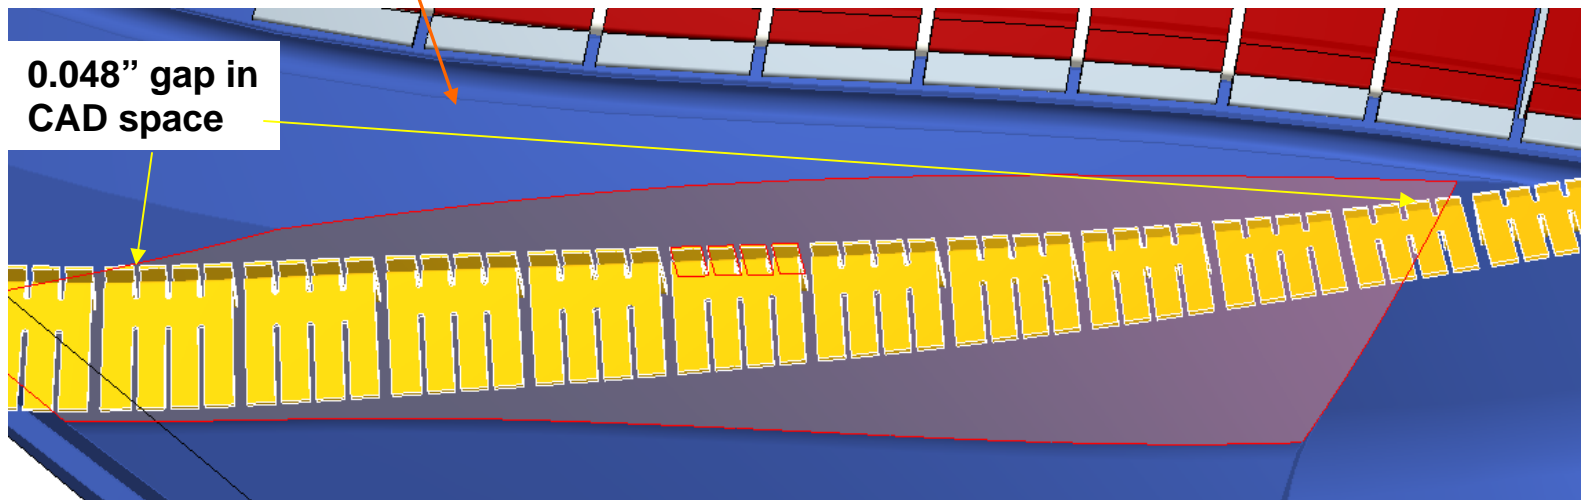
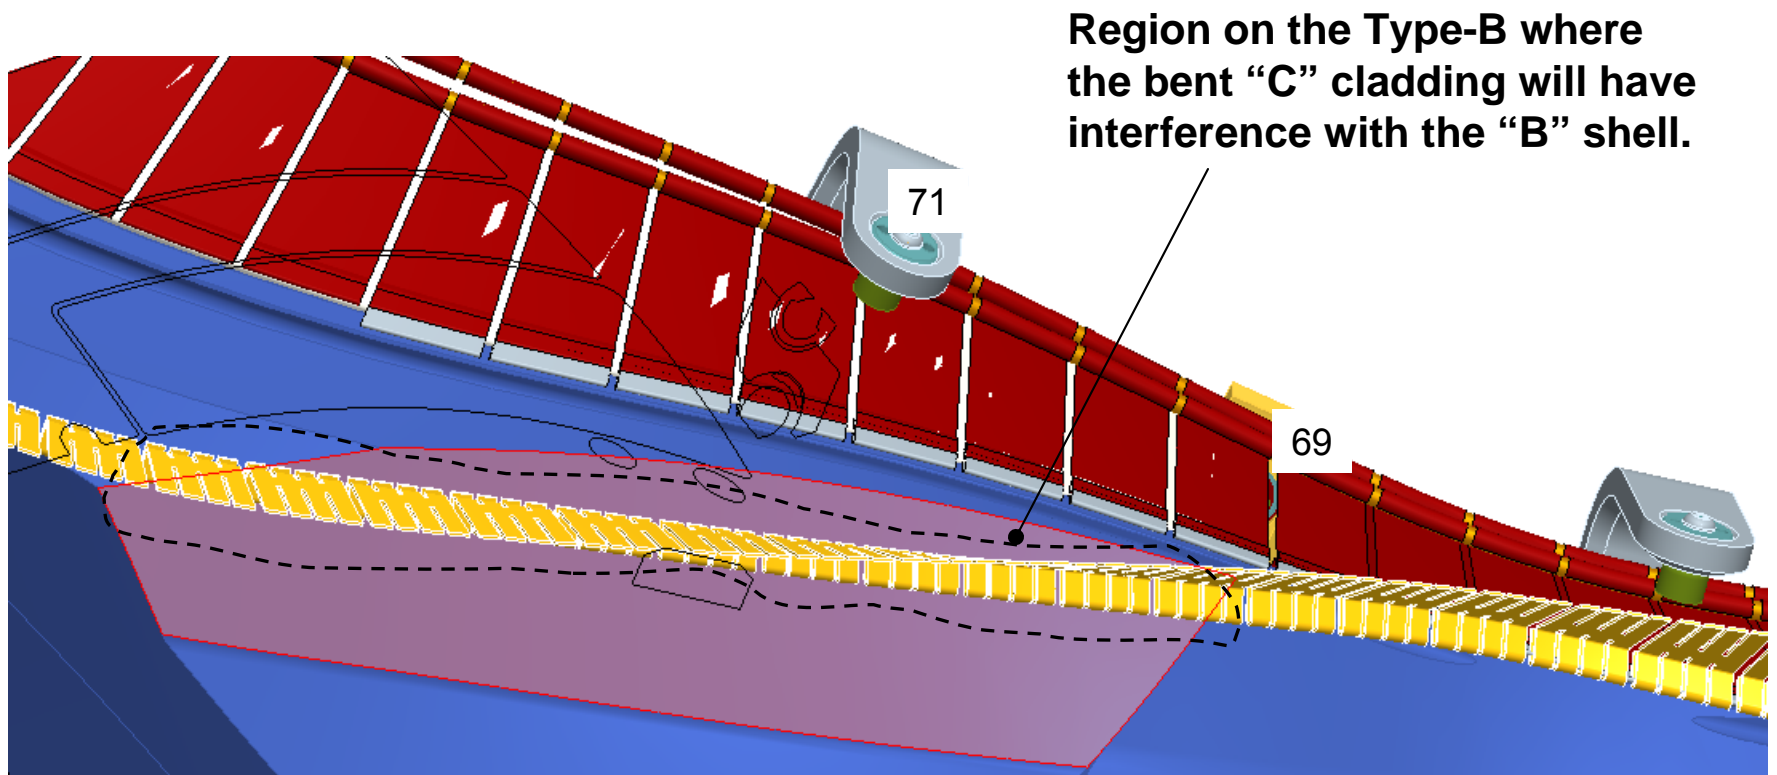
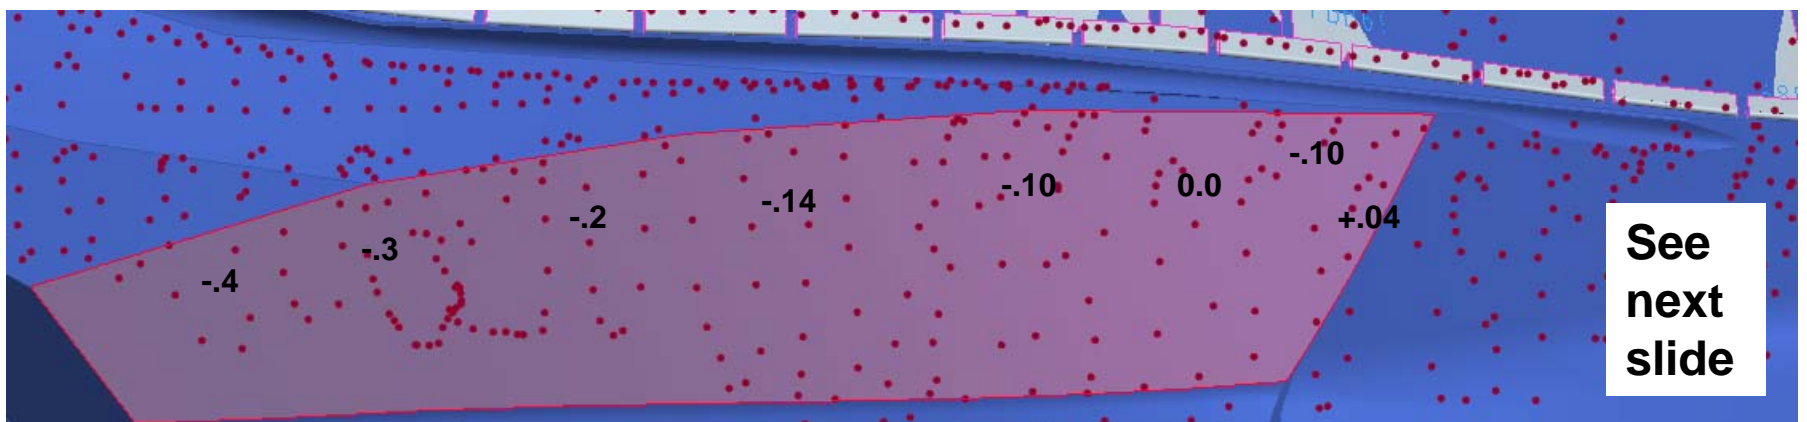
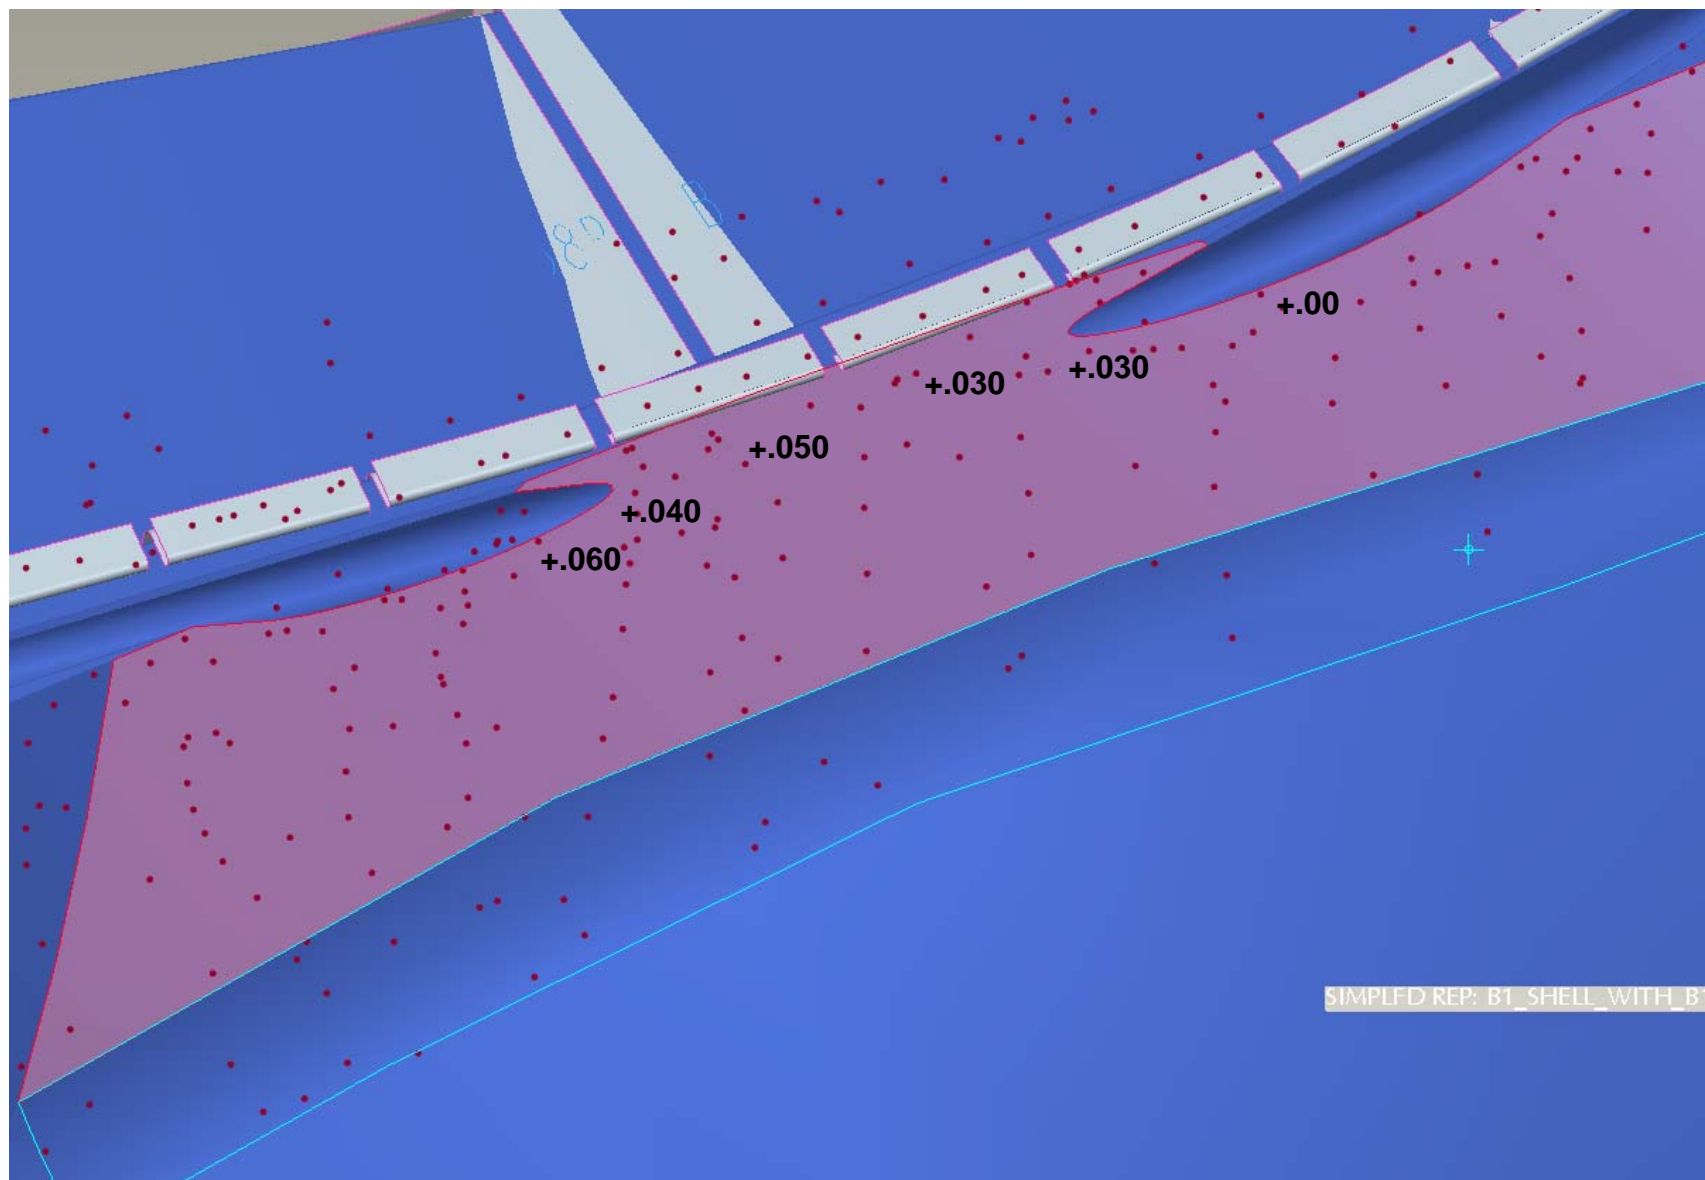
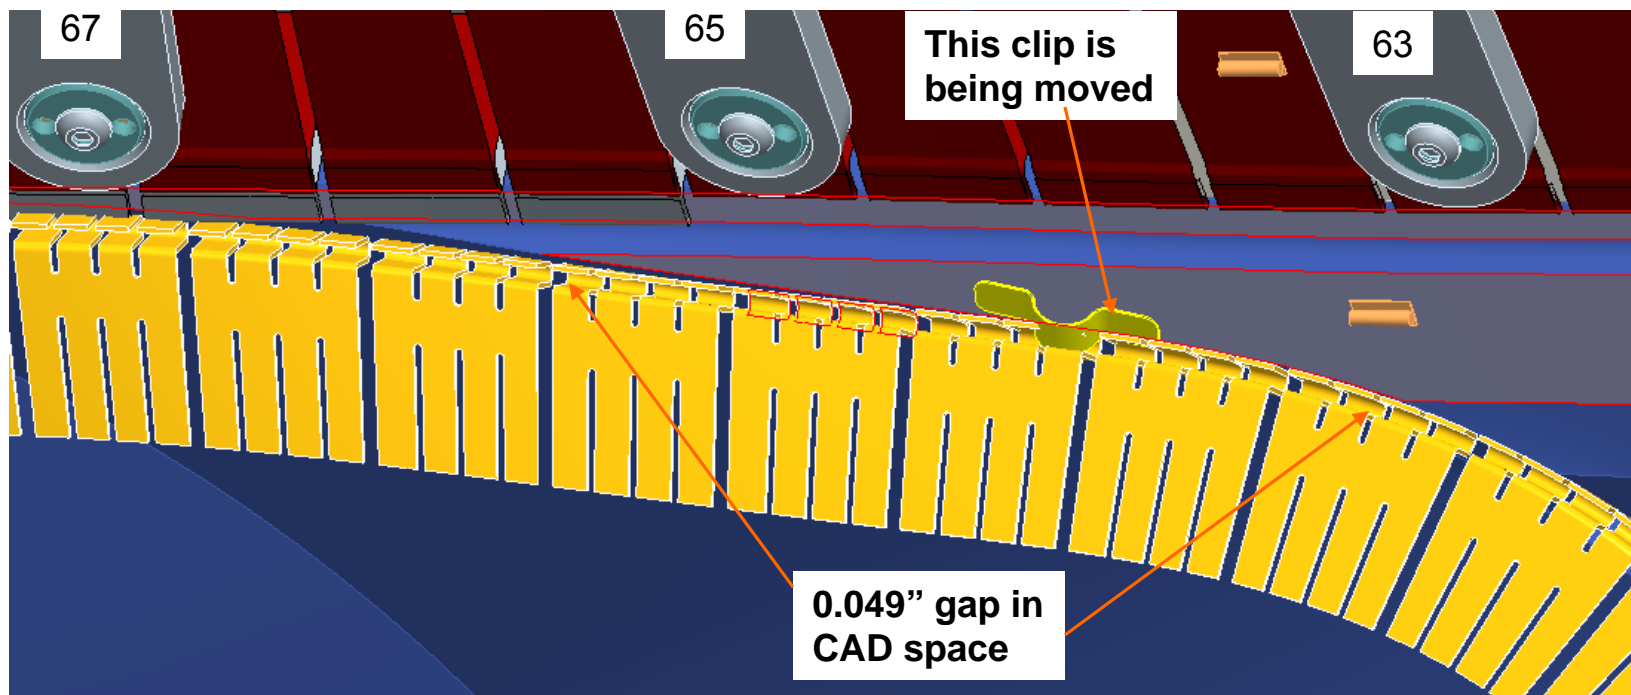
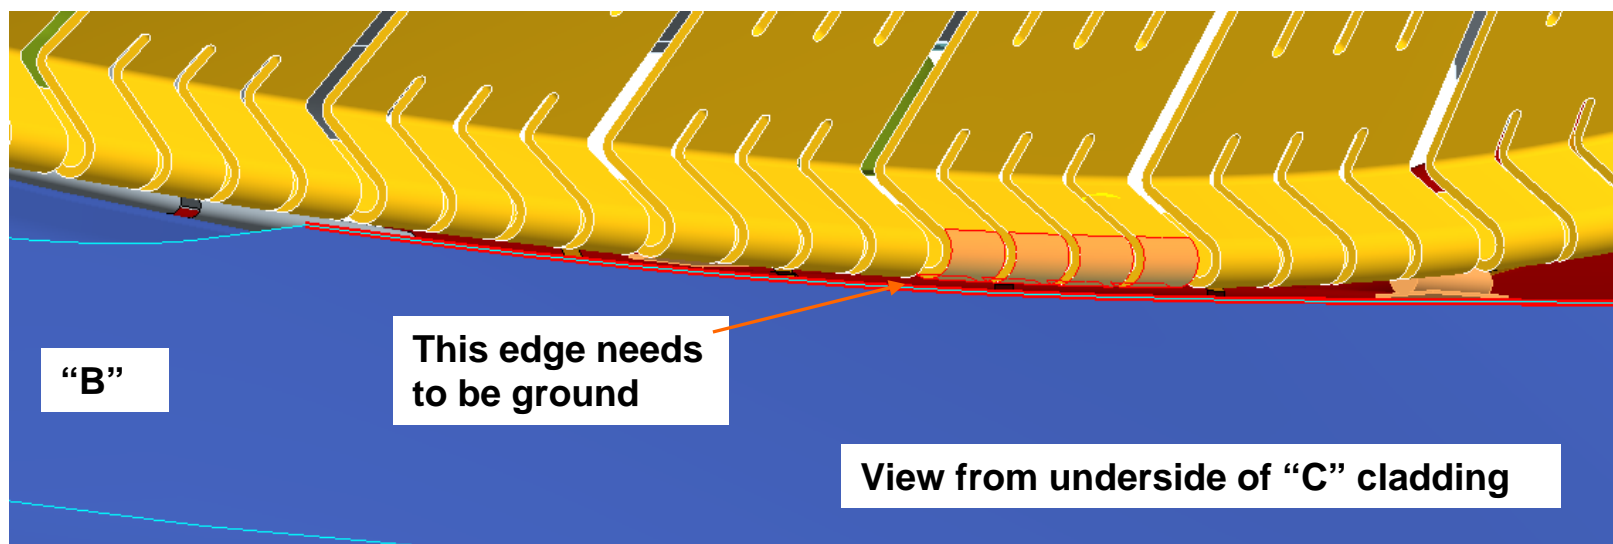
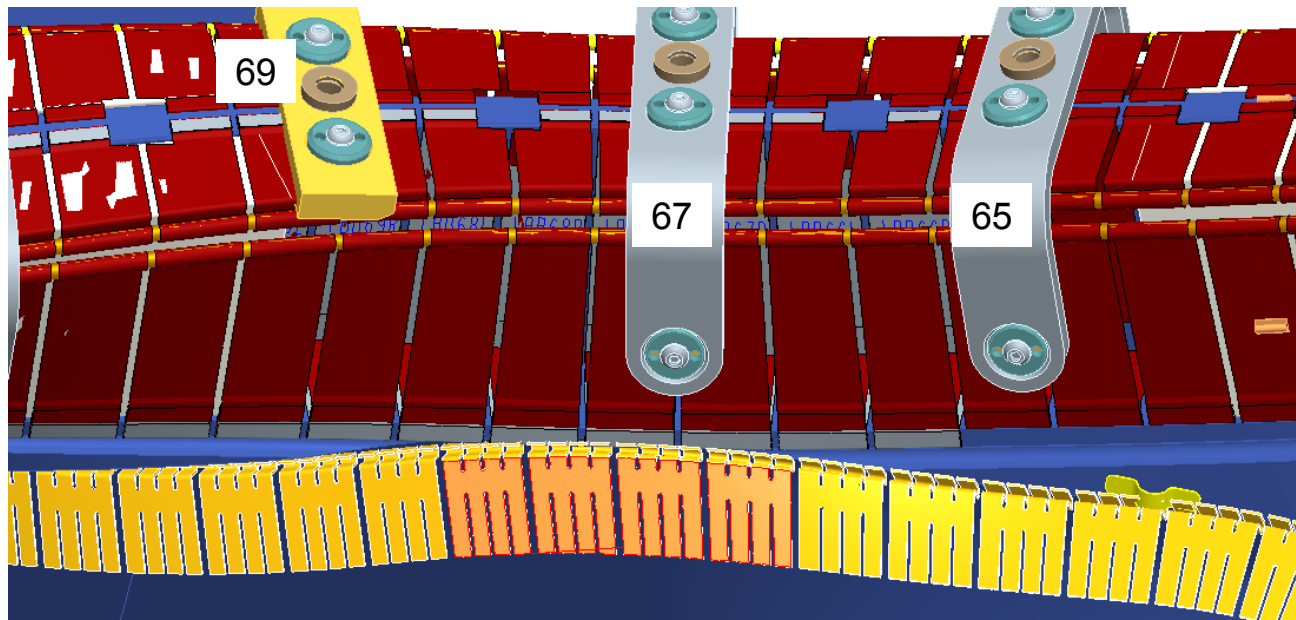
The “B” and/or  
“C” cladding in  
this area needs  
to be cut back.

- Unbend copper crimps & straighten copper.
- Form the copper as shown in the yellow circle. Bent out leg should be ~1/8".
- Form the upper copper to meet the bent out leg and form a crimp U section over the lower piece.
- Crimp the copper U.
- Epoxy the copper to the coil and overlay the repaired region with glass - epoxy.

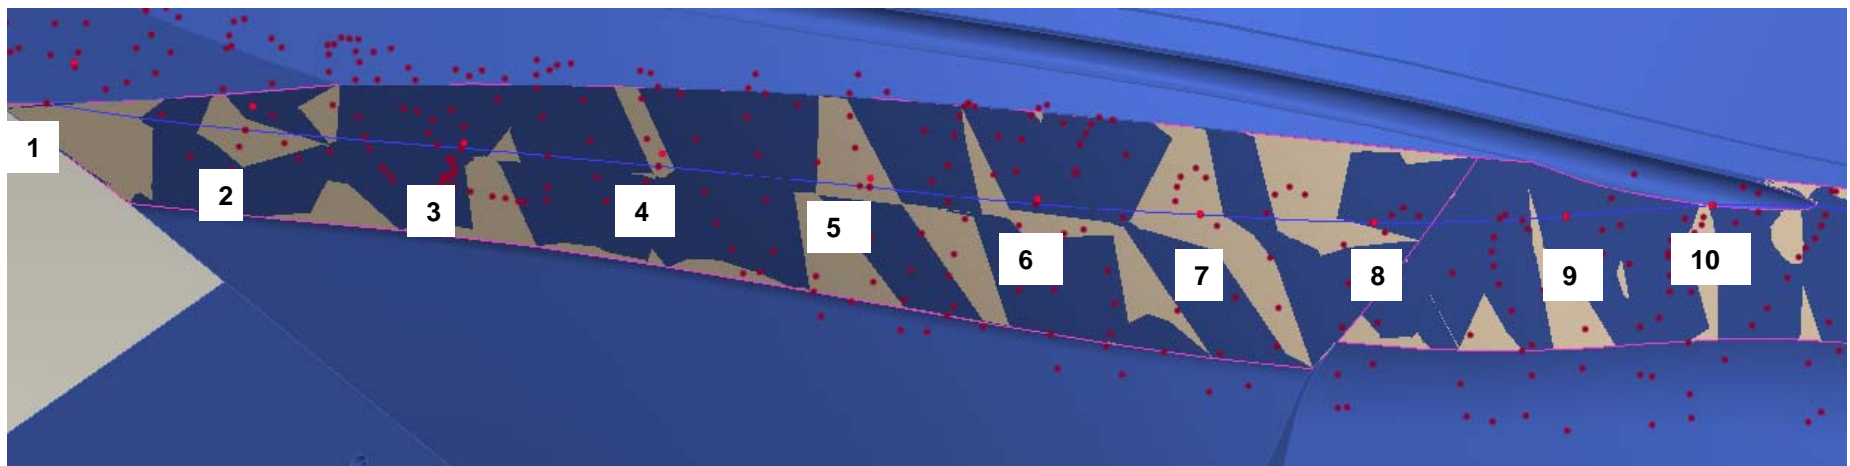
**Pts 3 thru 10**

Point data relative to the "B" default coordinate system FOR B1 AND C1								
	X	Y	Z	"B" surf to "C" cladding	Curnt. Ground Dist. from Met. Pts	Curnt "B" surf to "C" cladding	Additional grinding depth for 1/4" gap	Added fractional grinding depth
1	34.087	-27.853	-41.520	0.046	0.649	0.695		none
2	34.532	-26.814	-39.870	0.046	0.361	0.407		none
3	34.997	-25.567	-38.164	0.046	0.092	0.138	0.112	1/8
4	35.353	-24.380	-36.598	0.046	0.162	0.208	0.042	1/8
5	35.686	-23.086	-34.925	0.046	0.128	0.174	0.076	1/8
6	35.952	-22.079	-33.603	0.046	0.094	0.140	0.110	1/8
7	36.251	-21.049	-32.331	0.046	0.020	0.066	0.184	3/16
8	36.651	-20.010	-31.011	0.046	-0.014	0.032	0.218	1/4
9	37.241	-18.809	-29.617	0.046	0.009	0.055	0.195	1/4
10	37.769	-17.908	-28.587	0.046	0.048	0.094	0.156	3/16
11	38.350	-16.817	-27.066	0.046	0.022	0.068	0.182	3/16
12	38.650	-16.047	-25.906	0.046	0.058	0.104	0.146	3/16
13	39.070	-14.208	-22.898	0.046	0.093	0.139	0.111	3/16

14	39.163	-13.659	-22.105	0.046	0.063	0.109	0.141	3/16

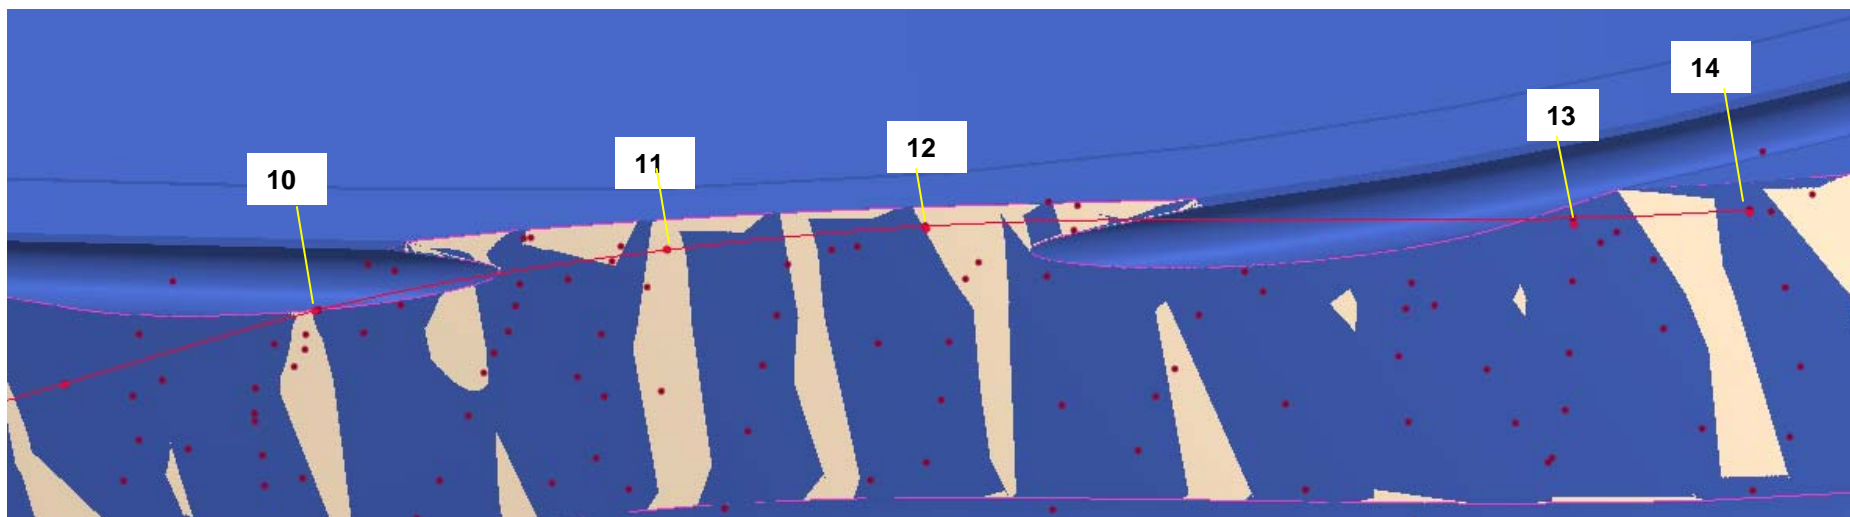
} **Pts 10 thru 14**

Point data relative to the "B" default coordinate system FOR B1 AND C1								
	X	Y	Z	"B" surf to "C" cladding	Currt. Ground Dist. from Met. Pts	Currt "B" surf to "C" cladding	Additional grinding depth for 1/4" gap	Added fractional grinding depth
1	34.087	-27.853	-41.520	0.046	0.649	0.695		none
2	34.532	-26.814	-39.870	0.046	0.361	0.407		none
3	34.997	-25.567	-38.164	0.046	0.092	0.138	0.112	1/8
4	35.353	-24.380	-36.598	0.046	0.162	0.208	0.042	1/8
5	35.686	-23.086	-34.925	0.046	0.128	0.174	0.076	1/8
6	35.952	-22.079	-33.603	0.046	0.094	0.140	0.110	1/8
7	36.251	-21.049	-32.331	0.046	0.020	0.066	0.184	3/16
8	36.651	-20.010	-31.011	0.046	-0.014	0.032	0.218	1/4
9	37.241	-18.809	-29.617	0.046	0.009	0.055	0.195	1/4
10	37.769	-17.908	-28.587	0.046	0.048	0.094	0.156	3/16
11	38.350	-16.817	-27.066	0.046	0.022	0.068	0.182	3/16
12	38.650	-16.047	-25.906	0.046	0.058	0.104	0.146	3/16
13	39.070	-14.208	-22.898	0.046	0.093	0.139	0.111	3/16

14	39.163	-13.659	-22.105	0.046	0.063	0.109	0.141	3/16

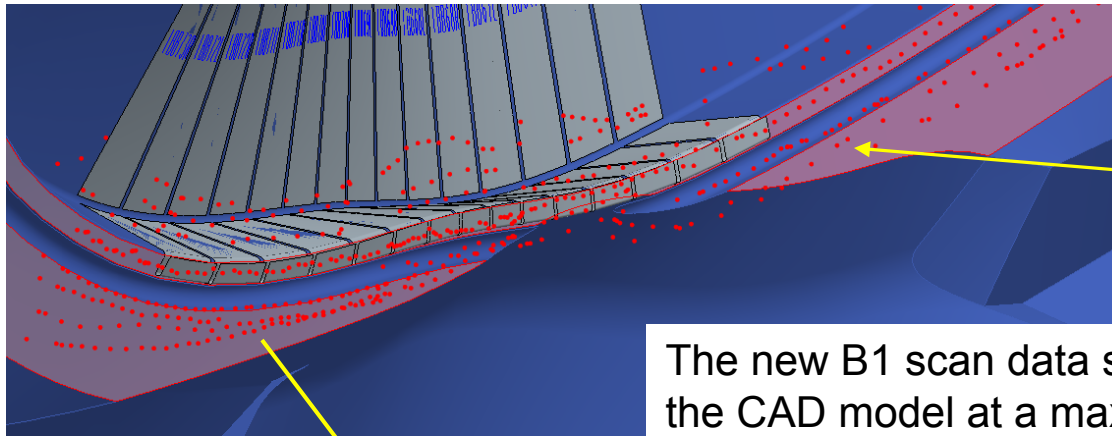
"B" MC is shown along with B1 scan points

-.050" to  
+.016

The new B1 scan data shows the surfaces are off the CAD model at a max condition on the order of +.058" and has a max value of +.092" off the cladding surface (see slides 16 and 17).
