PPPL NONCONFORMANCE REPORT NO: 3735    Open Date 11/15/07    Rev #: 1 , 12/20/2007

Status	1 - Eng Dept Head Concur Required	Trend	05-Design Interference
Department	NCSX	Division	WBS 142
Source/Org	Fabrication, Operations & Maintenance		
Item Dwg/Part#	b1_mtm_data_check.asm	Procurement #	WPF-1224
Cost Center	WBS/Other	00/00/00	
RAP#	3304	Job Doc #	WPF-1224
		Vendor	
RAP Title	Coil to Coil Assembly Trials

Review of “B1” to “C1” interface  
Response to NCR 3735  
and  
Deviation Request to Address  
Remaining B-C Coil Interfaces

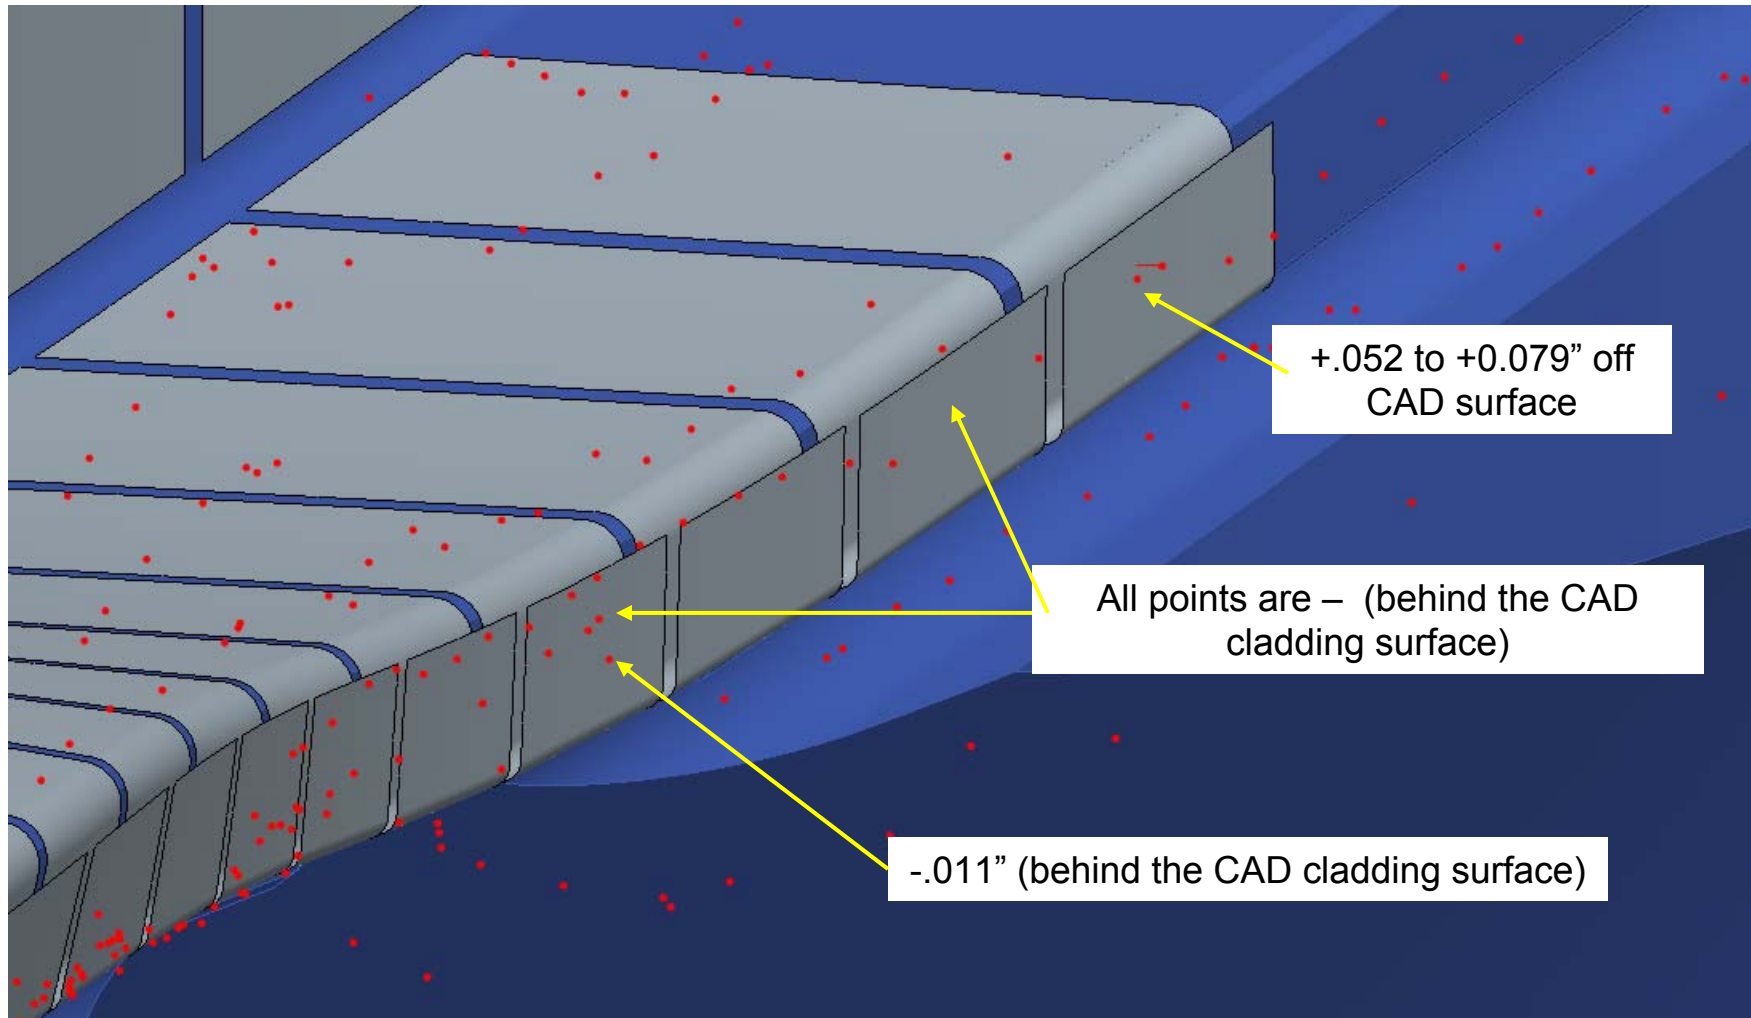
Recently scanned B1 points are shown in red shown with the CAD model of the C cladding.

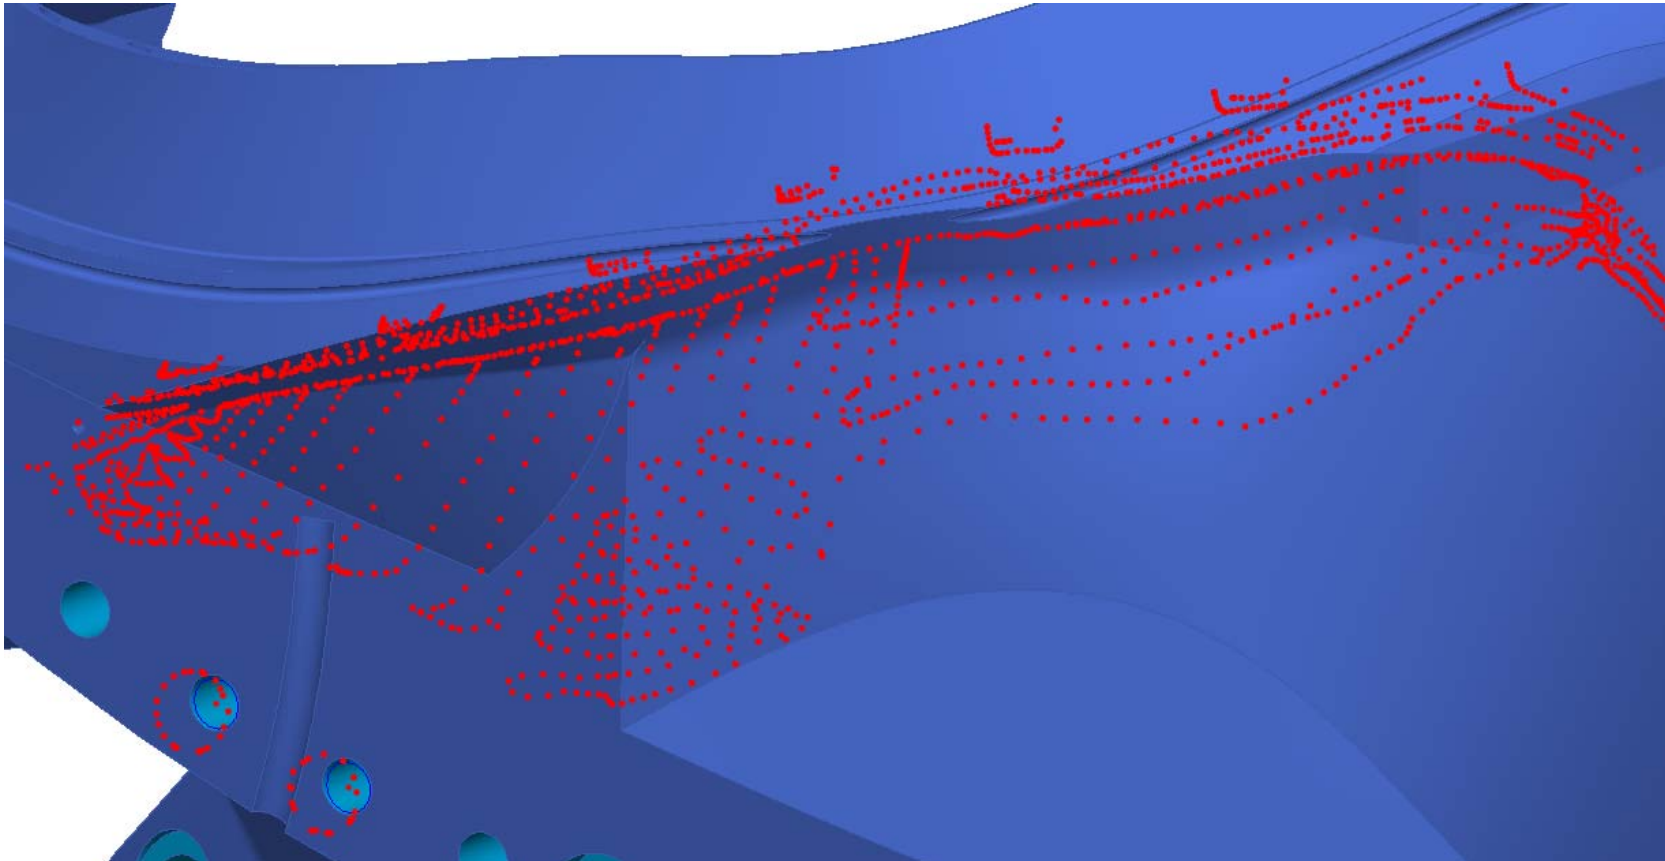
The recent C1 scanned points are shown as red points off the CAD model of the "B" MC.

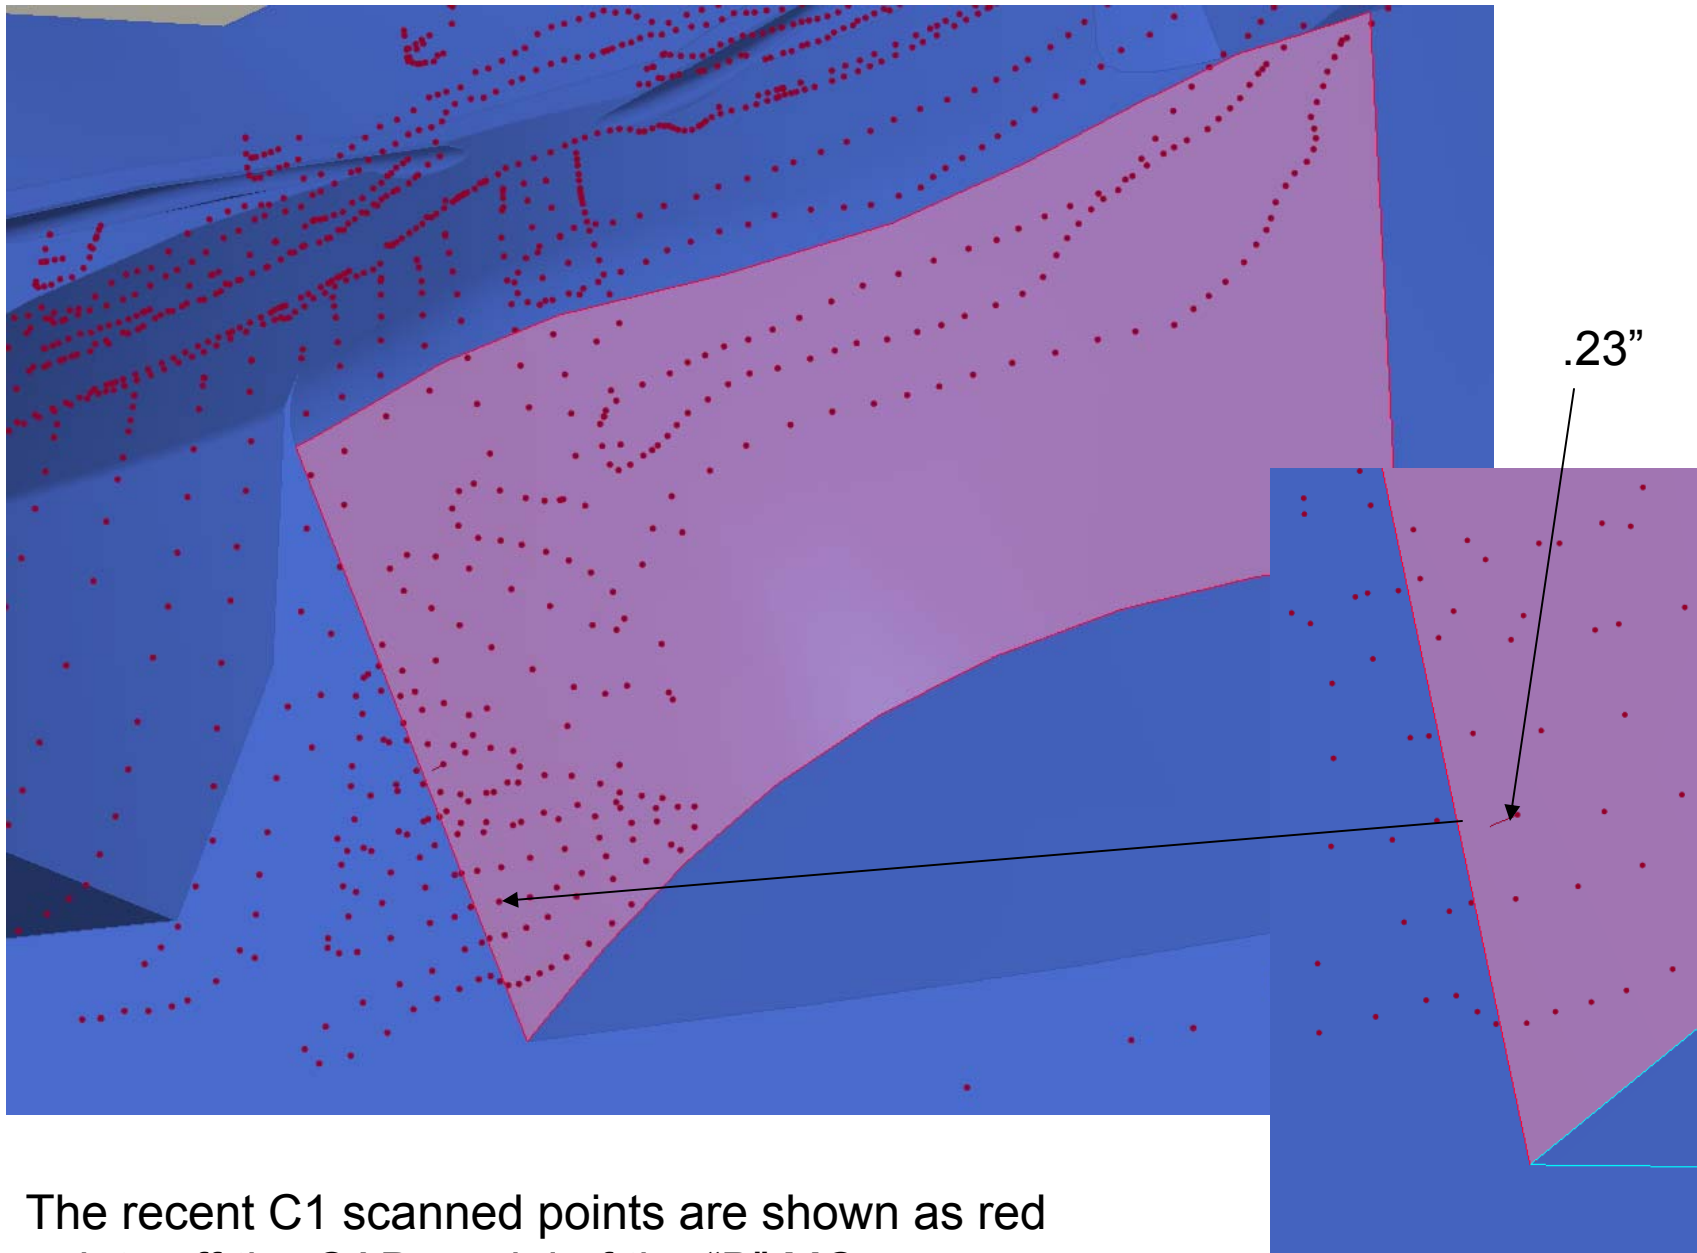
The recent C1 scanned points are shown as red points off the CAD model of the “B” MC.

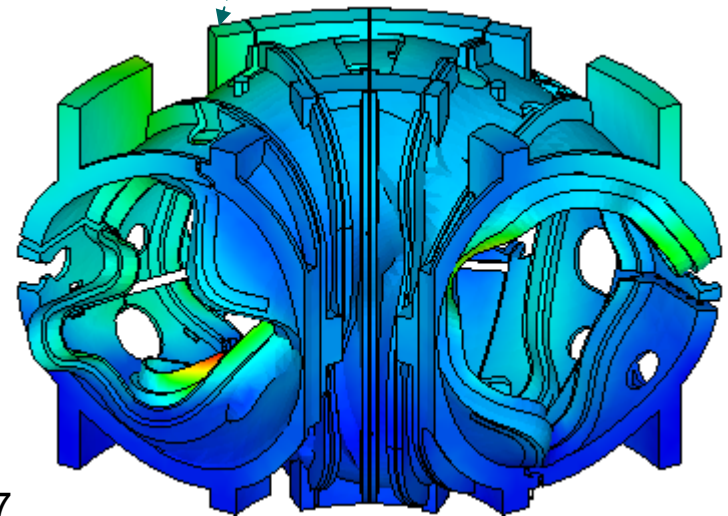
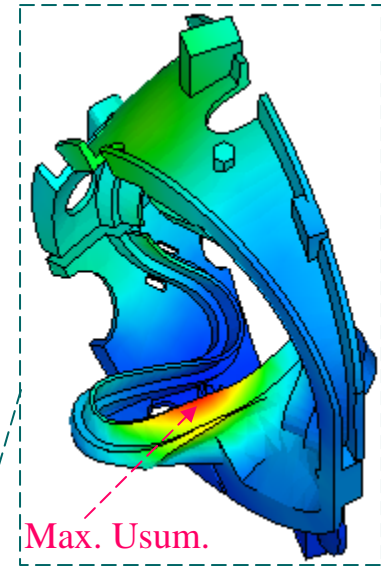
- The maximum displacement, 2.336 mm, occurs on tee in shell type B due to lateral deformation of web caused by the lateral force of the modular coil.
- Because of net vertical forces are equal and opposite with respect to the mid-span, the deformation at bottom of the mid-span is small.
- The smaller deformation at the inboard than the outboard is the result of higher shell stiffness in the inboard.
- The unit of the displacement is in meter

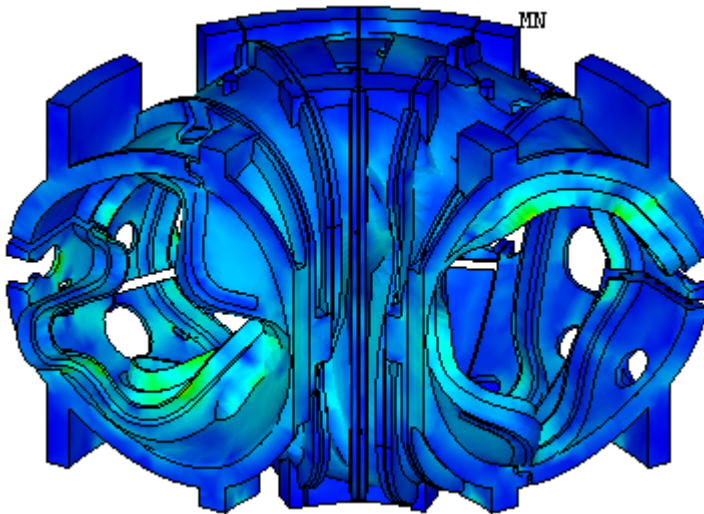
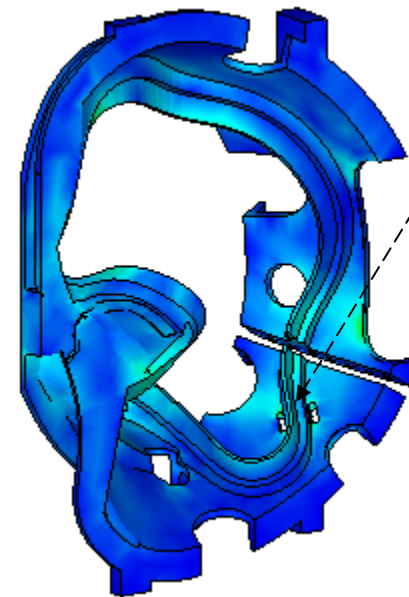
- The maximum local von Mises stress, Seqv, occurs at the corner of lead opening in shell type B.
- The model was built without chamfers at the lead openings. With chamfer, the local stress will be greatly reduced.
- The next slides will display some high stress areas
