Part: SE141-114 / MODULAR COIL WINDING FORM TYPE

Drawing ID: SE141-101
W/O Links: 1-Type:W: 65709/5.0 Sub: 0

Problem: Visual review of A5 identified several tool marks on T section and other miscellaneous items. See attachment for details.

NC21265 – A5 Visual Review

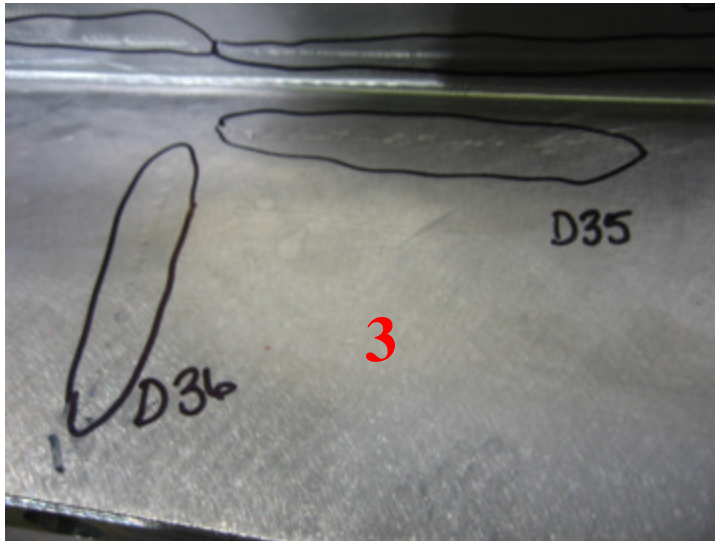
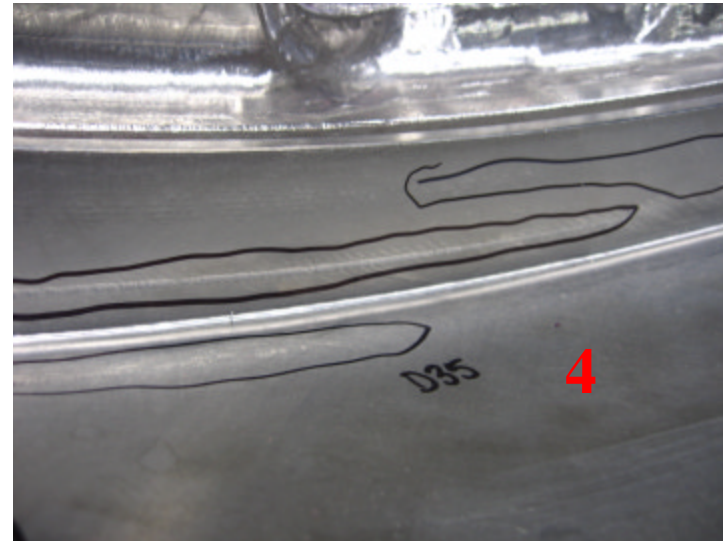
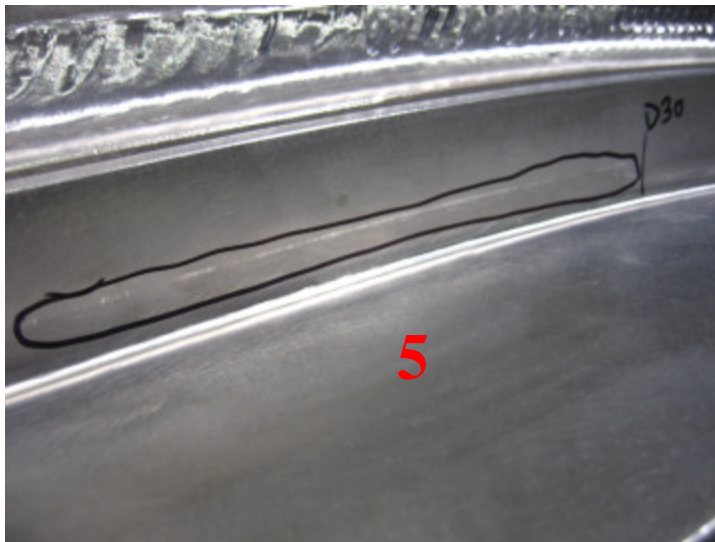
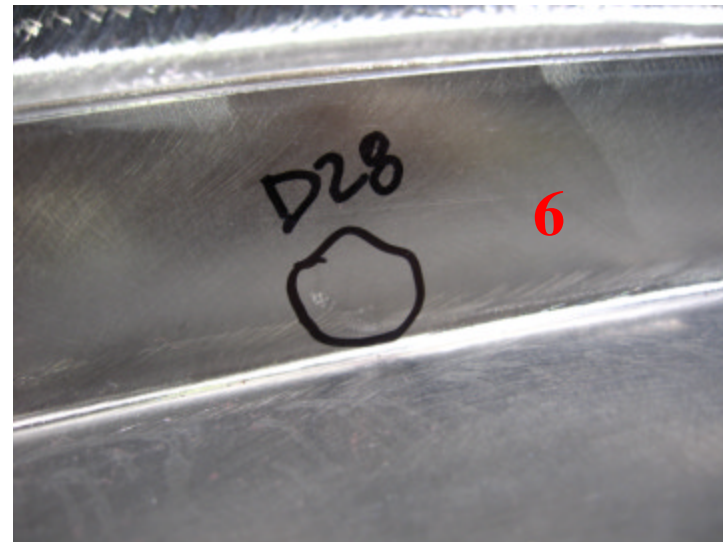
The attached list was reviewed during a conference call attended by J. Chrzanowski, L. Sutton, F. Malinowski, L. Dudek, D. Williamson, T. Brown, and P. Heitzenroeder on 2/28/07. The surface defects are shallow (<0.010") and therefore are not an issue. During the call it was noted that the lead pad offset caused by a less than optimal choice of initial casting best fit location brought the pad uncomfortably close to the lead slots; MTM resolved this by grinding a 0.5" chamfer immediately (see attachment). The break-out of some of the bolt threads were also discussed, but there is adequate thread engagement beyond this so it is accepted as is.

There are several shallow tool marks ($<.010''$) on the datum D side between T holes 28 and 40.

These are shown on slides 1 and 2.

MTM Proposes to accept deviations as-is.
