NCSX

Modular Coil Shim Testing

NCSX-CALC-14-003-00

25 Feb 2008

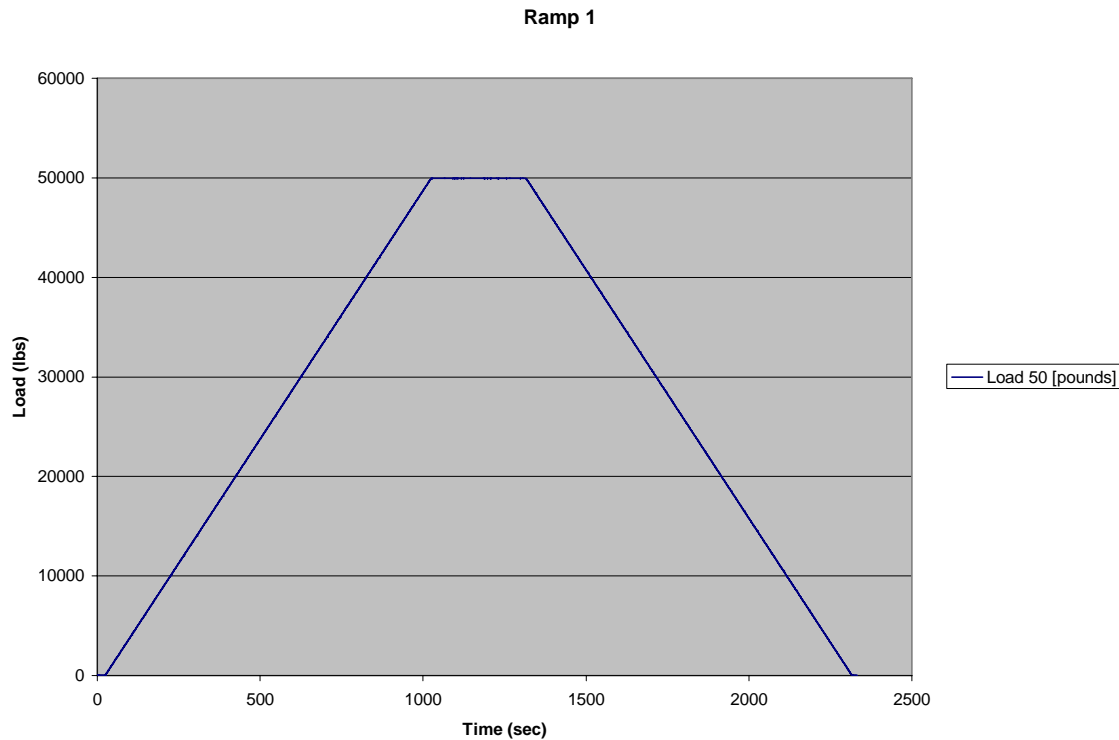
Figure 4 Ramp loading of unit.

The loading to 50,000 lbs proceeded without incident and indicated no slippage in the shims. The second cycle was identical to the first. See **Figure 4 and 5** for the load curves.

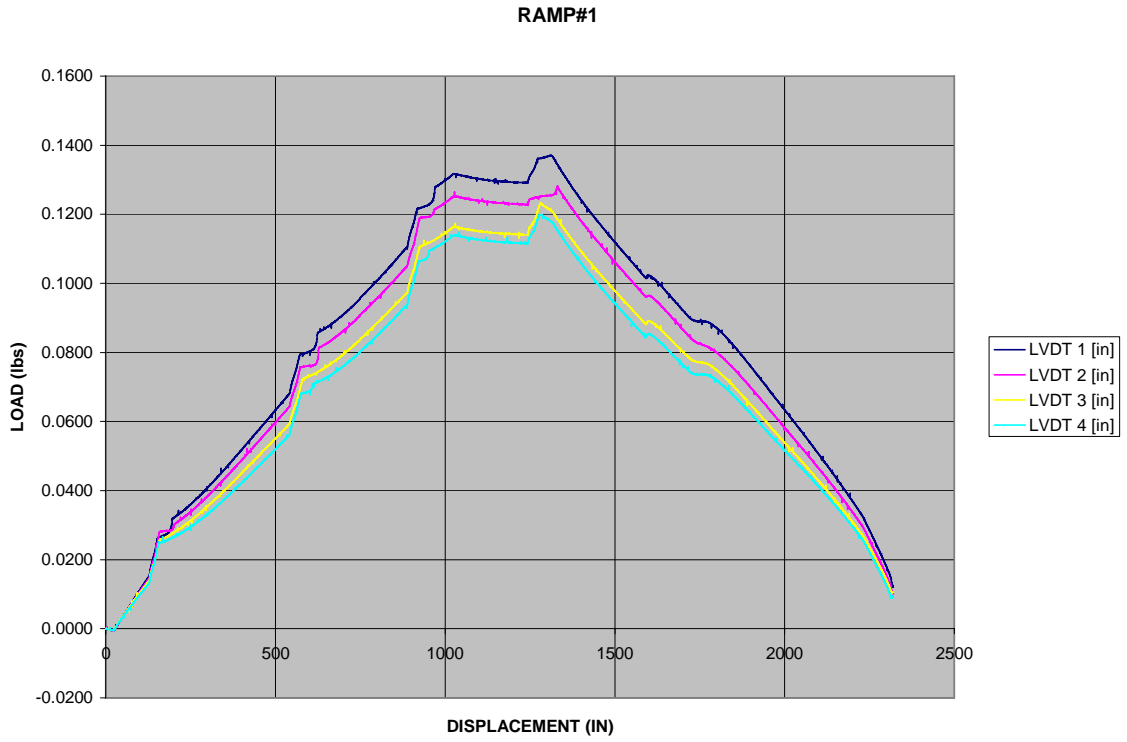
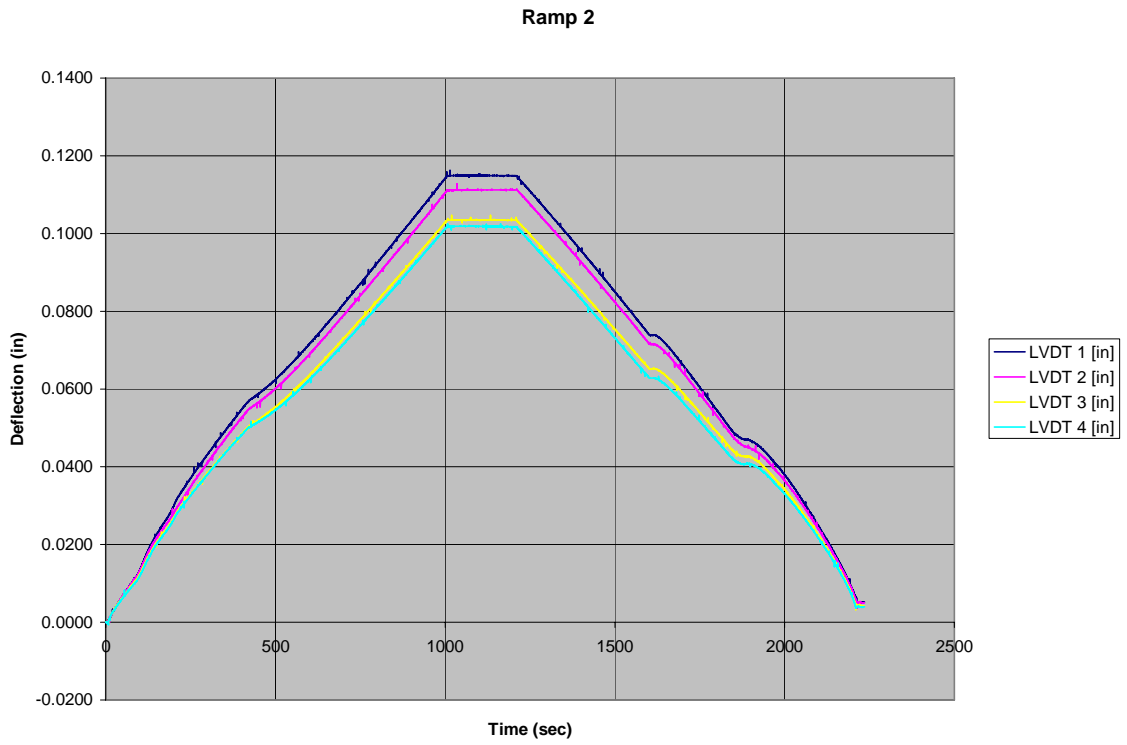
Figure 5 LVDT deflections during ramp testing.

The LVDT readouts tracked with each other and confirmed that there was no relative motion between the assembly yokes. At times the LVDT readouts became highly nonlinear but this was shown to coincide with the LN2 supply valve opening, resulting in increased nitrogen flow around the probe G10 extension rods and sudden contraction in

their length. This problem could be minimized by exchanging the rods with a lower expansion coefficient material. The effect was partially mitigated in the second ramp test by permitting a constant flow of cryogenic gas to flow through the system, decreasing the rod temperature transients.

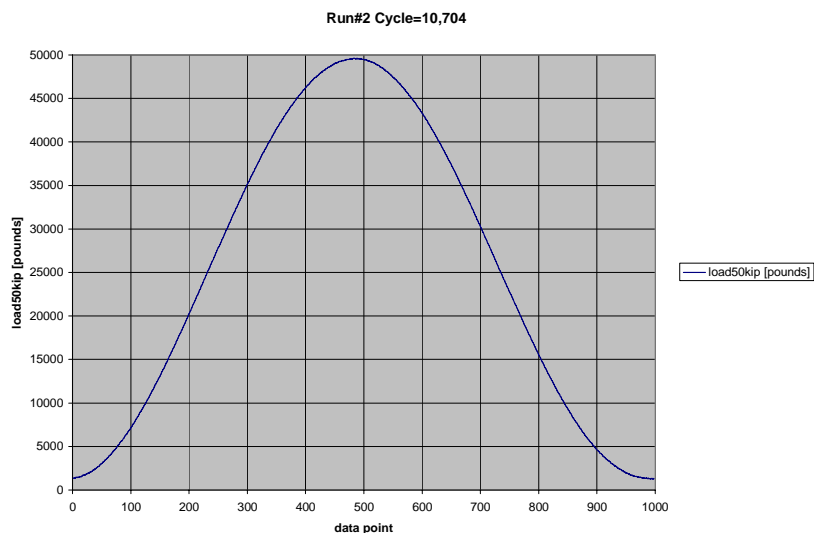
Figure 6. Typical cycle showing load train readout.

The testing proceeded at 4 HZ, with no slippage for 60,000 cycles, at which time the testing was halted and the unit was brought back up to room temperature. The LVDT readouts successfully tracked with the cycling. See **Figures 6 and 7** for the load curves.
