# NCSX

## Modular Coil Shim Testing

NCSX-CALC-14-004-00

25 Feb 2008

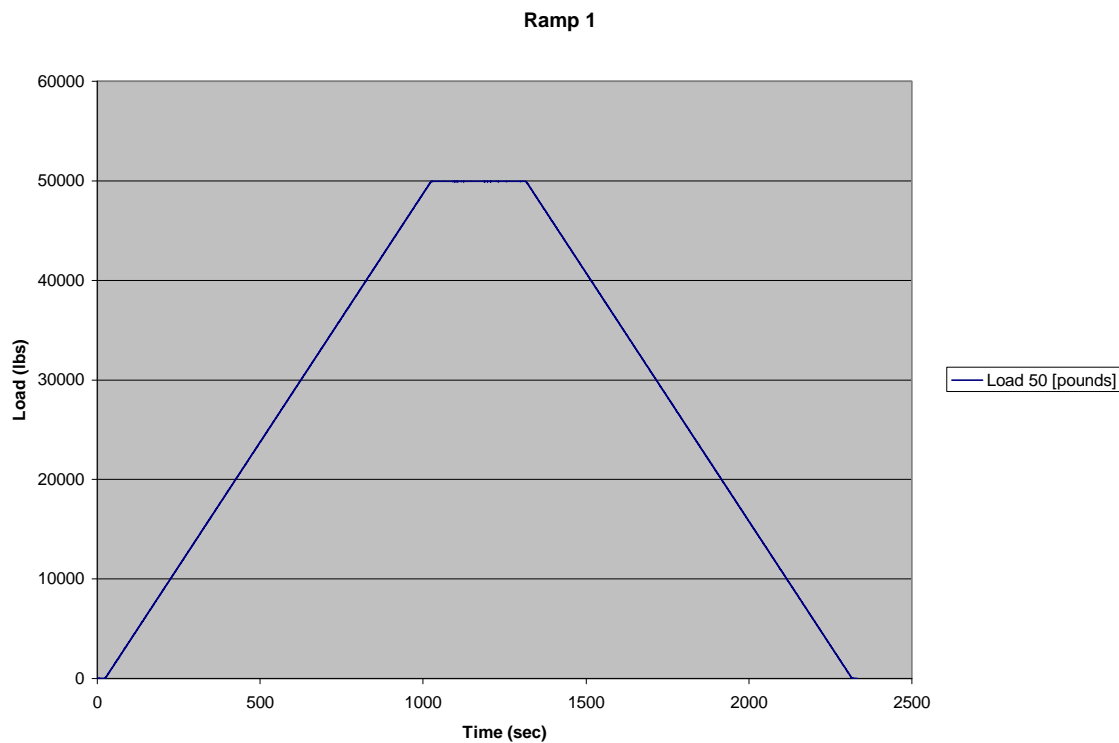
The loading to 50,000 lbs proceeded without incident and indicated no slippage in the shims. The second cycle was identical to the first. See **Figure 4 and 5** for the load curves.

**Figure 4** Ramp loading of unit.

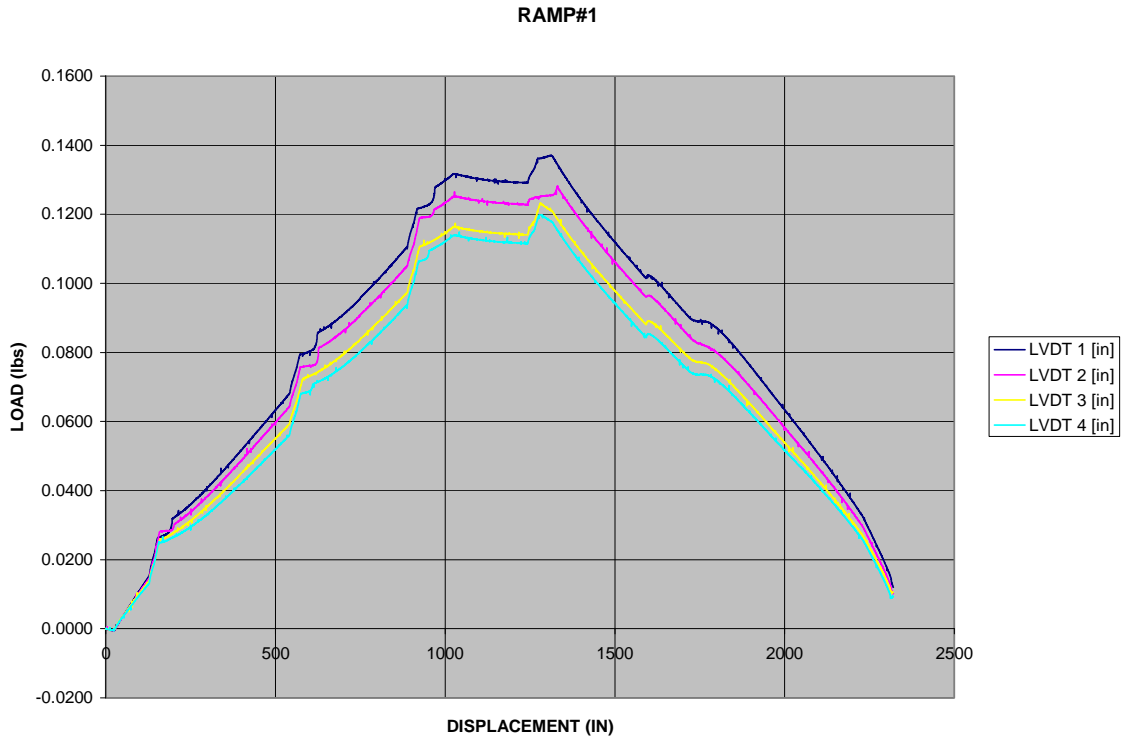
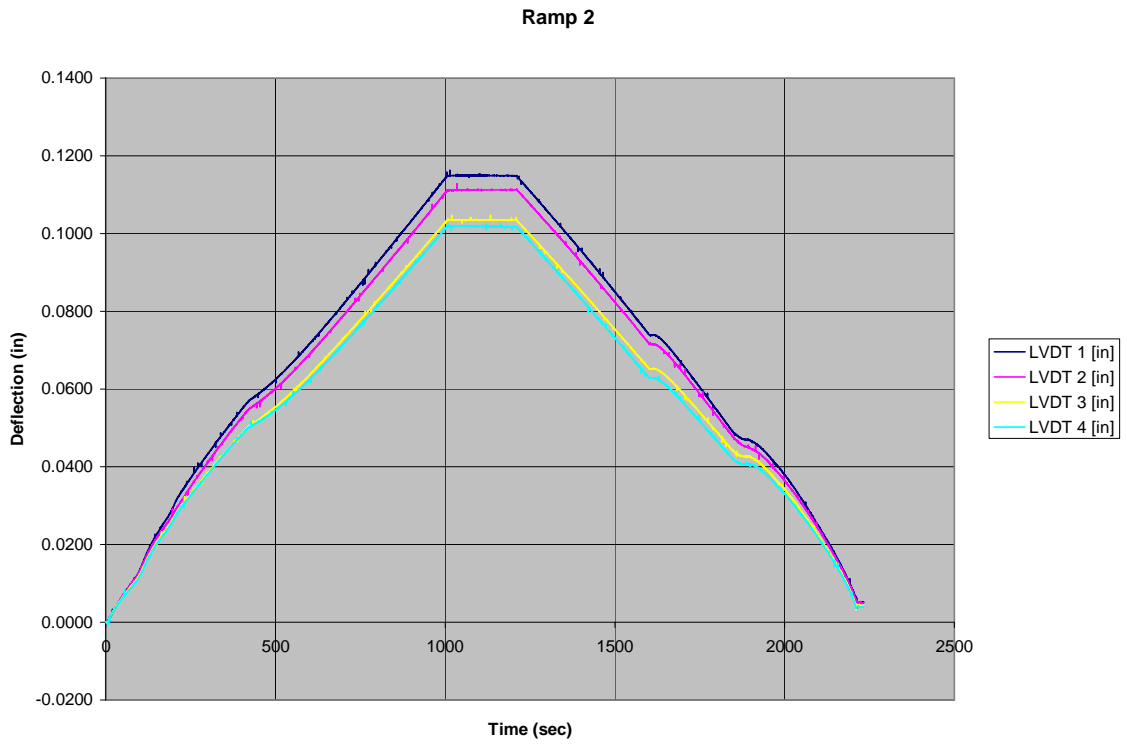
The LVDT readouts tracked with each other and confirmed that there was no relative motion between the assembly yokes. At times the LVDT readouts became highly nonlinear but this was shown to coincide with the LN2 supply valve opening, resulting in increased nitrogen flow around the probe G10 extension rods and sudden contraction in

**Figure 5** LVDT deflections during ramp testing.

their length. This problem could be minimized by exchanging the rods with a lower expansion coefficient material. The effect was partially mitigated in the second ramp test by permitting a constant flow of cryogenic gas to flow through the system, decreasing the rod temperature transients.

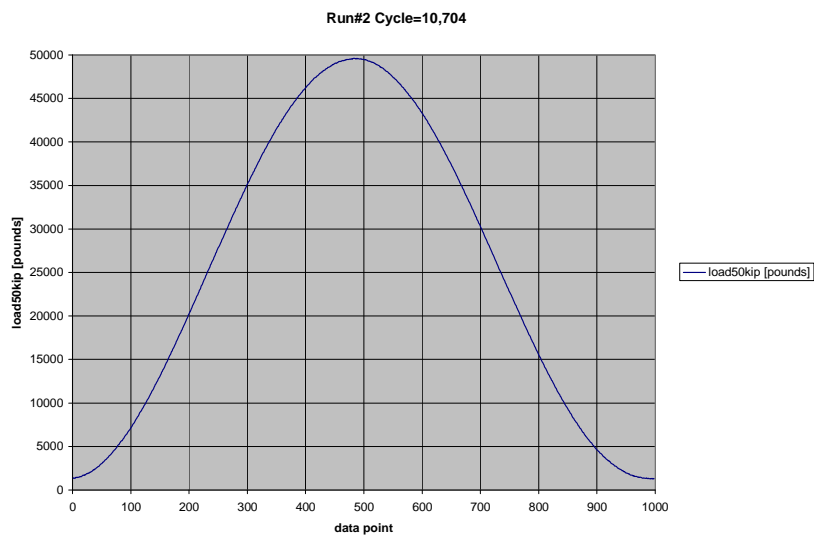
The testing proceeded at 4 HZ, with no slippage for 60,000 cycles, at which time the testing was halted and the unit was brought back up to room temperature. The LVDT readouts successfully tracked with the cycling. See **Figures 6 and 7** for the load curves.

**Figure 6.** Typical cycle showing load train readout.

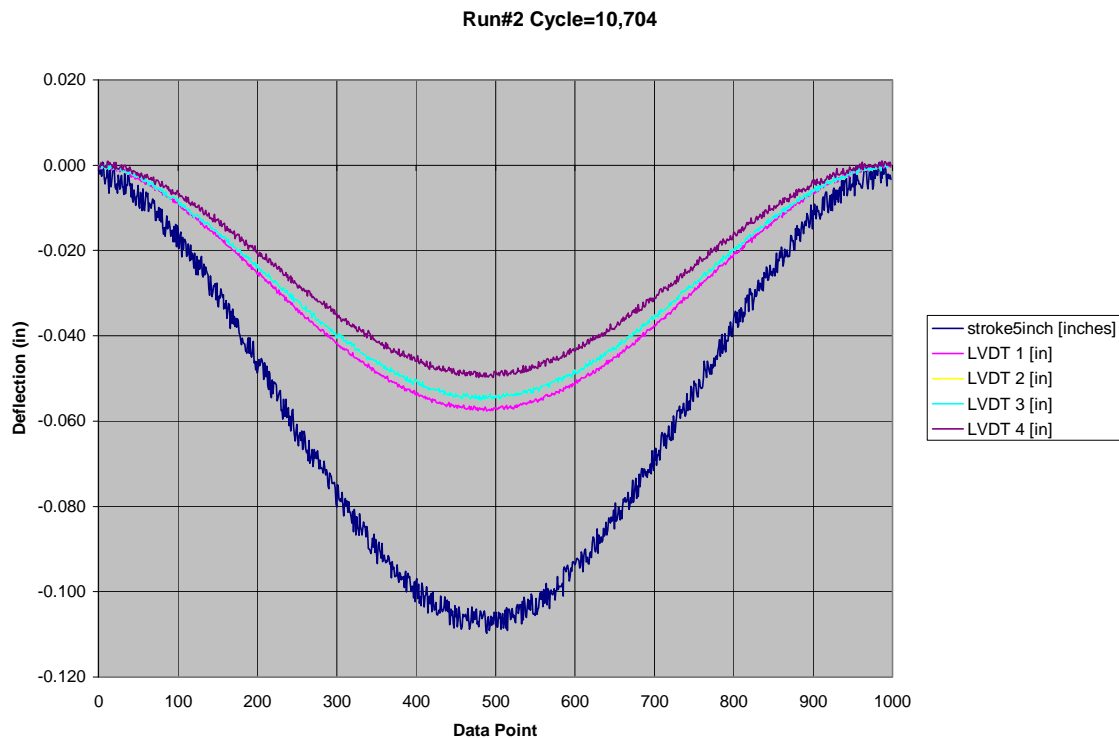
**Figure 7.** Typical LVDT readout during cycling run. Bottom trace is global motion of load train.
