NCSX

Modular Coil Shim Testing

NCSX-CALC-14-004-01

18 Aug 2008

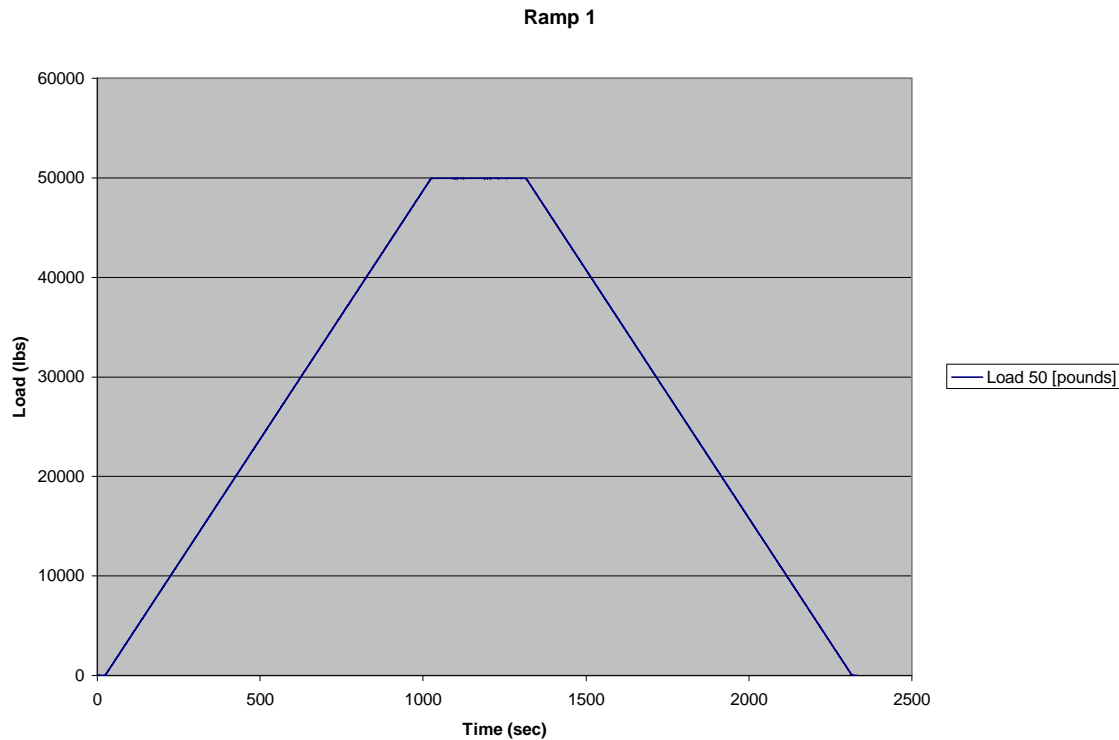
Figure 4 Ramp loading of unit.

The loading to 50,000 lbs proceeded without incident and indicated no slippage in the shims. The second cycle was identical to the first. See **Figure 4 and 5** for the load curves.

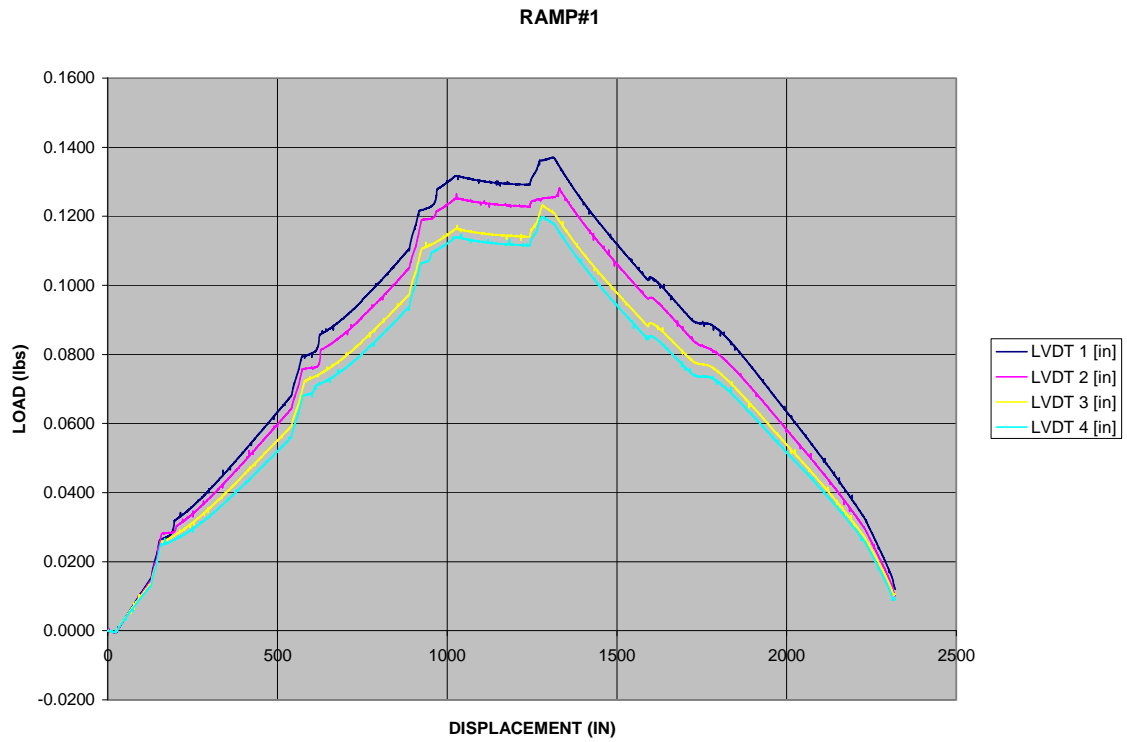
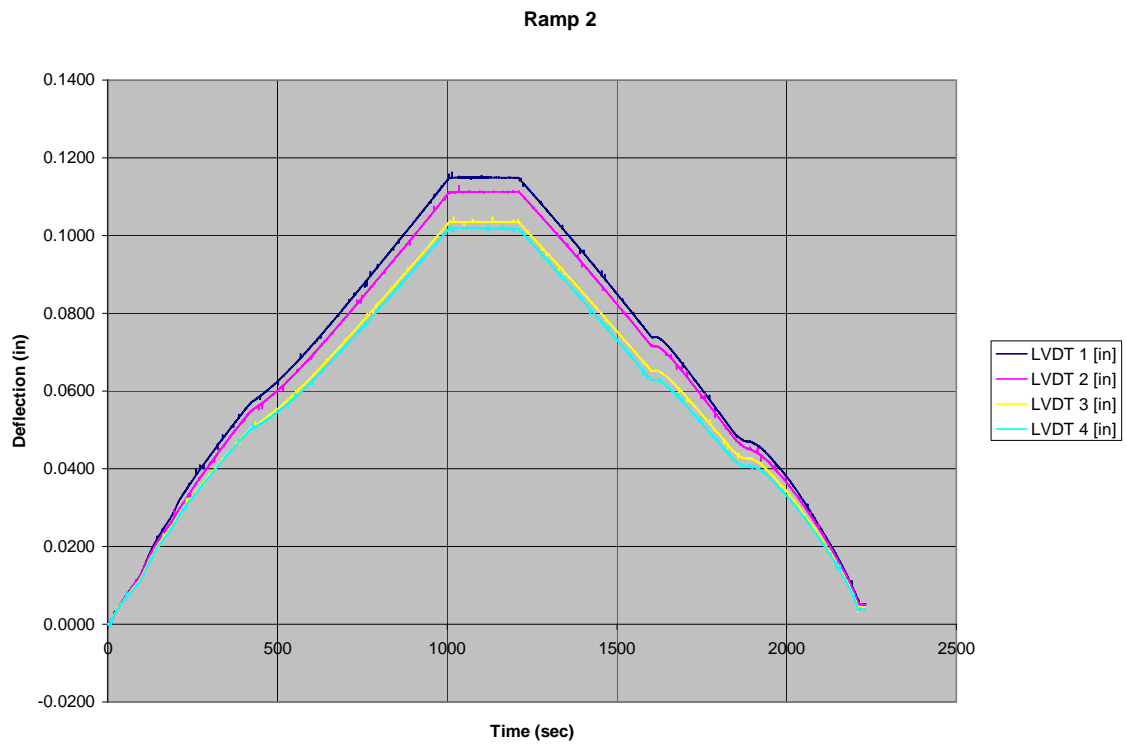
Figure 5 LVDT deflections during ramp testing.

The LVDT readouts tracked with each other and confirmed that there was no relative motion between the assembly yokes. At times the LVDT readouts became highly nonlinear but this was shown to coincide with the LN2 supply valve opening, resulting in increased nitrogen flow around the probe G10 extension rods and sudden contraction in

their length. This problem could be minimized by exchanging the rods with a lower expansion coefficient material. The effect was partially mitigated in the second ramp test by permitting a constant flow of cryogenic gas to flow through the system, decreasing the rod temperature transients.

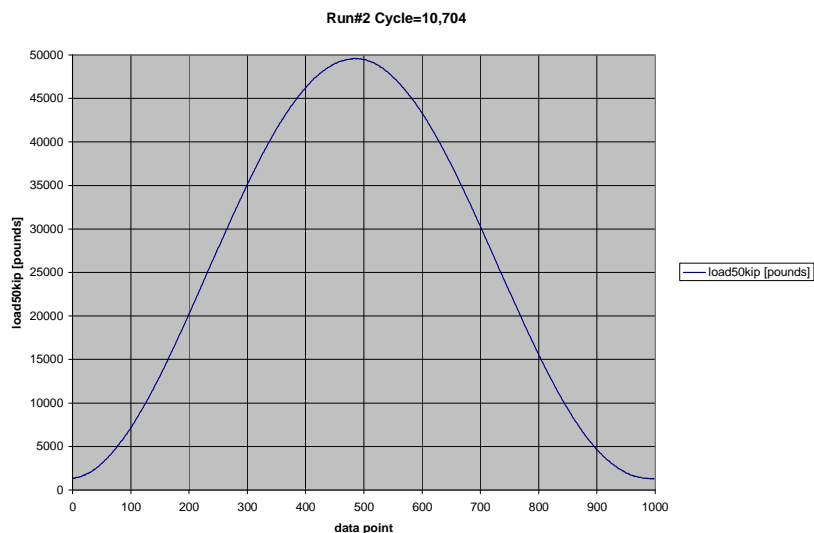
Figure 6. Typical cycle showing load train readout.

The testing proceeded at 4 HZ, with no slippage for 60,000 cycles, at which time the testing was halted and the unit was brought back up to room temperature. The LVDT readouts successfully tracked with the cycling. See **Figures 6 and 7** for the load curves.

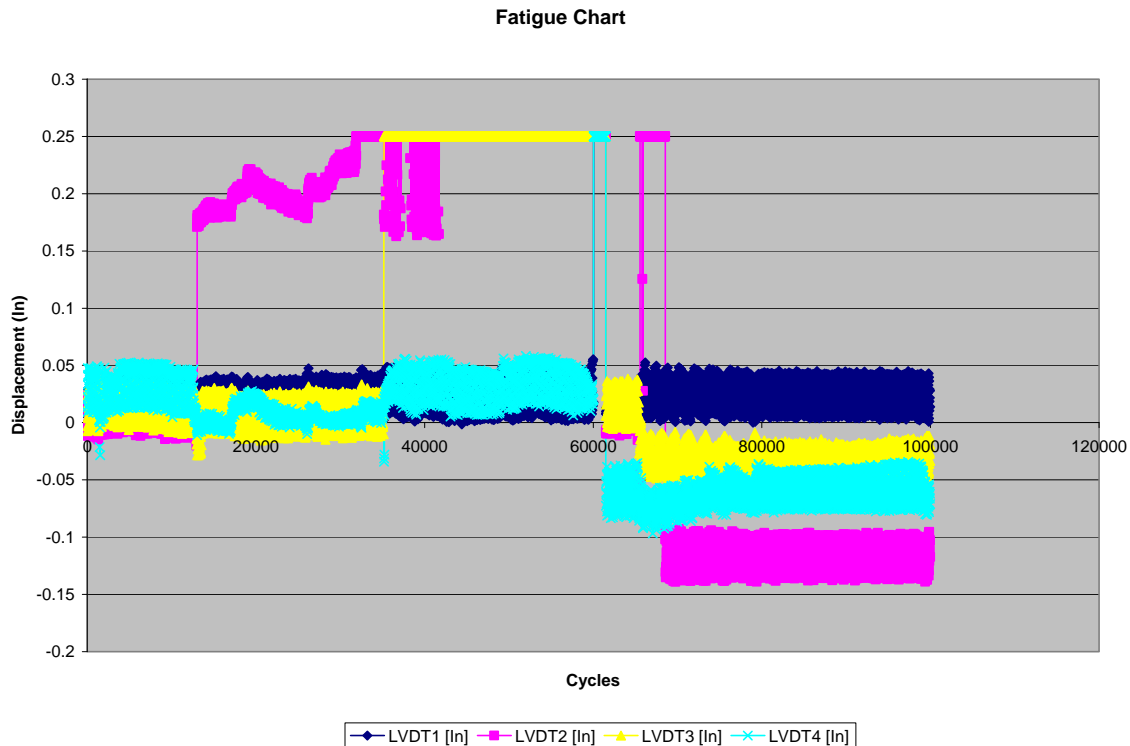
Figure 10. Fatigue Chart

The LVDT readouts (fatigue test) tracked with each other and confirmed that there was no relative motion between the assembly yokes. Figure 10 shows the displacement for all 4 LVDT's for 0 thru 100,000 cycles. The interruptions shown were the result of the breakage of the threaded adapter. The test fixture had to be brought back up to room temperature to make the repairs and then re-cooled to resume the test.

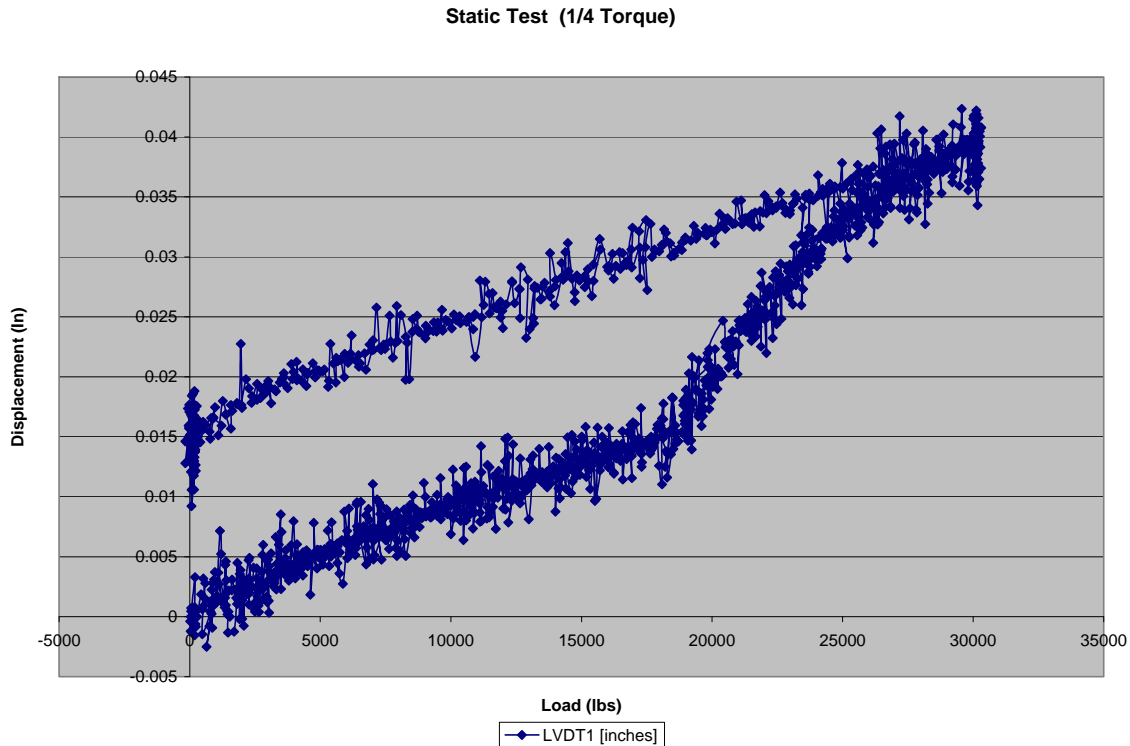
Figure 11. Static Test

The jack screws were loosened and the yoke assembly was compressed to allow slippage at a lower tensile load. The jack screws were torqued to 9 ft-lbs and the static test was re-ran. This data shows definite slippage at a load of 19,000 lbs (see Figure 11). The coefficient of friction is 0.44 with an uncertainty of $\sim \pm 0.9$. A possible reason for the more dramatic result on this test is that the g-10 had already been scuffed a bit on the first slippage test. The scuffed surfaces are more likely to exhibit "alumina like" behavior due to the increased roughness of the g-10 surfaces. The same distinct audible creaking noises were heard when this sample began slipping.

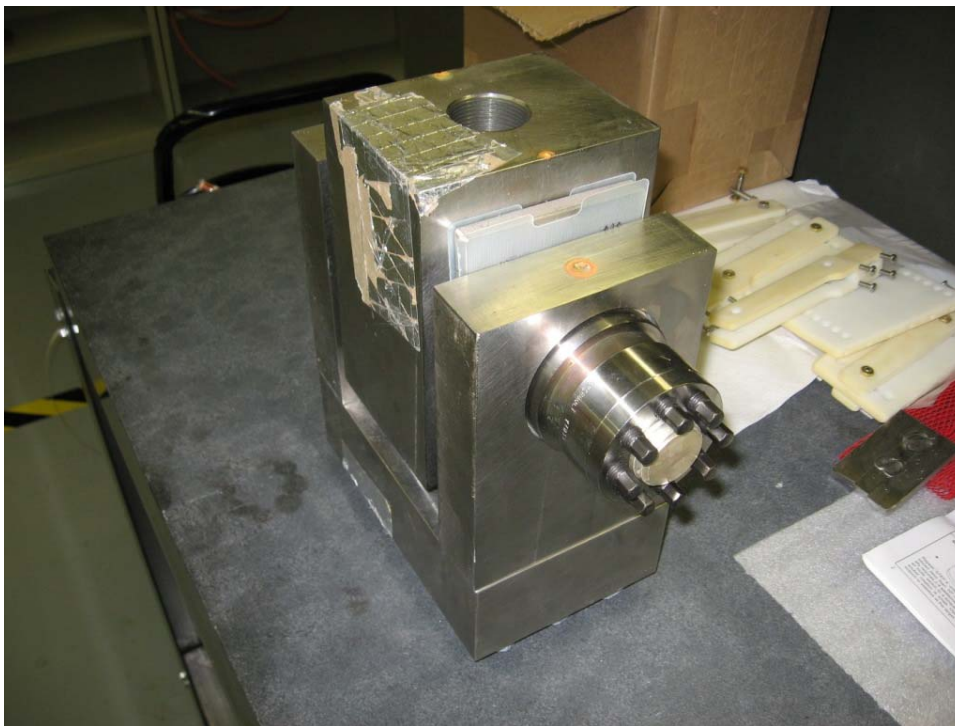
Yoke Assembly after testing

The assembly was allowed to return to room temperature and disassembled. Visual inspection of the g-10 material showed only a slight "scuffing" of the surface (see pictures). There was no cracking or breakage of the g-10 material and there was no visible g-10 residue on the stainless steel surfaces as there had been with the alumina shims.
