NC21265 – A5 Visual Review

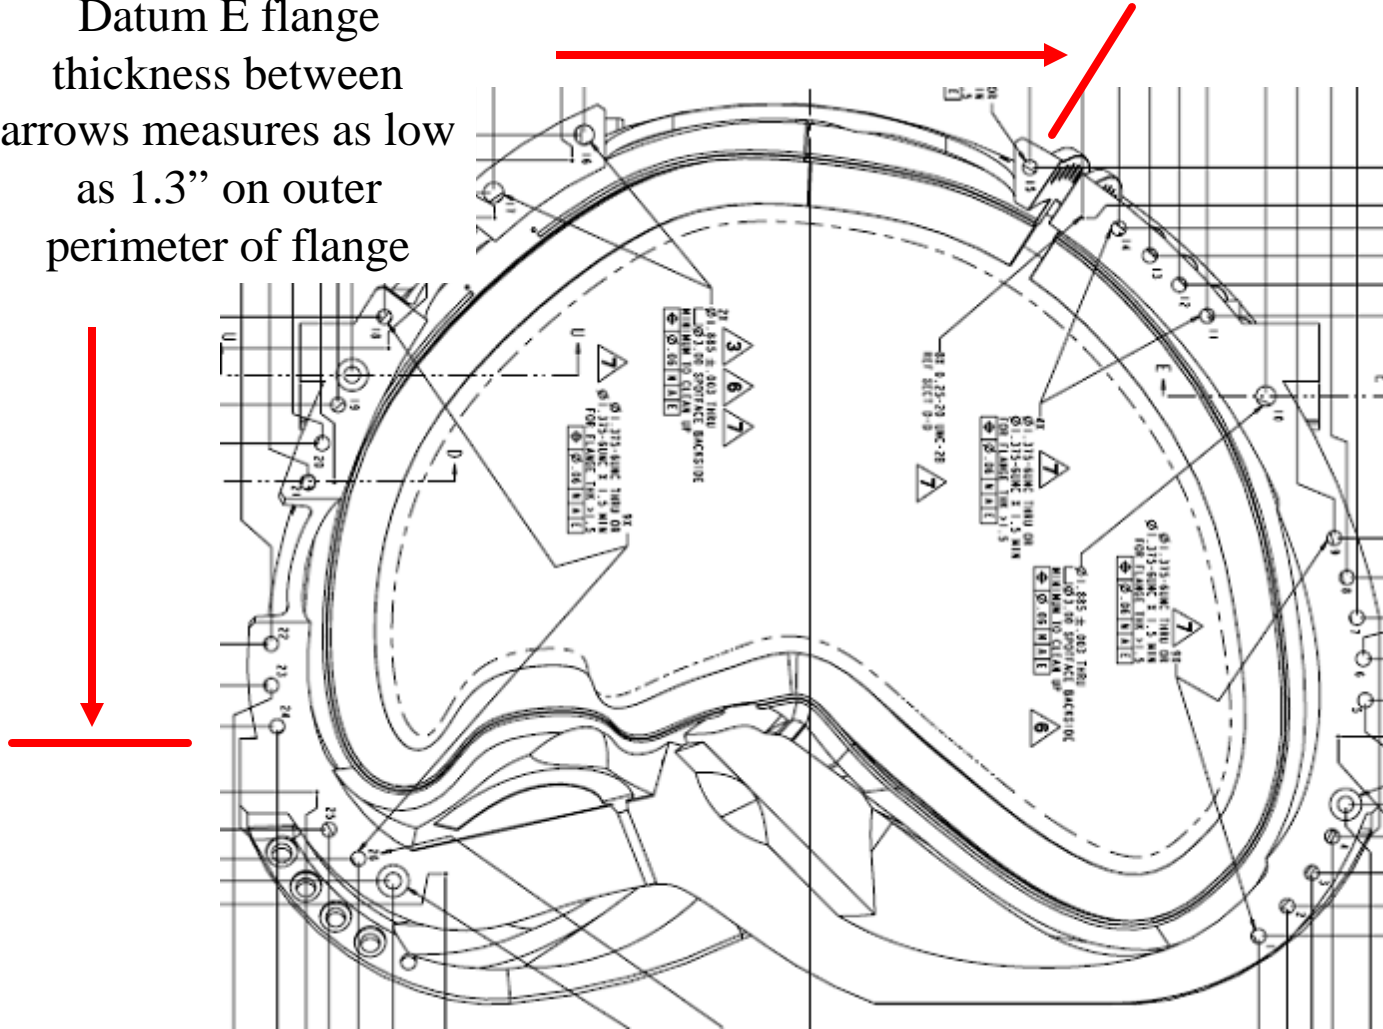
Datum E flange thickness between arrows measures as low as 1.3” on outer perimeter of flange

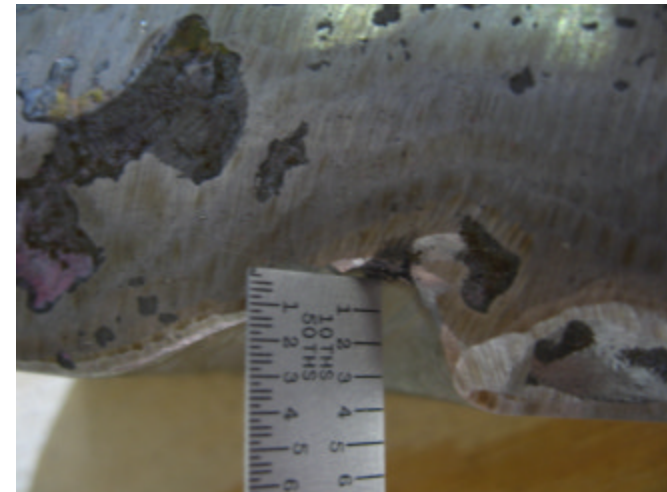
Picture to the left is of the 3" counterbore in the datum E flange as reported on NC21252 step 810. Area shows heavy stock around hole (too much to grind).
