NCSX Vacuum Vessel Fabrication

Major Tool and Machine – S005243-F

November Lehman Review

May 9, 2006

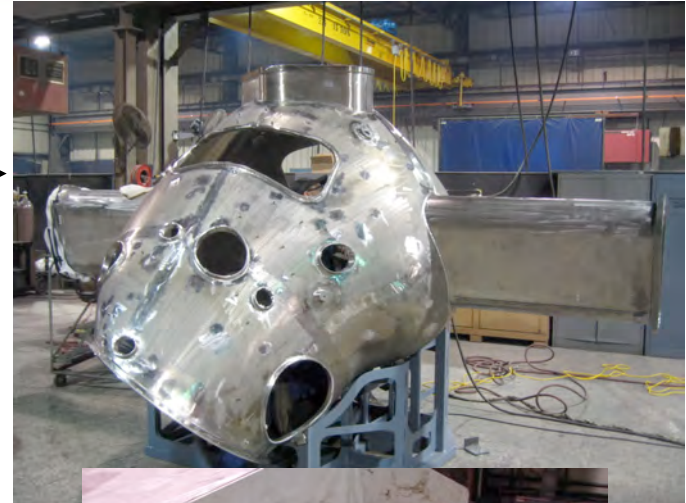
- ✓ VVSA #1 – Nearly Complete! →
 - Passed QC examination
 - Final scan in progress
 - Data package being collated for review

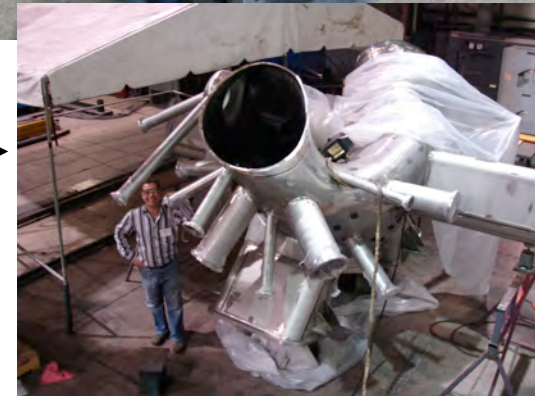
- VVSA #2 →
 - Ports welded on
 - Leak check imminent
 - Ports to be cut off and weld prepped
 - Learned from VVSA #1 extra time needed to properly trim & weld prep

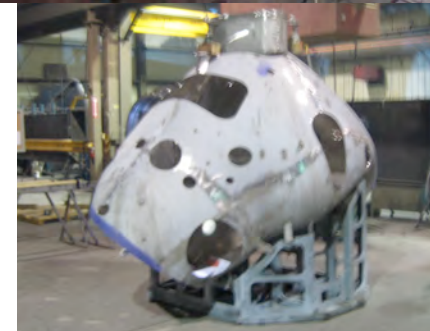
- VVSA #3 →
 - Ports being welded on.

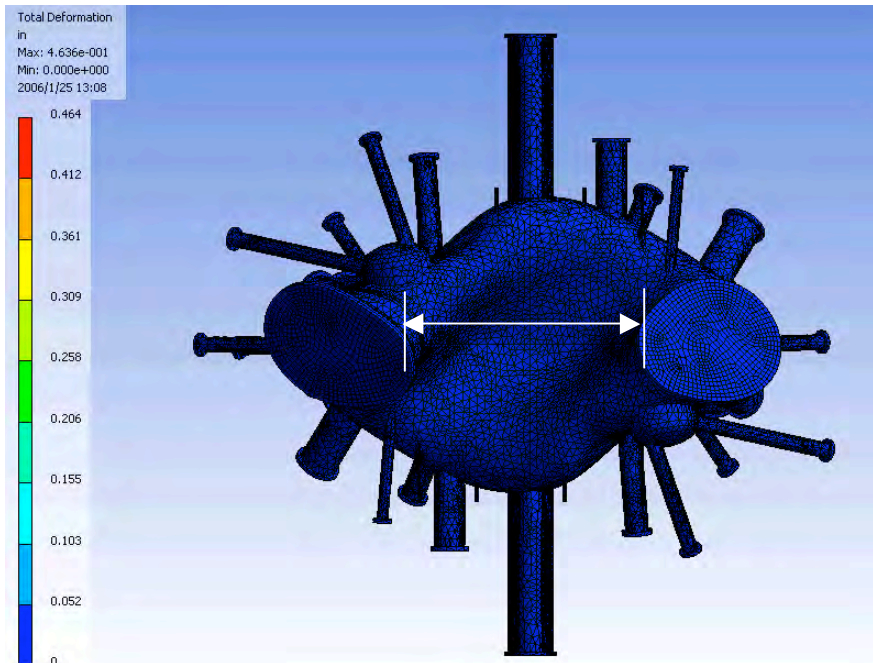
Leak check successful, deflect. confirms analysis

- No leaks detected, $P < 1e-7$ torr
- Distance between points on end flanges measured during leak test
- Deflection matches calculation (points move closer together by .35 inches)

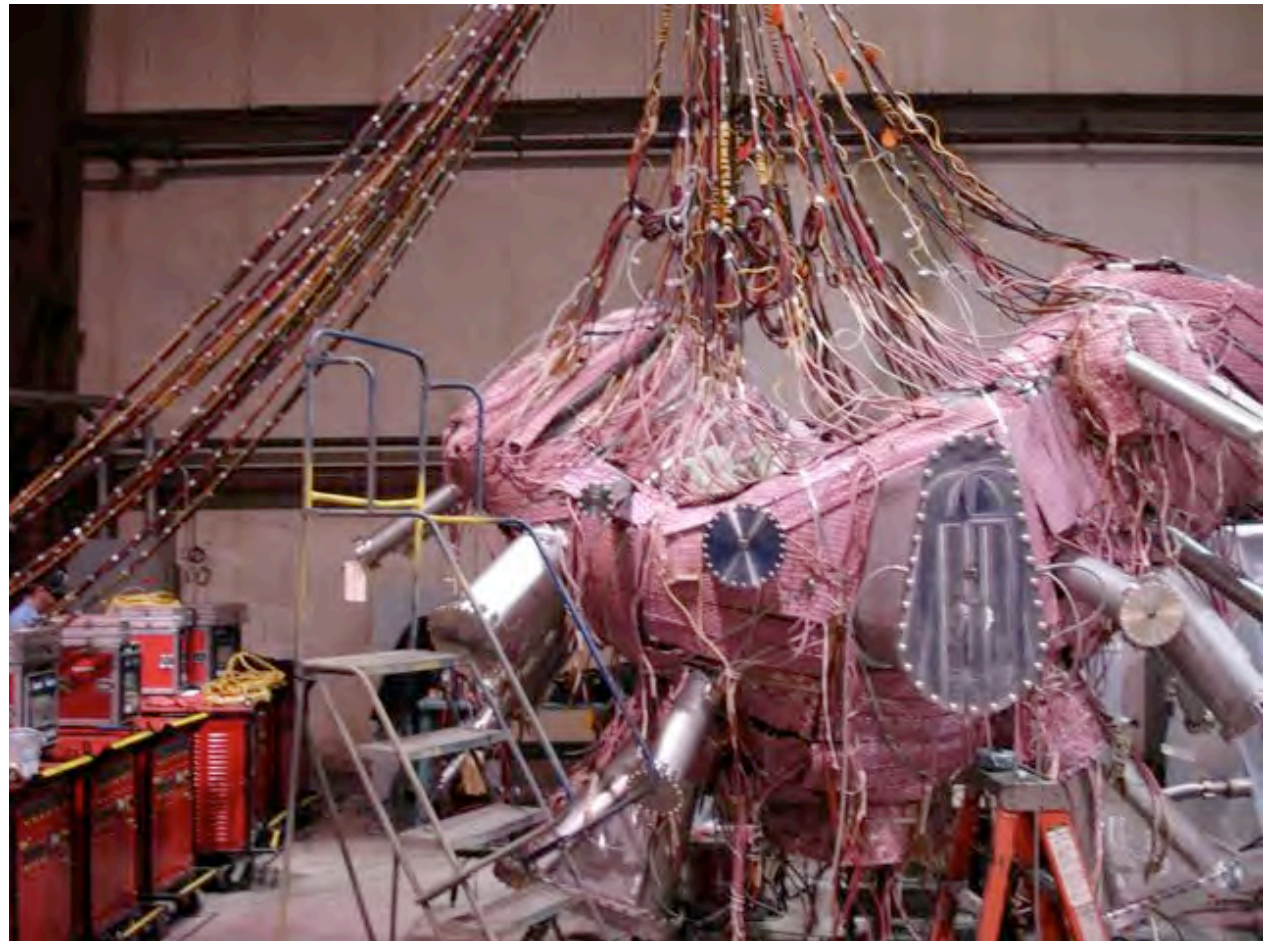
Thermal cycle qualified first VVSA

- **Thermal cycle completed successfully**
- **Further thermal cycling determined to be unwarranted**

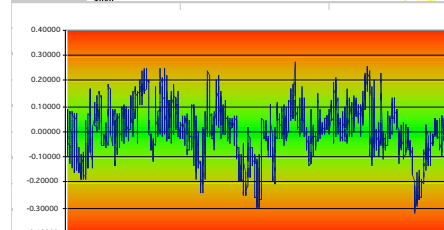
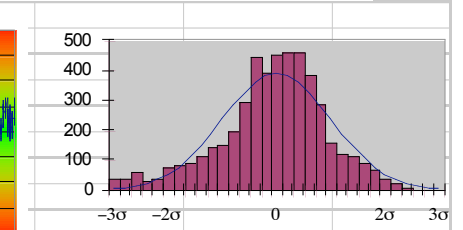
VVSA #2

- 5.7% Out of Tolerance after shell welded.
- 8% Out of Tolerance after holes machined.

- Tolerance conditions are improved over VVSA #1.
- Conditions acceptable.

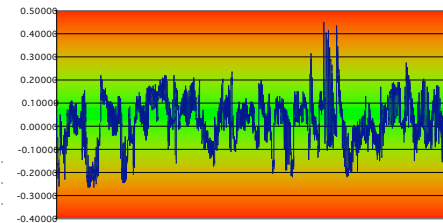
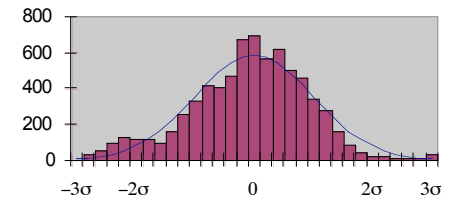
VVSA #3

• <1% Out of Tolerance after shell welded.

• 7% Out of Tolerance after holes machined.

• Conditions acceptable.
