VV support and diagnostic port interference

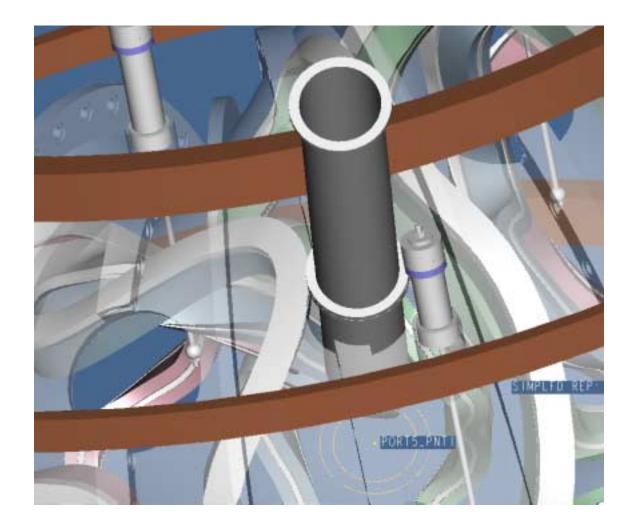
Port location after rotating port

Location Before:

Torordial angle 17 deg Poloidal angle 47 deg

Location after rotation

Torordial angle 18.5 deg Poloidal angle 56 deg

Port dia 10" od before and after

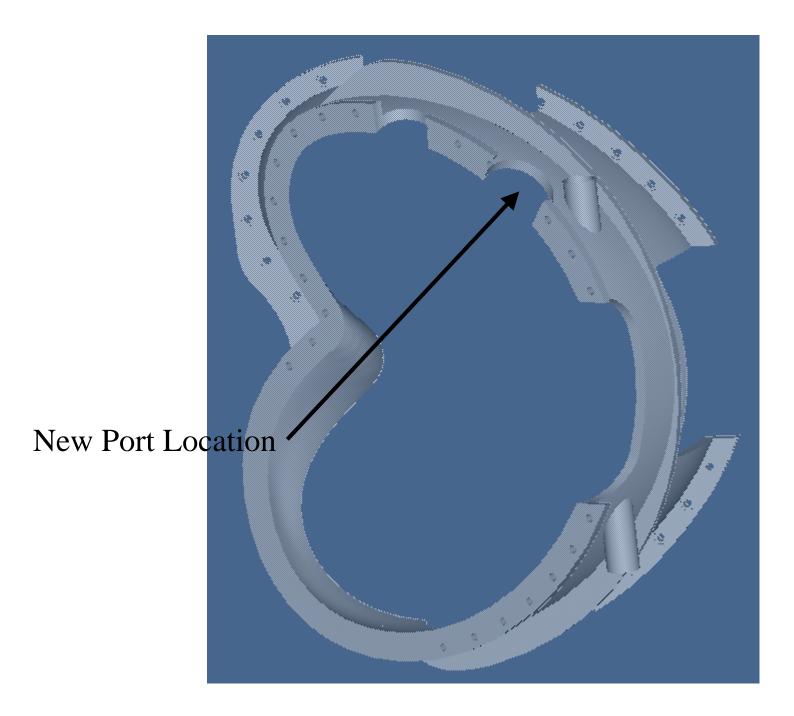
Reduced port dia. From 10" od to 8" od.

While a 10" od may work with additional tweaking reducing the od to 8" seems to assure clearance for now.

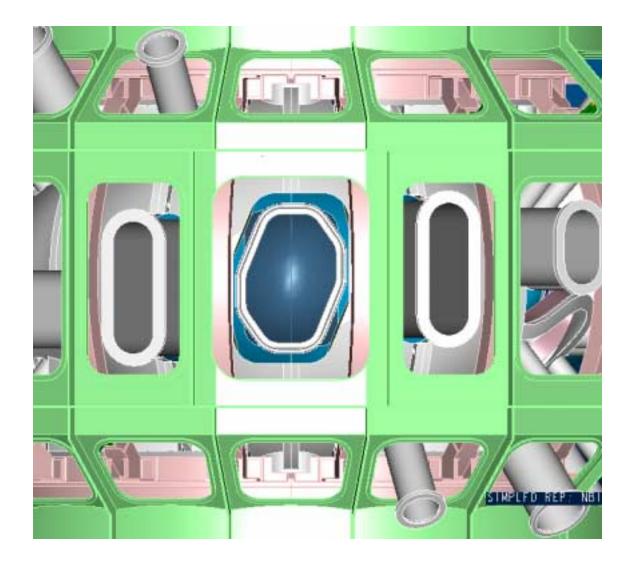
The modular coil shell opening and NBI port were reshaped to eliminate port interference with modular coils.

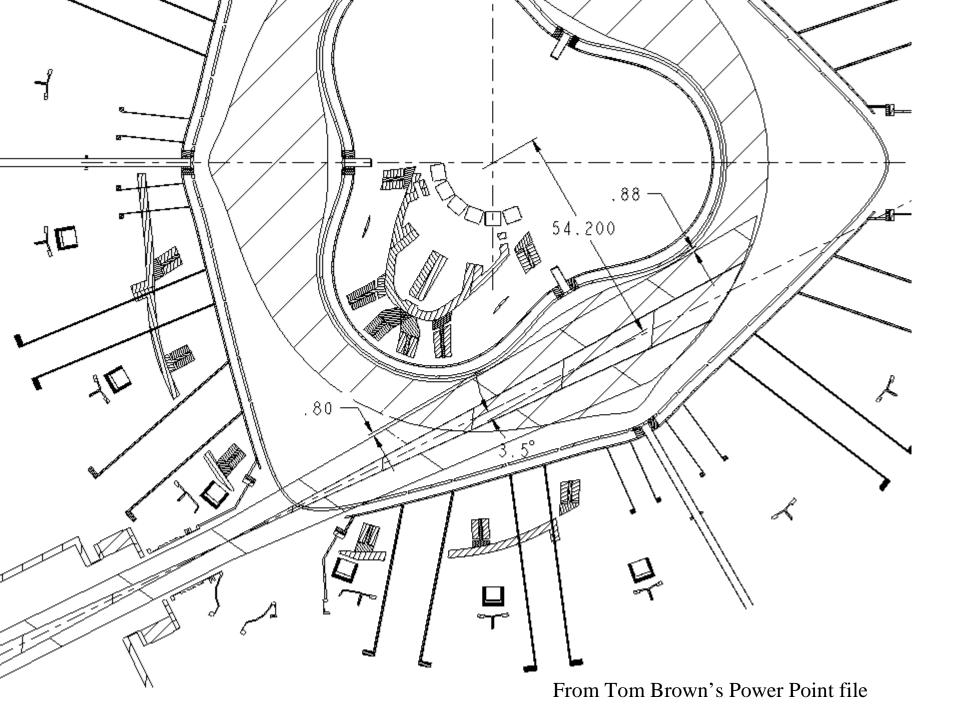
View from the bottom looking up

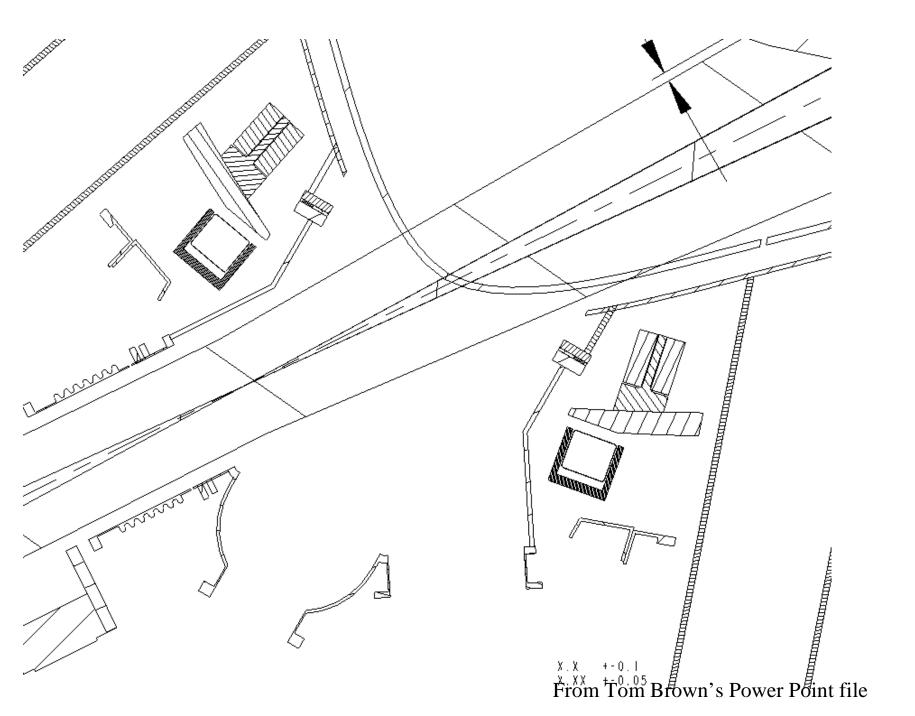
View looking down on the machine
