Trim Coils for Field Error Compensation

Presented by Art Brooks
*for the NCSX Team at
Princeton Plasma Physics Laboratory
Oak Ridge National Laboratory*

NCSX Construction Feasibility Review
October 31, 2007

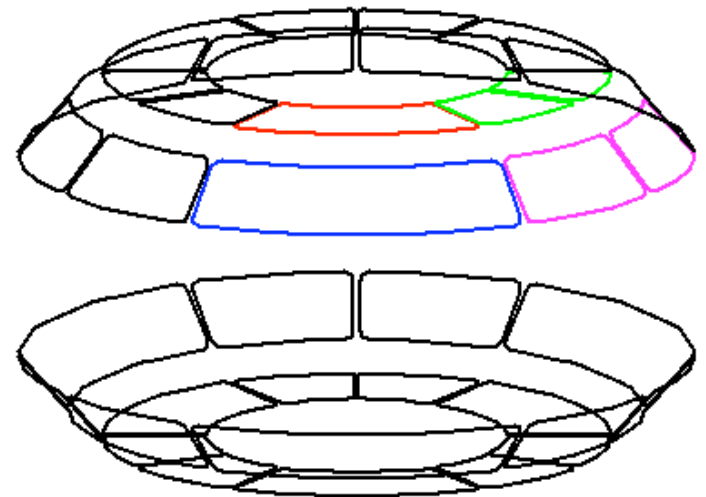
Concept Design – Trim Coil Configuration

36 Total Coils
Grouped into 24 circuits
Coils Spanning Period
Boundary Split for
Assembly

Stellarator Symmetry Maintained in Coil Geometry

but Coils can be Driven Asymmetrically

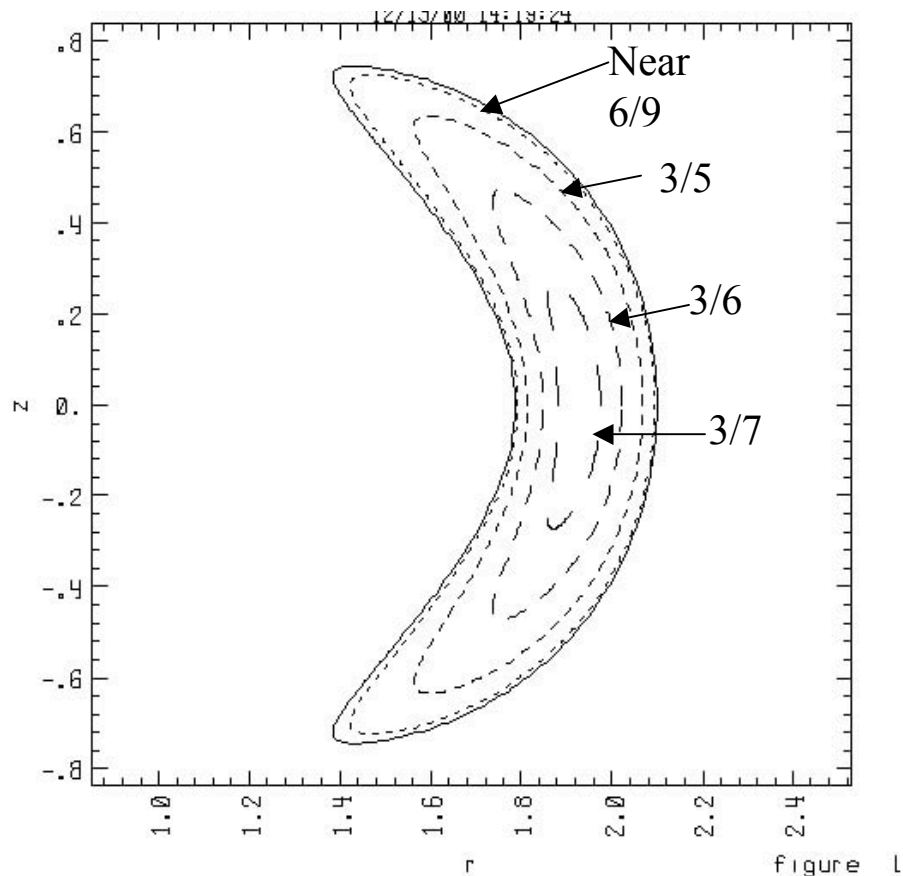
Targeted Resonances in Reference Plasma

Figure 1

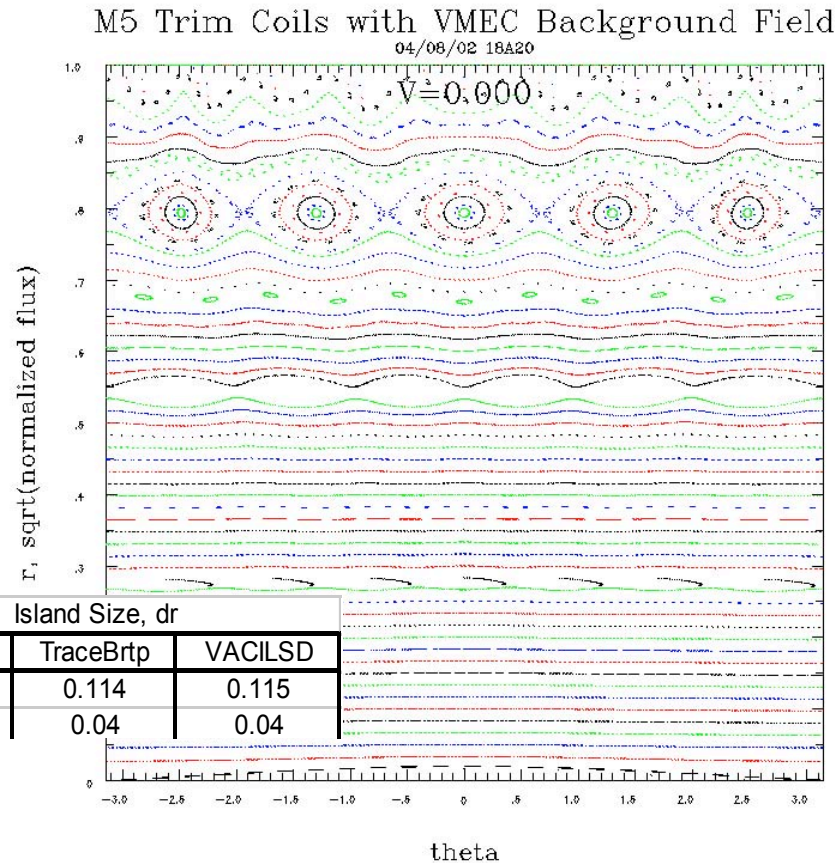
Benchmark of Field Line Tracing of Perturbation Field* from Coils on VMEC Field

mode	Island Size, dr		
	PIES	TraceBrtp	VACILSD
5,3	0.098	0.114	0.115
6,3	0.043	0.04	0.04

PIES

TraceBrtp

Verification of Addition of Perturbation Field
On VMEC Field. Not Full Pies Run

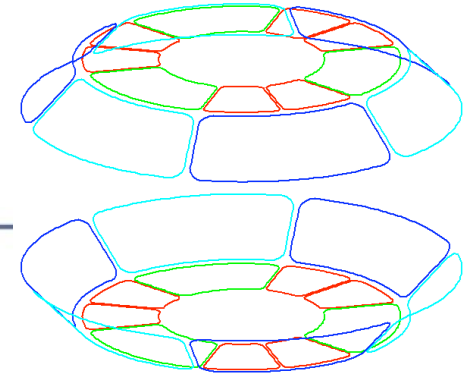
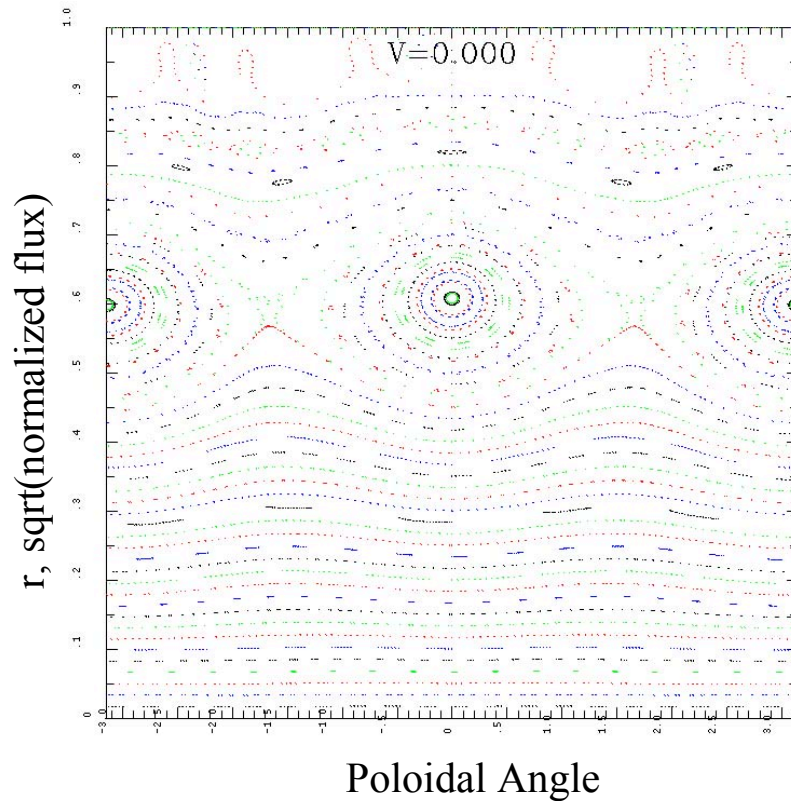
Results from Earlier Studies With Trim Coils Outside TF

Very Large $\iota=1/2$ Island Induced
by coil tolerance

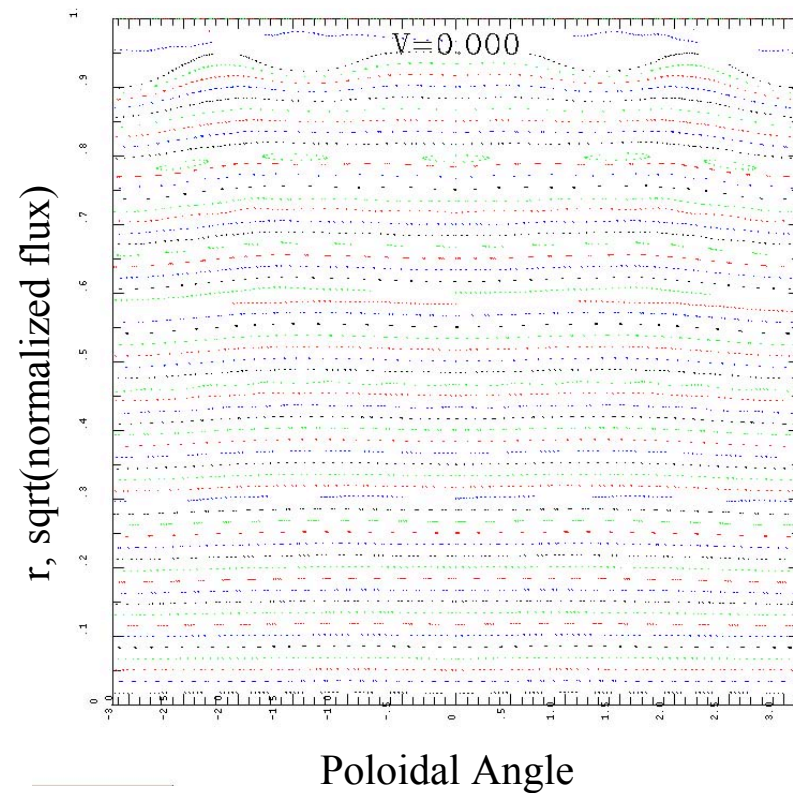
$\iota=1/2$ Island Suppressed,
Max trim coil current = 30.5 kA-T
