# A-6 COIL WELD MAP

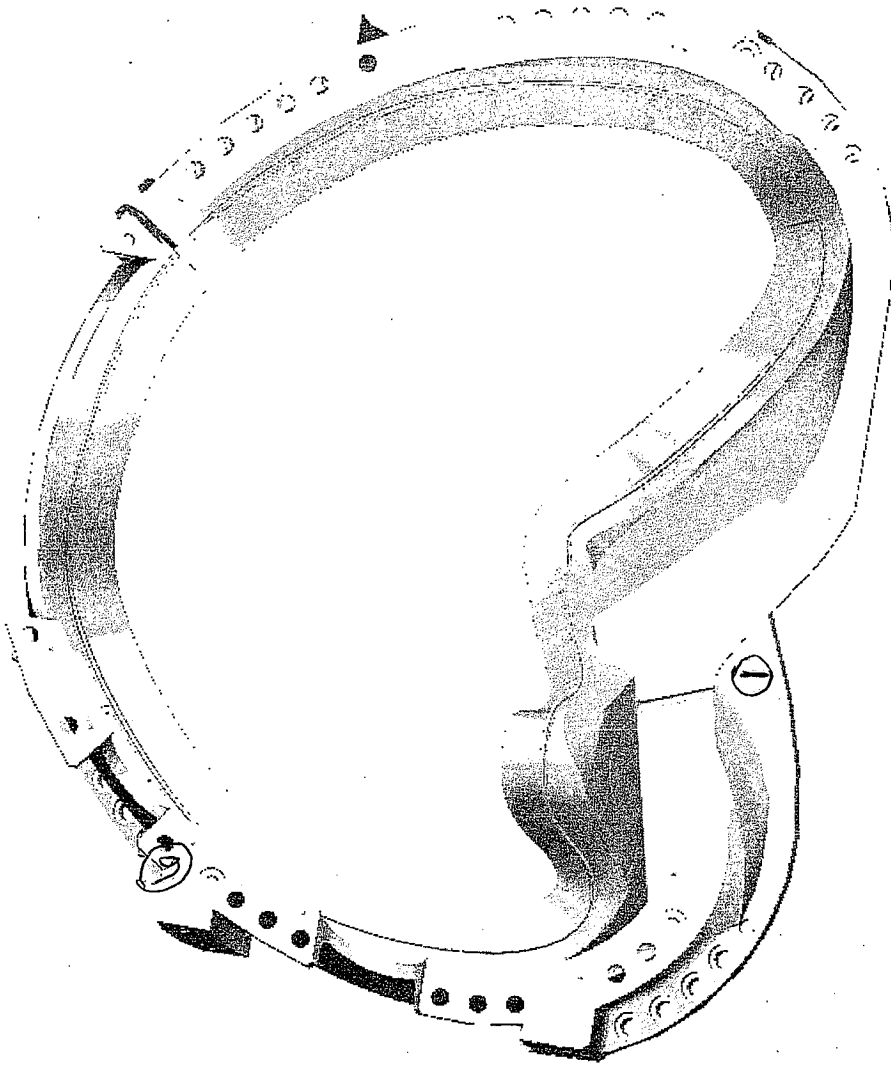
Defect Number	Drawing View	Length Inches	Width Inches	Depth Inches	Over 20% wall Over 1 inch Over 10 <sup>2</sup> inches Yes/No
1	LEFT	5.50	4	2.50	YES
2	TOP	3	3	1.50	YES
3	BACK	10	3	2.75	YES
4	BACK	8	2.75	2.75	YES
5	BACK	8	4	1	YES
6	LEFT	2	2	1.50	YES
