# B-4 COIL WELD MAP

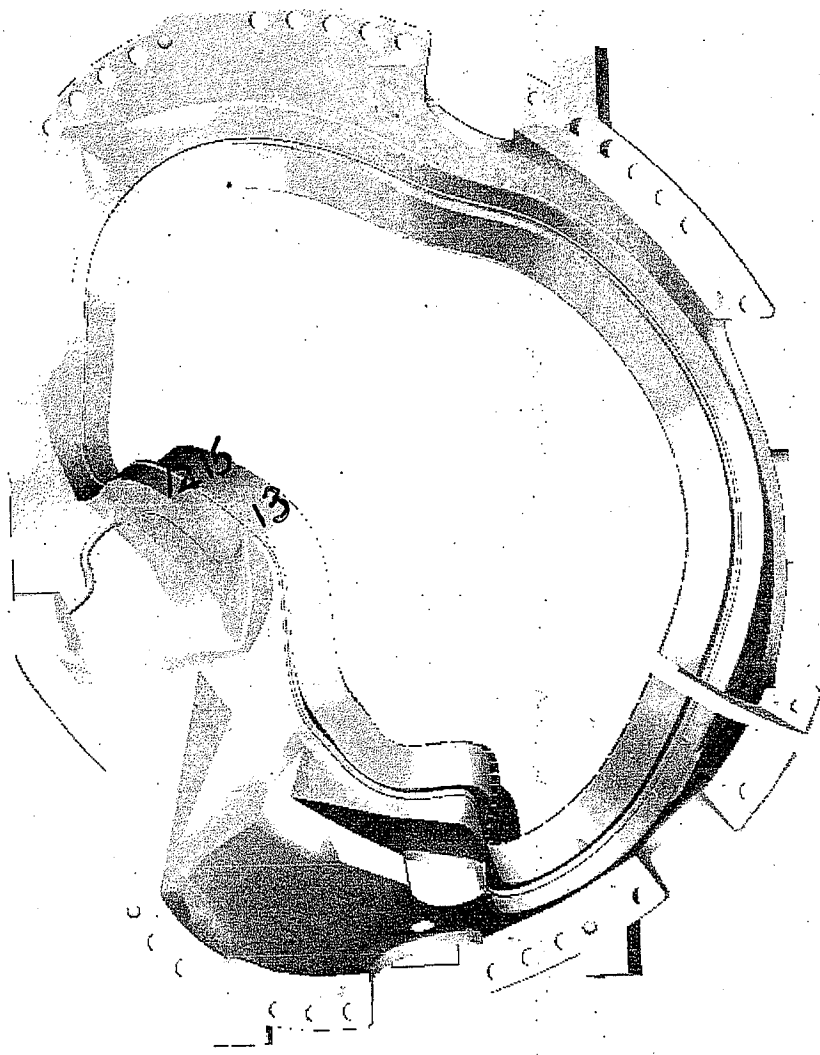
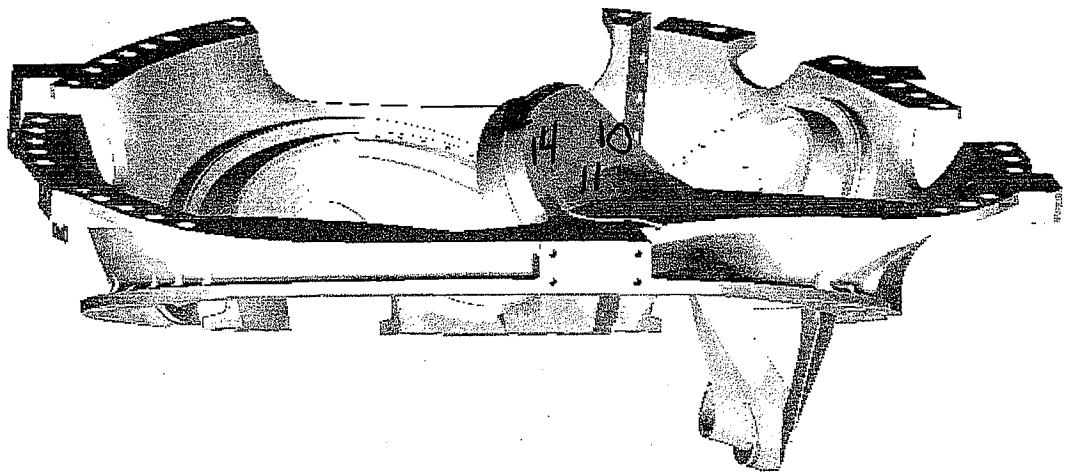
Defect Number	Drawing View	Length Inches	Width Inches	Depth Inches	Over 20% wall Over 1 inch Over 10 <sup>2</sup> inches Yes/No
1	LEFT	7	5	5	YES
2	LEFT	8	6.50	.25	YES
3	LEFT	4	1.50	1	YES
4	LEFT	6	2	1	YES
5	LEFT	22	9	.75	YES
6	LEFT	8	6	THRU	YES
7	LEFT	1.50	1	1	YES
8	BACK	16	3.50	.50	YES
9	TOP	6.50	2	1	YES
10	Front	6 $\frac{1}{4}$	6 $\frac{3}{4}$	$\frac{1}{2}$	yes
11	Front	3 $\frac{1}{8}$	5 $\frac{1}{2}$	1	↓
12	Right	8 $\frac{1}{4}$	4 $\frac{1}{4}$	$\frac{1}{2}$	
13	Right	2 $\frac{1}{2}$	1 $\frac{3}{4}$	1 $\frac{1}{8}$	
14	FRONT	6 $\frac{1}{2}$	5 $\frac{1}{2}$	$\frac{3}{4}$	
15	Right	6 $\frac{3}{4}$	3 $\frac{3}{4}$	1
