# Case 0918a14

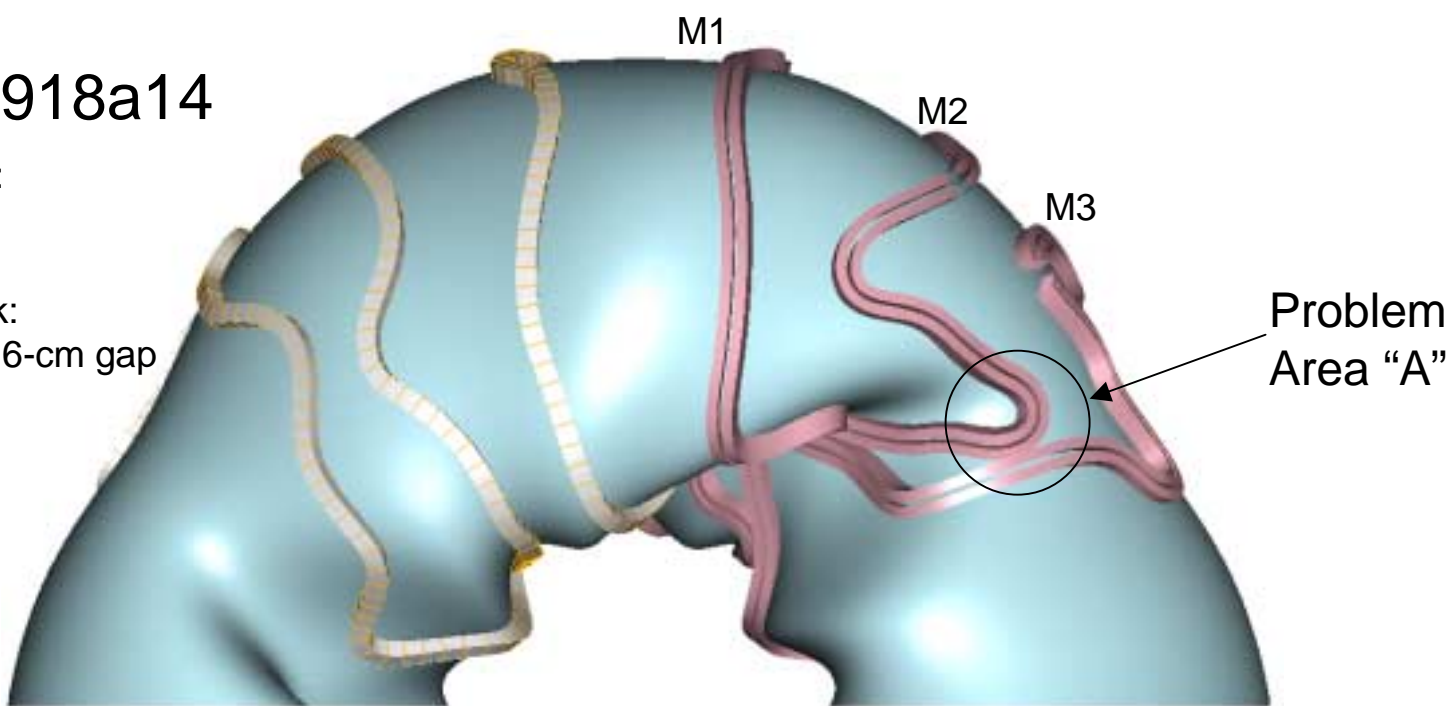
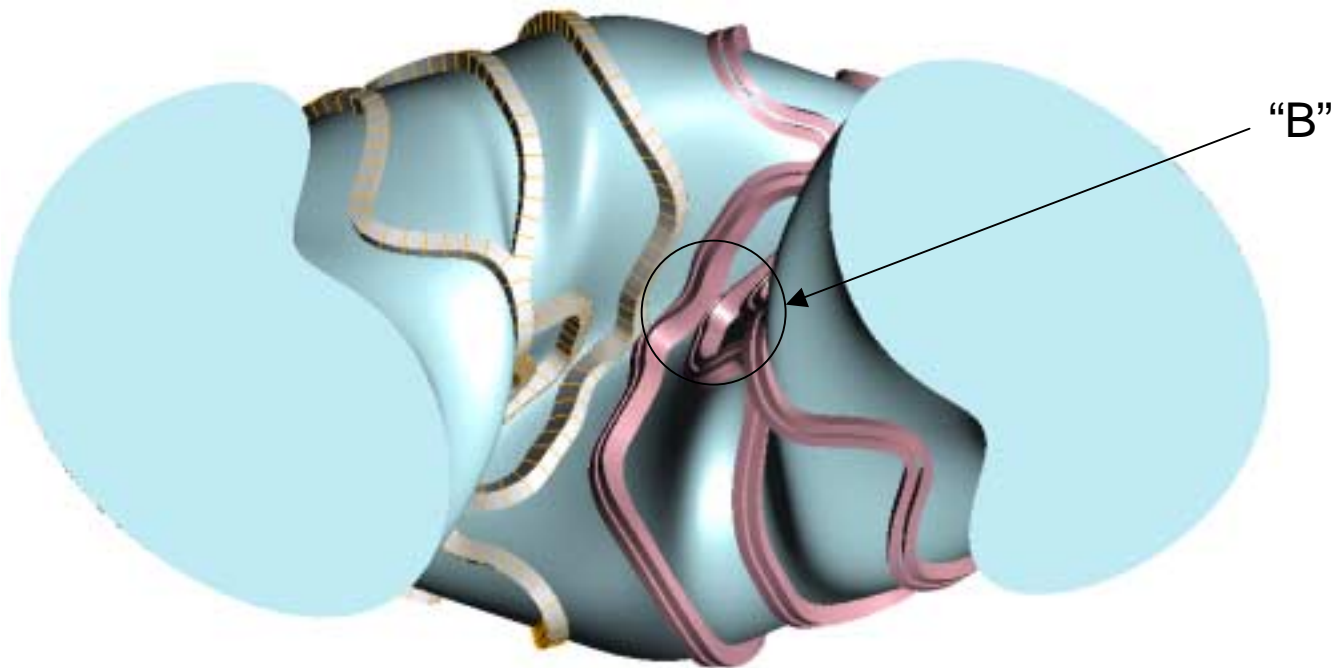
Single Pack:  
7.3 x 11-cm

Double Pack:  
4 x 12-cm, 1.6-cm gap

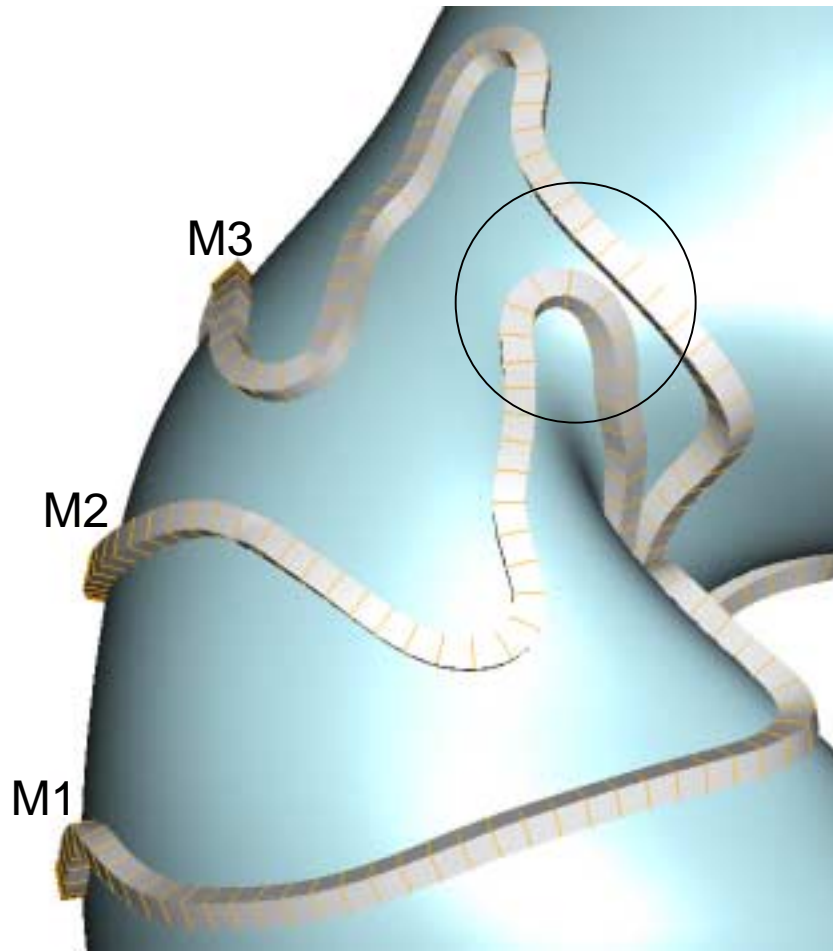
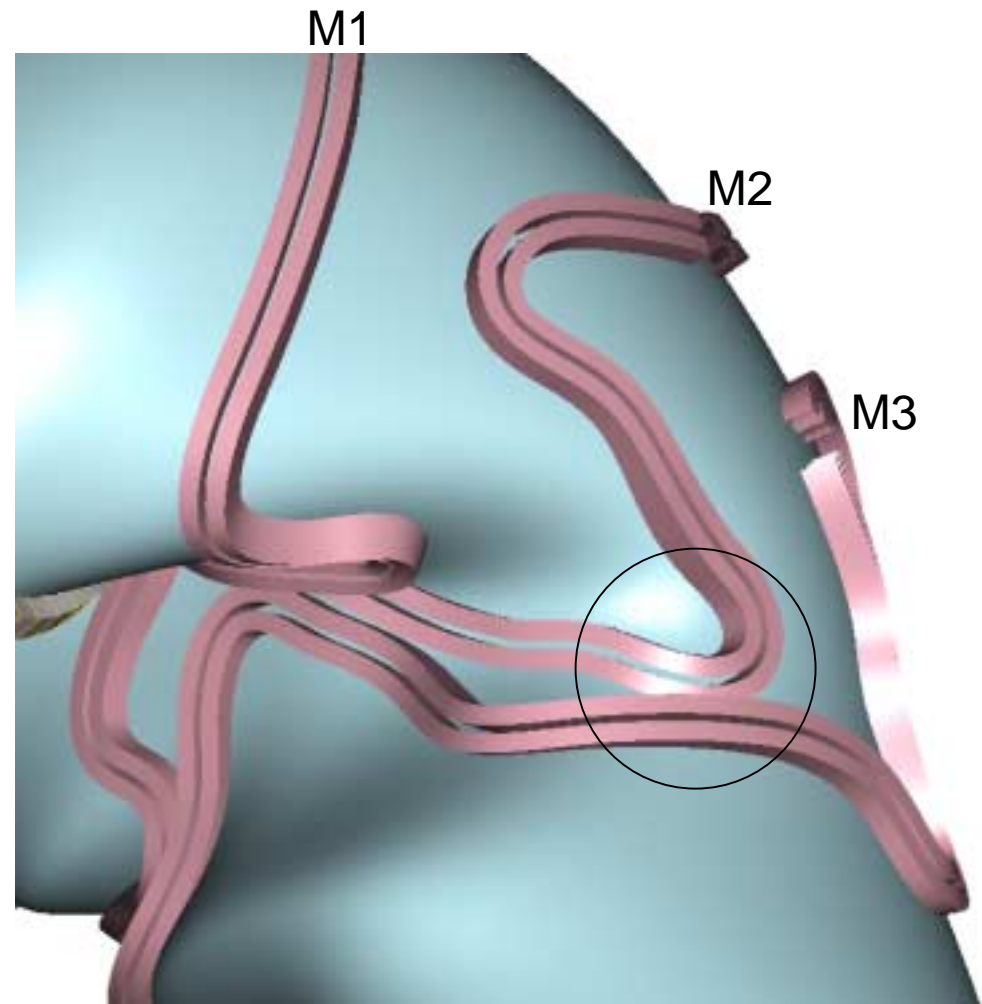
# Problem Area "A"

Needs local adjustment of M2 winding center
